# Providence Water Supply Board Facility Assessment - Phase I

December 2008

*Final Report*

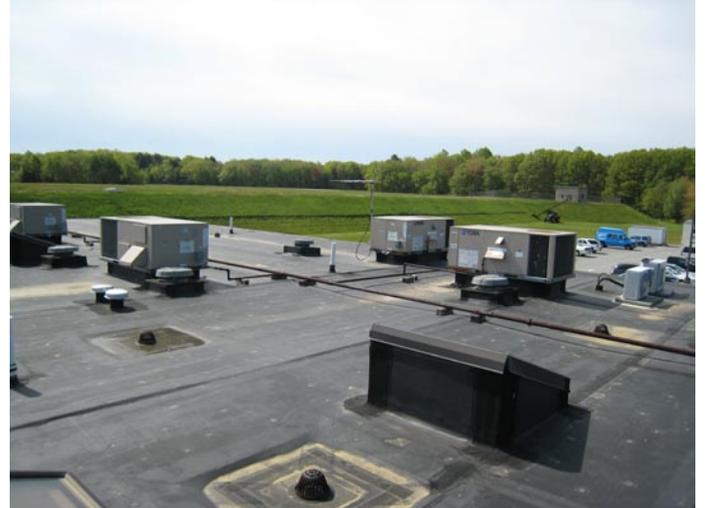
Cranston Roof

<u>Exterior Building System:</u>	<u>Condition Assessment:</u>
Exterior wall (EIFS)	Good
Windows	Good
Doors	Good
Roofing	Good, some “ponding” of rain water

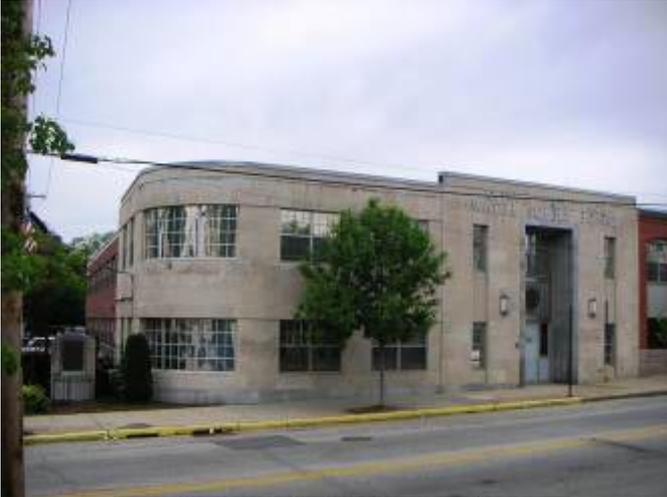
Providence Building Facade

<u>Exterior Building System:</u>	<u>Condition Assessment:</u>
Masonry walls	Good physical condition but uninsulated at garage and its support spaces, minor spalling of brick at exterior, pointing of masonry at back of parapet and tile coping needed
Windows (multi-pane)	Poor, inoperable or difficult to operate, energy inefficient single pane, no thermal break frames with deteriorated weather stripping, mill finish aluminum corroded
Windows (storefront)	Good, new insulating glass, anodized aluminum frames
Service doors	Fair, light duty, uninsulated
Personnel doors	Fair
Roofing system	Fair, some membrane fasteners not seated properly, counterflashing in poor condition

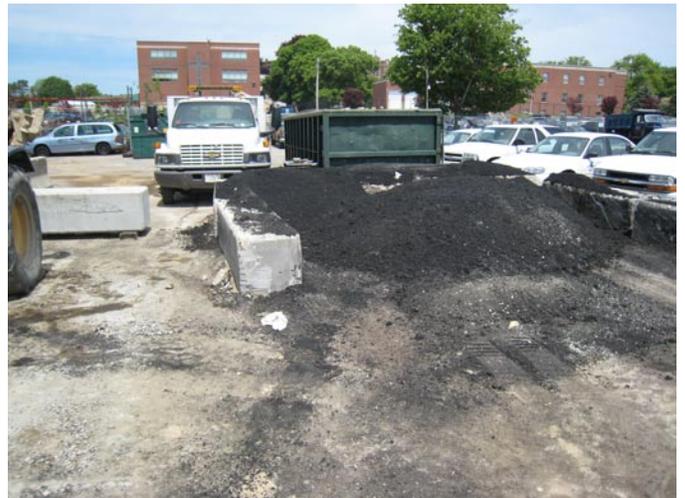
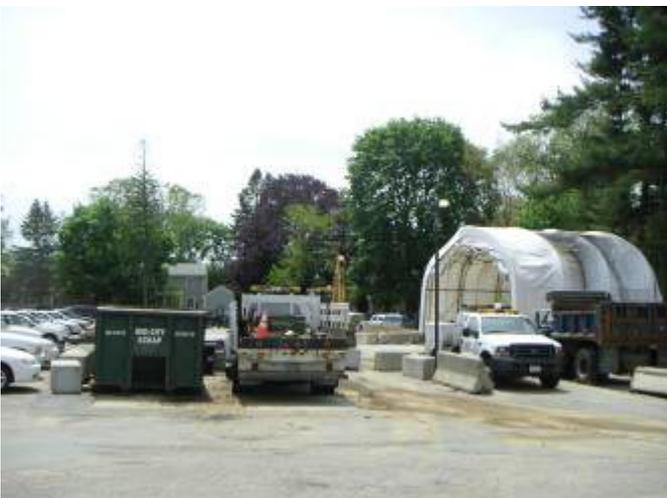
Providence Materials Storage

- Parking for employees and PWSB vehicles in the yard is inadequate, and restricted aisle space has caused accidents and damage to vehicles.
- Storage and handling of bulk materials is limited, and maneuvering space for trucks and loaders is severely restricted.

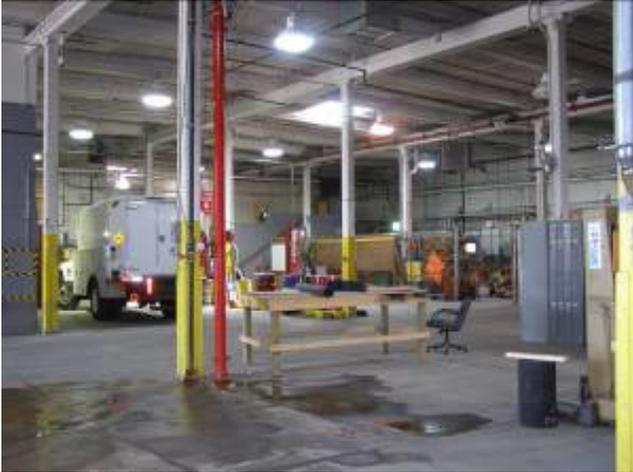
Providence Garage Interior

<u>Interior Finishes Garage Area:</u>	<u>Condition Assessment:</u>
Wood columns	Poor/Fair, damaged and covered with steel channels
Roof deck	Poor, peeling paint in many areas, some water damage by past roof leaks
Concrete floor finish	Fair, worn paint, cracks, misalignment
Masonry wall finish	Fair, soiled by age and exposure
Partitions, painted	Fair, worn, soiled by age and exposure, not dust tight at electronic equipment room
Partitions, paneled	Fair, residential quality
Doors	Fair, functional residential quality
Terrazzo floors	Fair, need refinishing
Tile wainscoting	Good, selective regrouting needed
Acoustical tile ceilings	Fair, misaligned and some damage
Painted plaster ceilings	Fair
Lockers	Poor

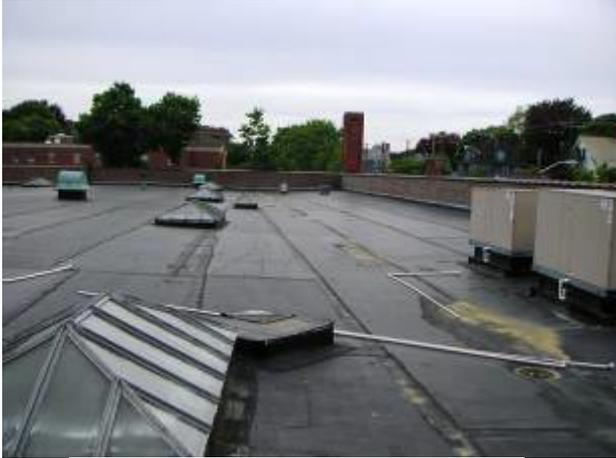
Providence Roof

- **Age** – The original roof deck was constructed before 1900. The roof deck of the addition was constructed around 1953.
- **Condition** – The roof deck appears to be in good condition.

- **Recommendations** – A secondary roof drainage system should be added. One option is to install openings in the parapet.

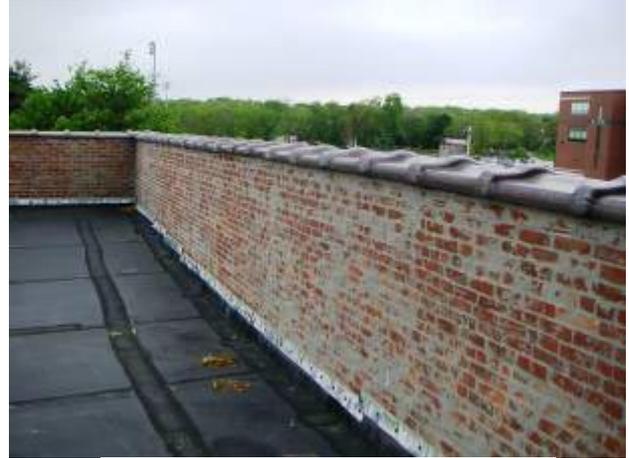
Providence Roof Wall

- **Snow Load Issue** – The top of the brick parapet is as much as 6 feet above the low point of the roof. This leads to heavy snow loads from drifting snow. Calculations indicate beams and girders will be overstressed due to code recommended snow loads.
- **Recommendations** – The beams close to the parapet should be reinforced for increased snow loads due to drifting snow. Wood columns are subject to damage caused by vehicle operations in the garage area. The columns should be replaced or reinforced for protection.

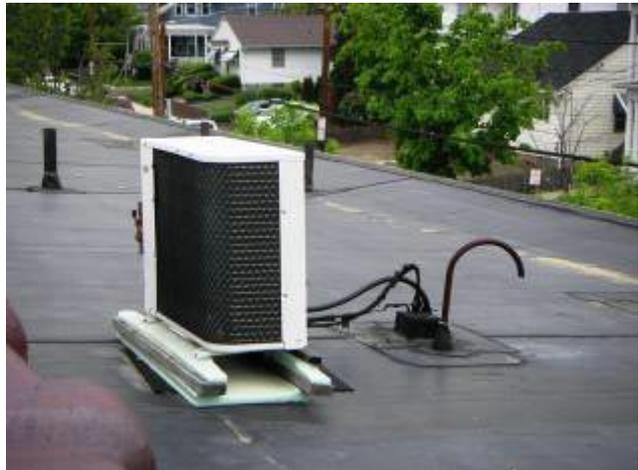
Providence Roof Equipment

- **Condition** –
  1. Air conditioning units appear in acceptable condition, although they were not operating during the inspection. Internal inspection was not performed.

1. Two active roof exhaust fans are rated at 7500 cfm each. These appear to date back to 1953 and are in poor condition.
2. The propeller exhaust fan mounted in the north wall appears more recent and in operable condition, although it was not running during the inspection.
3. The two carbon monoxide exhaust systems appear relatively new and in operable condition. Capacity information was not available; however, system duct and flexible hose diameters appear marginal for the type and size of equipment being stored in the facility. Roof mounted exhaust fans flow and pressure capacities also appear undersized for this type of service.

- **Recommendations** –
  1. Large area type roof exhaust fans should be replaced with new equipment.
  2. Carbon monoxide exhaust systems should be evaluated for adequate flow and pressure capacity appropriate for the required service and modifications made as required for acceptable performance.
  3. Current codes require maintenance and service garages be continuously ventilated with outdoor air; there is currently no equipment installed to provide this ventilation.
  4. All occupied spaces adjoining the garage and equipment storage area should be provided with continuous outdoor air ventilation to reduce the tendency for vehicle exhaust emissions to migrate into these areas.
  5. Carbon monoxide and Nitrogen Oxide monitoring should be installed in the garage area to operate incremental ventilation automatically based upon elevated levels of vehicle emissions.

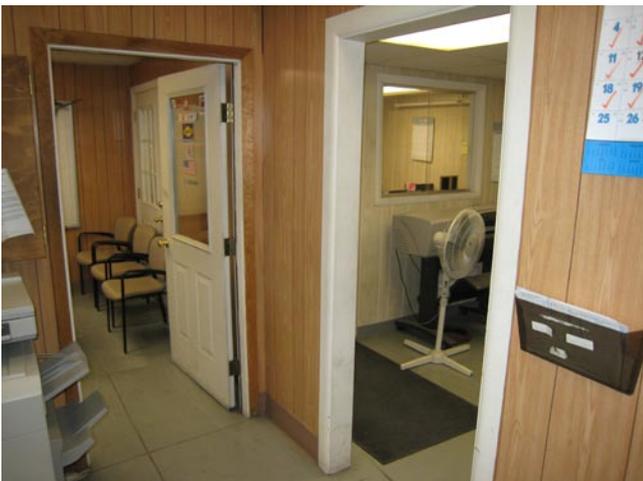
Providence Offices

<u>Interior Building System:</u>	<u>Condition Assessment:</u>
Carpet	Fair
Resilient flooring	Good
Ceiling system	Fair
Gypsum board walls	Fair
Doors and hardware	Fair
Modular furniture system	Fair
Kitchen cabinets	Good
Toilet partitions	Fair

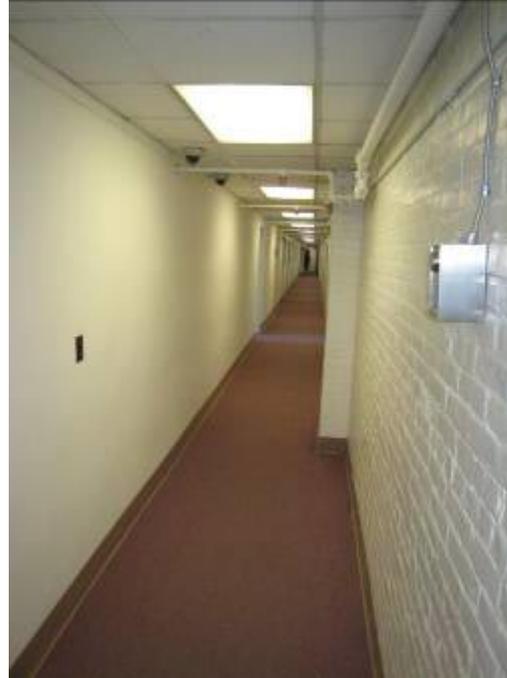
Providence Office Hallway  
(Brick Wall Abuts Garage)
