Providence Water Supply Board Facility Assessment - Phase I

December 2008

Final Report

CDM

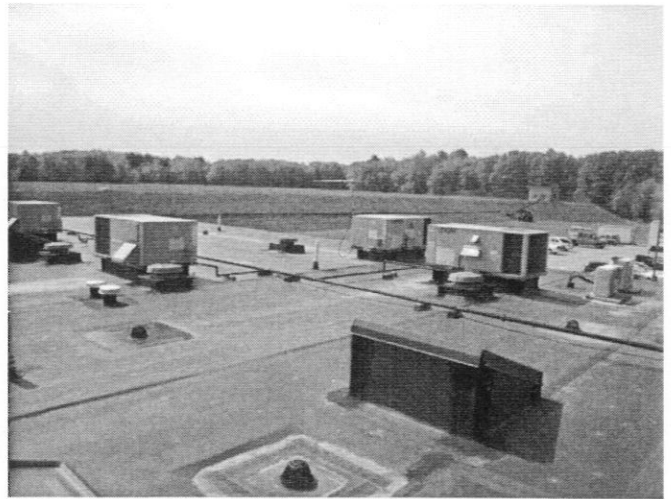
<u>Exterior Building System:</u>	<u>Condition Assessment:</u>
Exterior wall (EIFS)	Good
Windows	Good
Doors	Good
Roofing	Good, some "ponding" of rain water

Cranston Roof

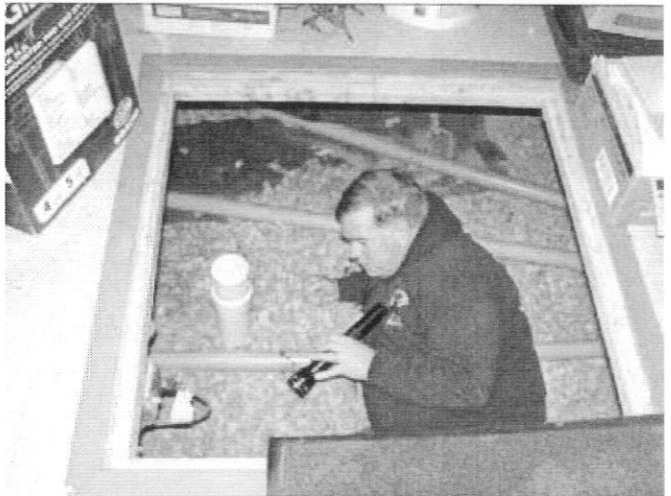
- *Condition* – The condition of the PVC piping appears to be in very good condition. The piping is bowed a little bit in the crawl space due to lack of support, but that can be easily addressed through the installation of additional supports.

Cranston Crawl Space Access

- *Recommendations* – The sanitary PVC piping is in very good condition and is only ten years old. The piping in the crawl space needs additional support, as some of the piping is sagging between the supports and the piping is developing a slight bow. The piping should also be labeled.

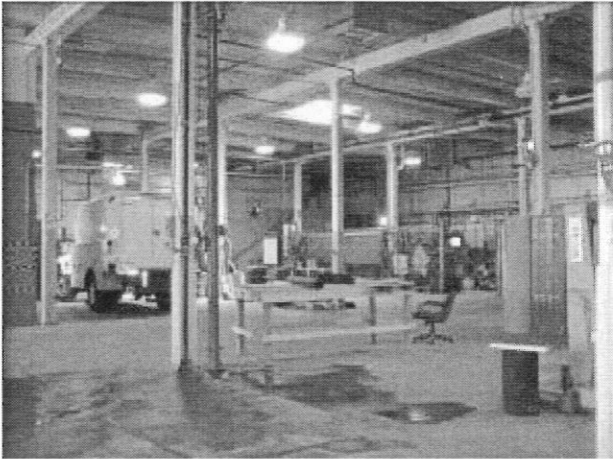
<u>Interior Finishes Garage Area:</u>	<u>Condition Assessment:</u>
Wood columns	Poor/Fair, damaged and covered with steel channels
Roof deck	Poor, peeling paint in many areas, some water damage by past roof leaks
Concrete floor finish	Fair, worn paint, cracks, misalignment
Masonry wall finish	Fair, soiled by age and exposure
Partitions, painted	Fair, worn, soiled by age and exposure, not dust tight at electronic equipment room
Partitions, paneled	Fair, residential quality
Doors	Fair, functional residential quality
Terrazzo floors	Fair, need refinishing
Tile wainscoting	Good, selective regrouting needed
Acoustical tile ceilings	Fair, misaligned and some damage
Painted plaster ceilings	Fair
Lockers	Poor

Providence Garage Interior

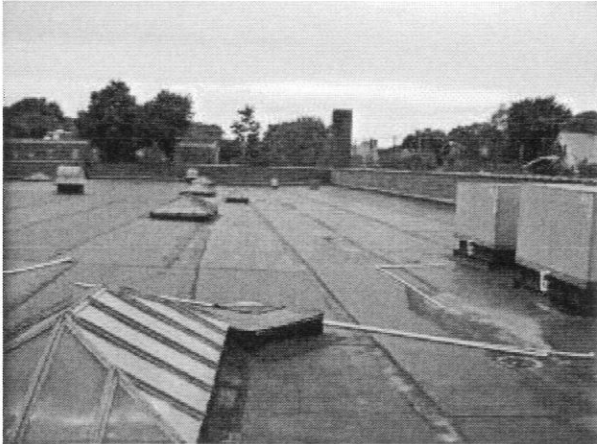
- **Snow Load Issue** – The top of the brick parapet is as much as 6 feet above the low point of the roof. This leads to heavy snow loads from drifting snow. Calculations indicate beams and girders will be overstressed due to code recommended snow loads.
- **Recommendations** – The beams close to the parapet should be reinforced for increased snow loads due to drifting snow. Wood columns are subject to damage caused by vehicle operations in the garage area. The columns should be replaced or reinforced for protection.

Providence Roof

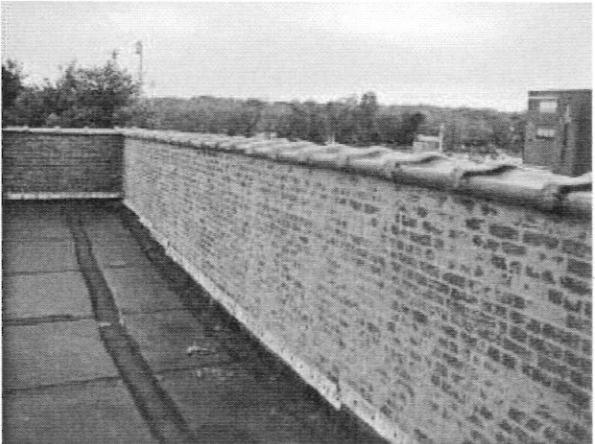
<u>Exterior Building System:</u>	<u>Condition Assessment:</u>
Masonry walls	Good physical condition but uninsulated at garage and its support spaces, minor spalling of brick at exterior, pointing of masonry at back of parapet and tile coping needed
Windows (multi-pane)	Poor, inoperable or difficult to operate, energy inefficient single pane, no thermal break frames with deteriorated weather stripping, mill finish aluminum corroded
Windows (storefront)	Good, new insulating glass, anodized aluminum frames
Service doors	Fair, light duty, uninsulated
Personnel doors	Fair
Roofing system	Fair, some membrane fasteners not seated properly, counterflashing in poor condition

Providence Roof Wall

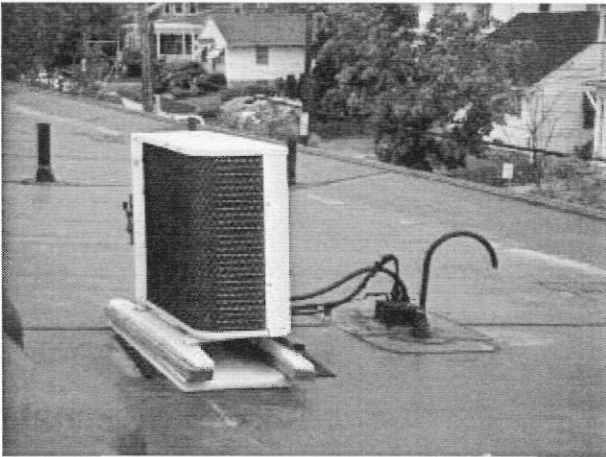
1. Two active roof exhaust fans are rated at 7500 cfm each. These appear to date back to 1953 and are in poor condition.
2. The propeller exhaust fan mounted in the north wall appears more recent and in operable condition, although it was not running during the inspection.
3. The two carbon monoxide exhaust systems appear relatively new and in operable condition. Capacity information was not available; however, system duct and flexible hose diameters appear marginal for the type and size of equipment being stored in the facility. Roof mounted exhaust fans flow and pressure capacities also appear undersized for this type of service.

Providence Roof Equipment

1. Large area type roof exhaust fans should be replaced with new equipment.
2. Carbon monoxide exhaust systems should be evaluated for adequate flow and pressure capacity appropriate for the required service and modifications made as required for acceptable performance.
3. Current codes require maintenance and service garages be continuously ventilated with outdoor air; there is currently no equipment installed to provide this ventilation.
4. All occupied spaces adjoining the garage and equipment storage area should be provided with continuous outdoor air ventilation to reduce the tendency for vehicle exhaust emissions to migrate into these areas.
5. Carbon monoxide and Nitrogen Oxide monitoring should be installed in the garage area to operate incremental ventilation automatically based upon elevated levels of vehicle emissions.
