Property Condition Assessment

125 Dupont Drive
Providence, RI

June 2015

RE: Property Condition Assessment Report
Proposed Central Operations Facility
125 Dupont Drive, Providence RI

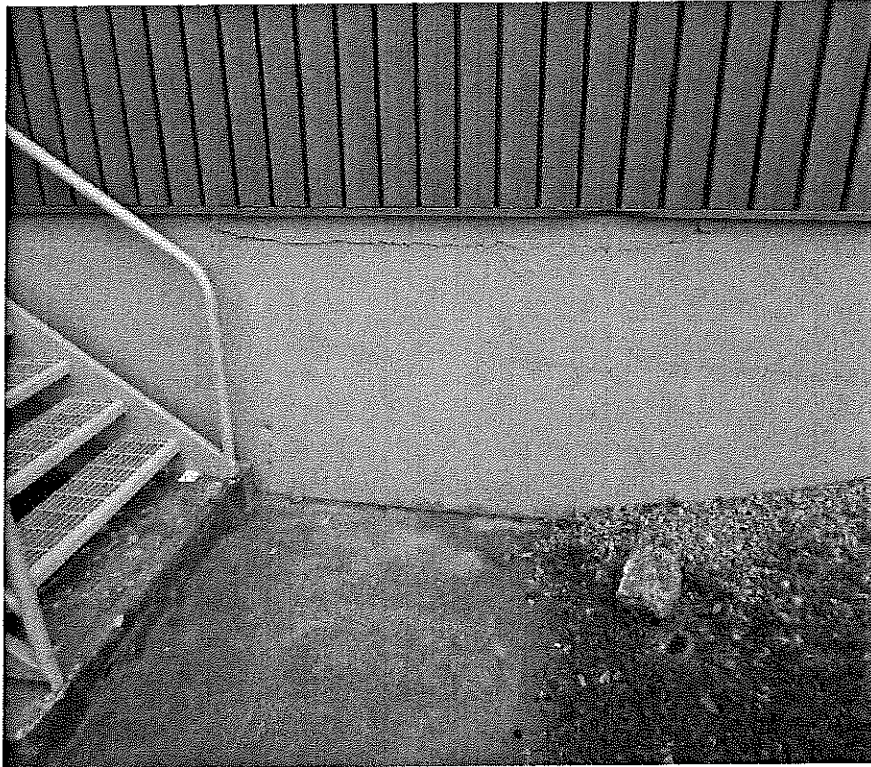
1. The foundation consists of concrete frost walls constructed on strip footings at the exterior perimeter (or the existing exterior perimeter prior to additions constructed in the mid 1980's). Shallow concrete spread footings support columns within the building. The first floor is a grade supported concrete slab of varied thickness.
2. The foundation was observed to be generally in good condition not exhibiting any structural distress. A minor horizontal crack was noted along the north wall adjacent to the eastern loading dock.

Photo A-1: Foundation crack at westernmost loading dock along north wall

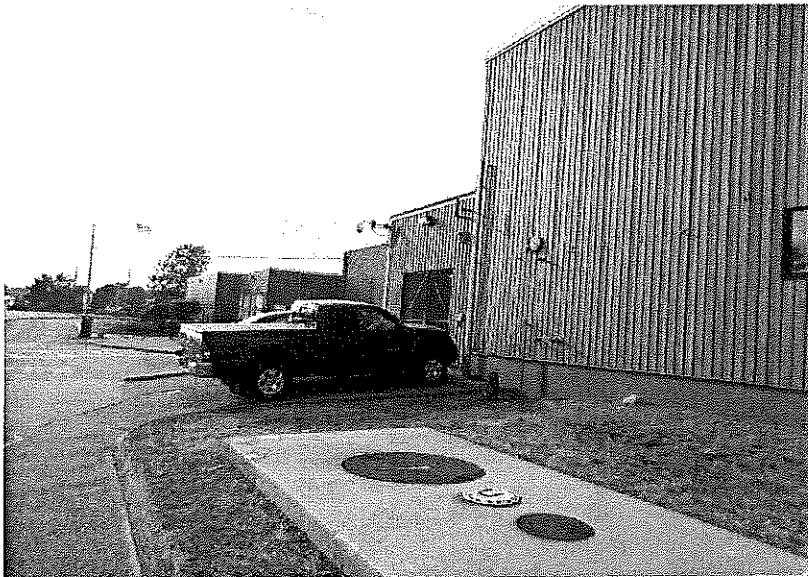
1. Rust stains were observed at locations where unprotected steel penetrate or are attached to the structure. Though this condition can be observed in several discrete locations along the buildings perimeter, the most visible locations include the attached masonry garage and the EIFS cornice at the bank entrance to the west.
2. On the southernmost wall there is a small relatively steeply sloped parking area adjacent to the building. It appears that vehicles colliding with the building while attempting to park on the slope may be a common occurrence.

Photo A-10: Minor damaged to façade at adjacent parking area on southern wall

Issues appear to be cosmetic and do not appear to impede function of affected areas. No additional action is recommended at this time.

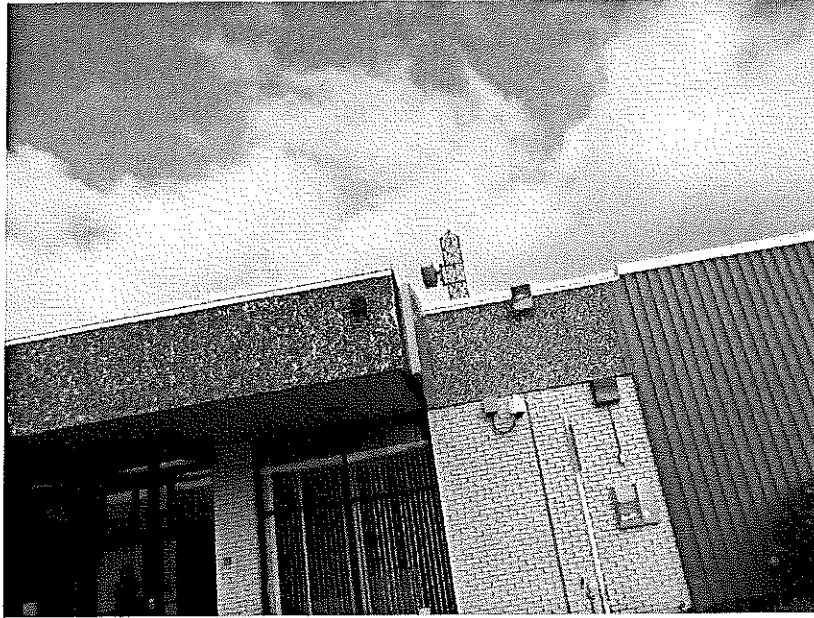
Photo A-11: Rust stain on cornice (west wall)

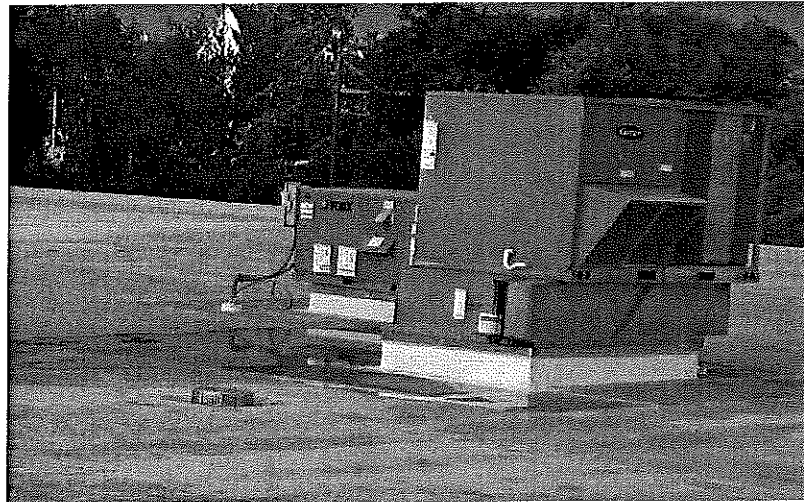
Observation revealed some locations with minor amounts of standing water, other locations display staining that can be attributed to minor ponding. The Property Manager stated that the low-points are within the manufacturers specifications and the roof is currently under warranty. Stained acoustical ceiling tiles were also noted within the building. The stains observed are typically attributed to water intrusion. It is possible that any observed staining occurred prior to the recent roof replacement. In general, the entire main roof appears to be in good condition.

Photo A-14: Minor ponding observed

Based on observations, the roofing systems at the main office building is expected to last through its warranted service life with routine maintenance. It is recommended to install a secondary scupper system in the parapet walls in the western portion of the building to prevent accumulation of rain water or snow-melt on this roof in the event the primary drainage system becomes clogged.

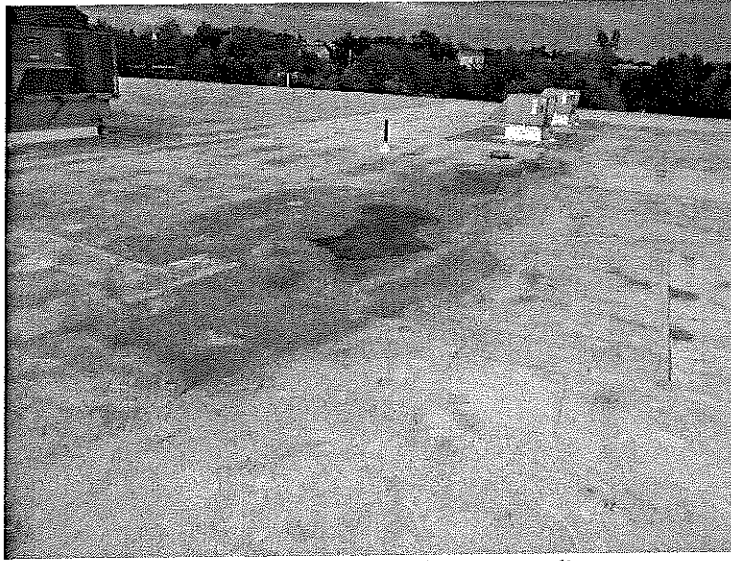
Photo A-15: Evidence of minor ponding

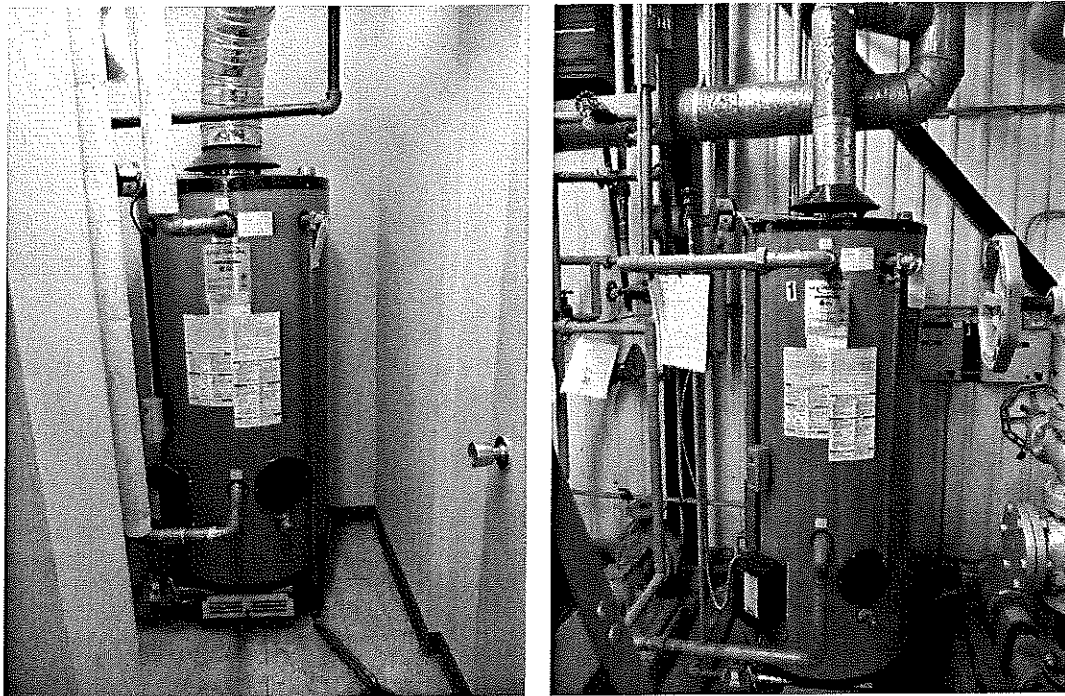
1. A 4" domestic cold water line from city main water supply enters the facility through the lower exterior wall of mechanical room 144.1, located at the center east side of the building. This mechanical room also houses the 3" natural gas line and the first of three 8" fire protection risers.
2. Domestic hot water is provided via three gas-fired water heaters described in the table below. Gas exhaust is vented through the building roof. All water heaters and piping appear to be in good condition. However, not all piping was insulated. (See Photo B-1)

Photo B-1: Gas-Fired Water Heaters (Typical)

- a. Insulate hot water piping in all areas of the building, including toilet rooms and mechanical room.
- b. Consider pro-active replacement of water heaters older than 10 years old.

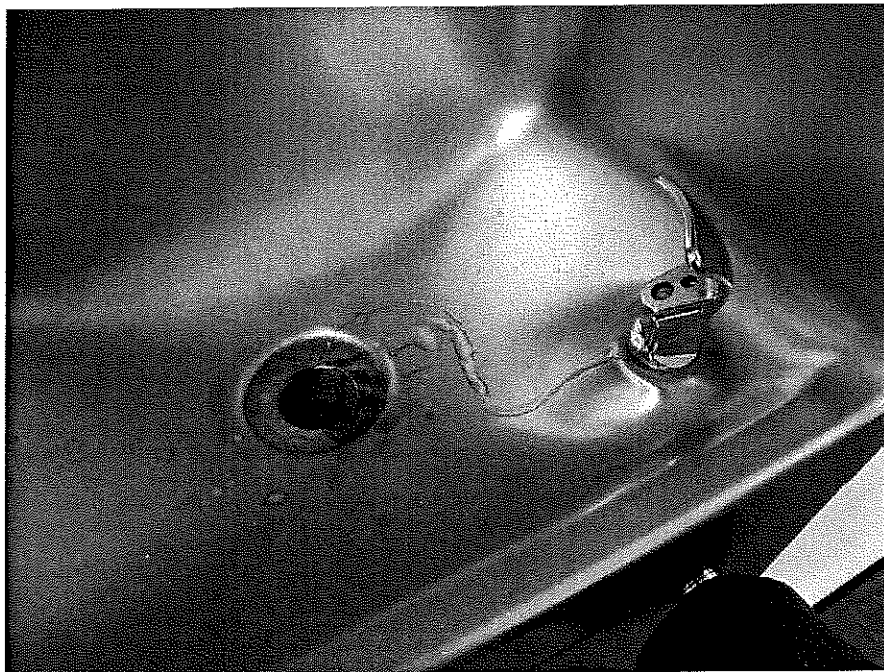
5. Several water coolers are located in the hallways between cubicle areas. These fountains have minimal to no flow. (See Photo B- 18).
6. A janitor closet in on the second floor (Room 251) contains a mop sink. The sink with pail hook appeared to be in usable condition. (See Photo B- 10).

Photo B-18: Water Coolers (Typical)

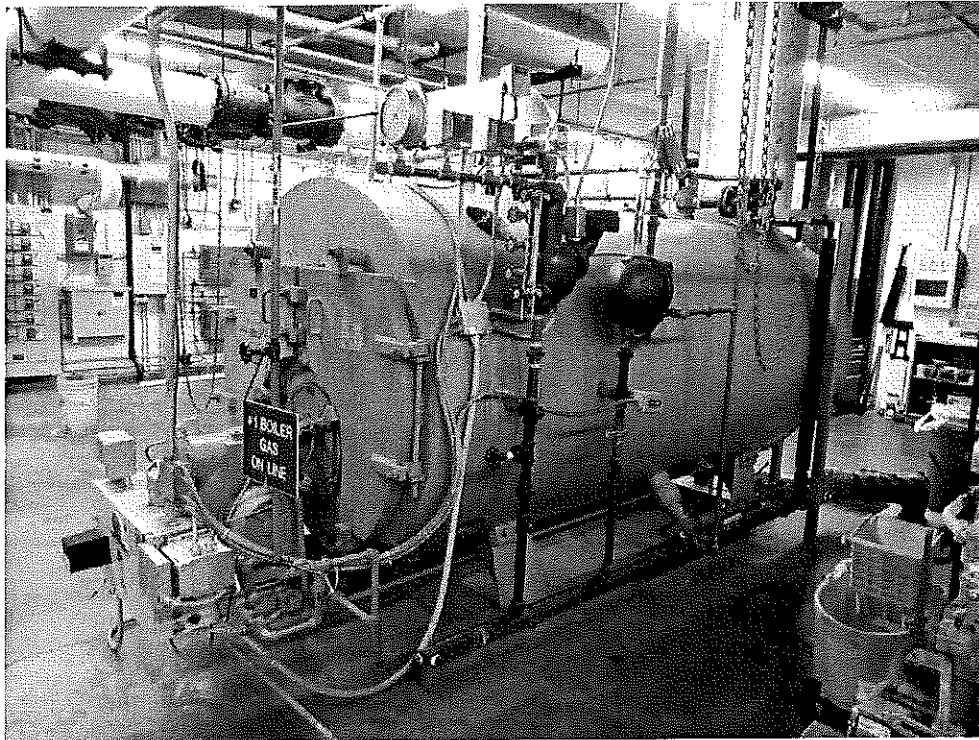
- 1. Two natural gas-fired steam boiler units are located within the mechanical room on the second floor. These boilers also have the capability of burning # 2 fuel oil which is fed from an aboveground storage, tank located adjacent to the mechanical room. These units are detailed in the table below. Each unit feeds a steam-to-water heat exchanger. Hot water from this heat exchanger is pumped to terminal devices located throughout the building. At the time of observation, one boiler was out of service. (See Photo B-20 and Photo B- 21)

Photo B-20: Whirl Power Boiler # 1

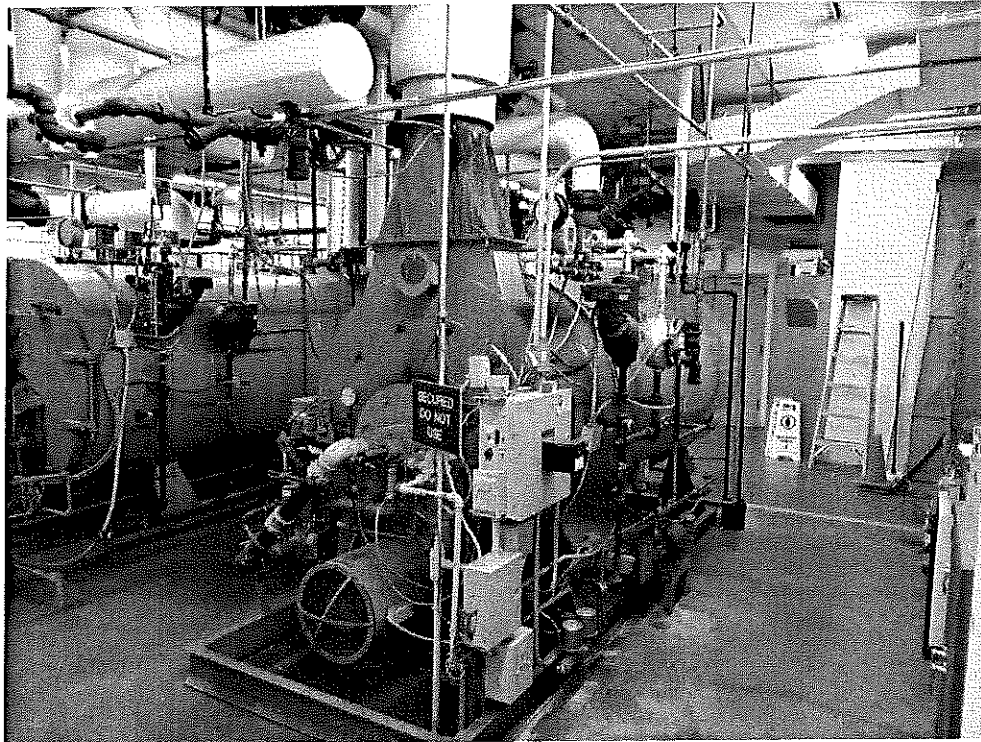
Photo B-21: Cyclotherm Boiler # 2

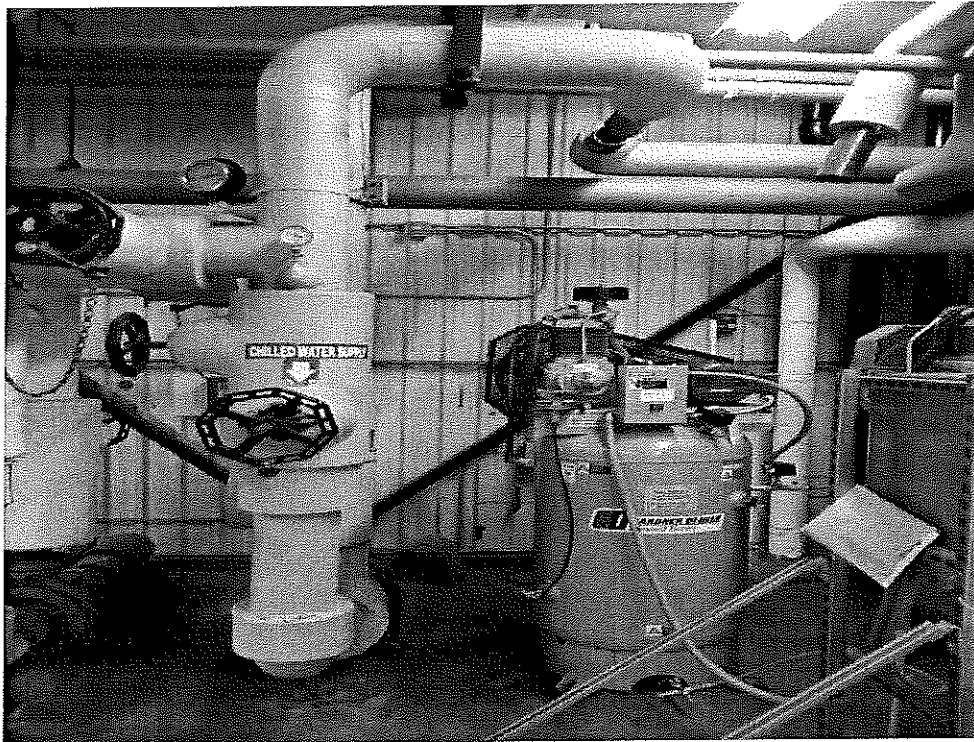
Photo B-25: Chiller Piping, Abandoned-in-Place

- a. Continue phased replacement of oldest packaged DX units.
- b. Replace dirty grilles and clean all ductwork.
- c. Remove disconnected and abandoned equipment and associated piping.
- d. Update centralized DDC control system and eliminate all pneumatic control functions other than actuation.

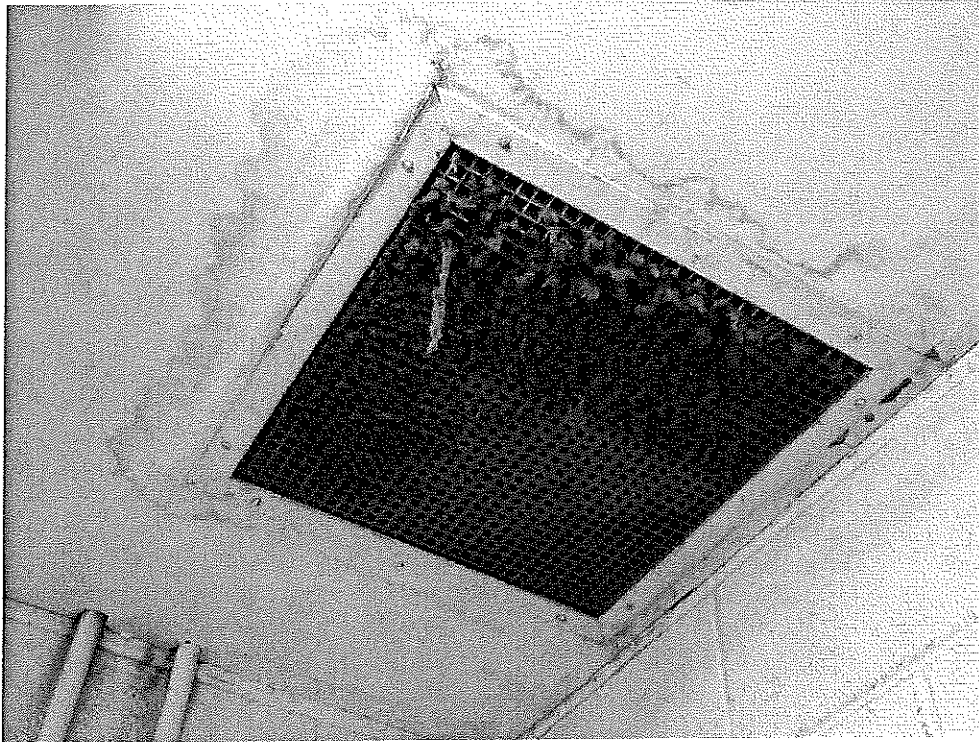
Photo B-27: Dirty Exhaust Grille

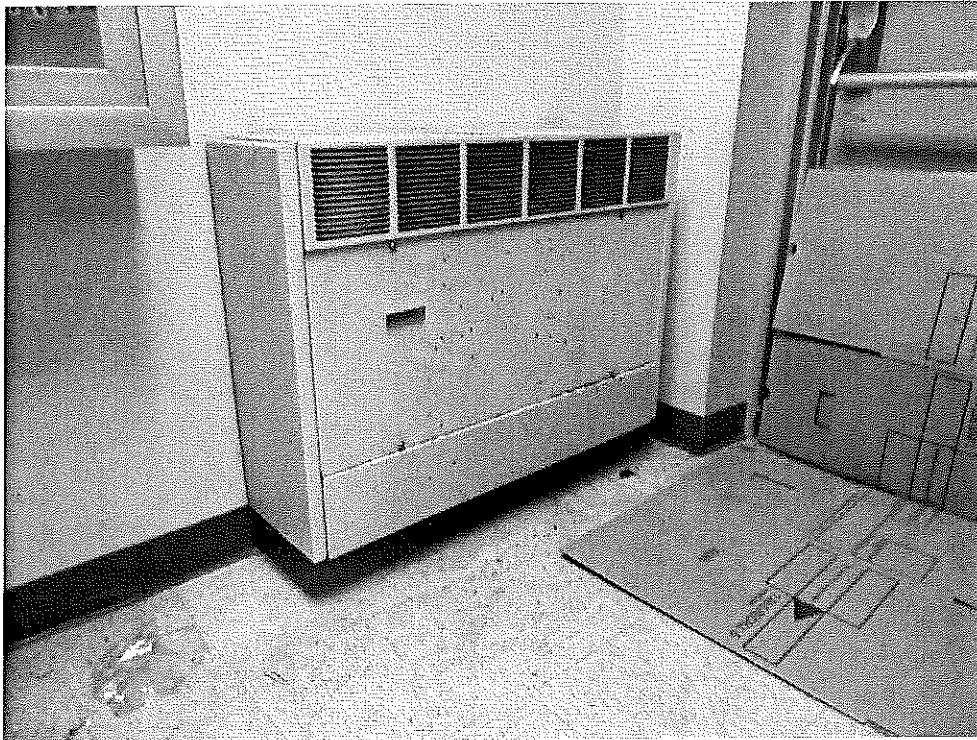
12. The mail room has an air curtain installed above the overhead door. (See Photo B-38).
13. Electric cabinet unit heaters are located at the bottom of each stairwell. Older units should be considered for pro-active replacement (see Photo B-28 and Photo B-29).

Photo B-28: Stairwell Cabinet Unit Heater (Typical)

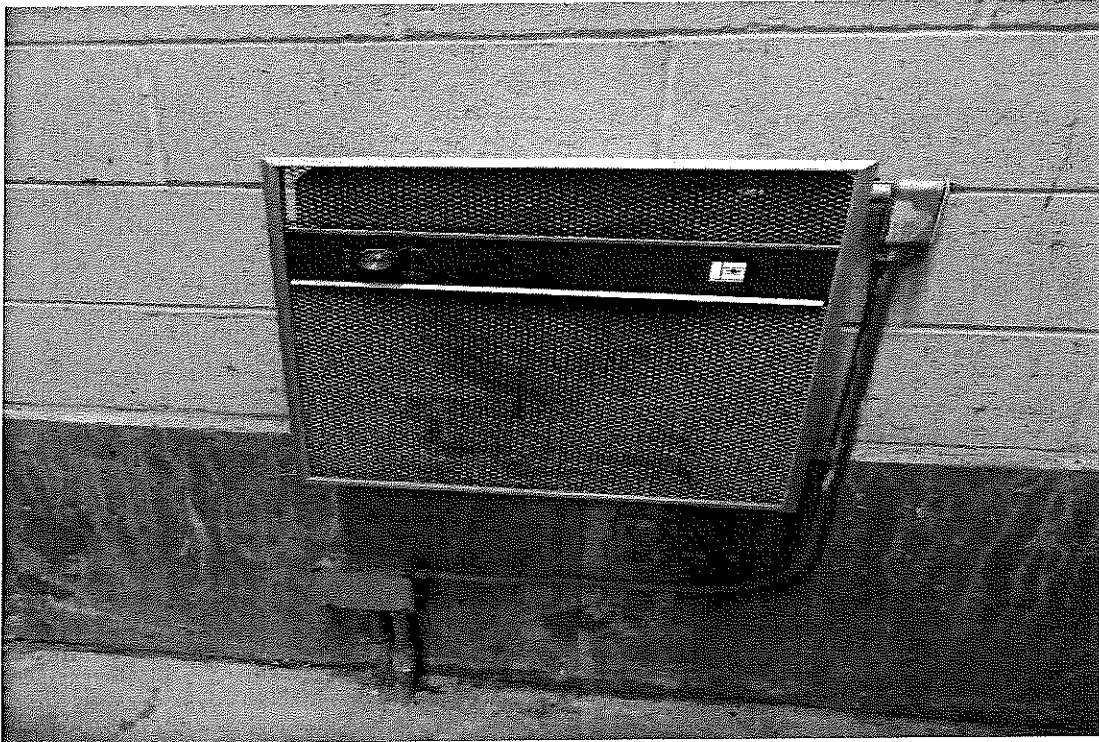
Photo B-29: Electric Cabinet Unit Heater

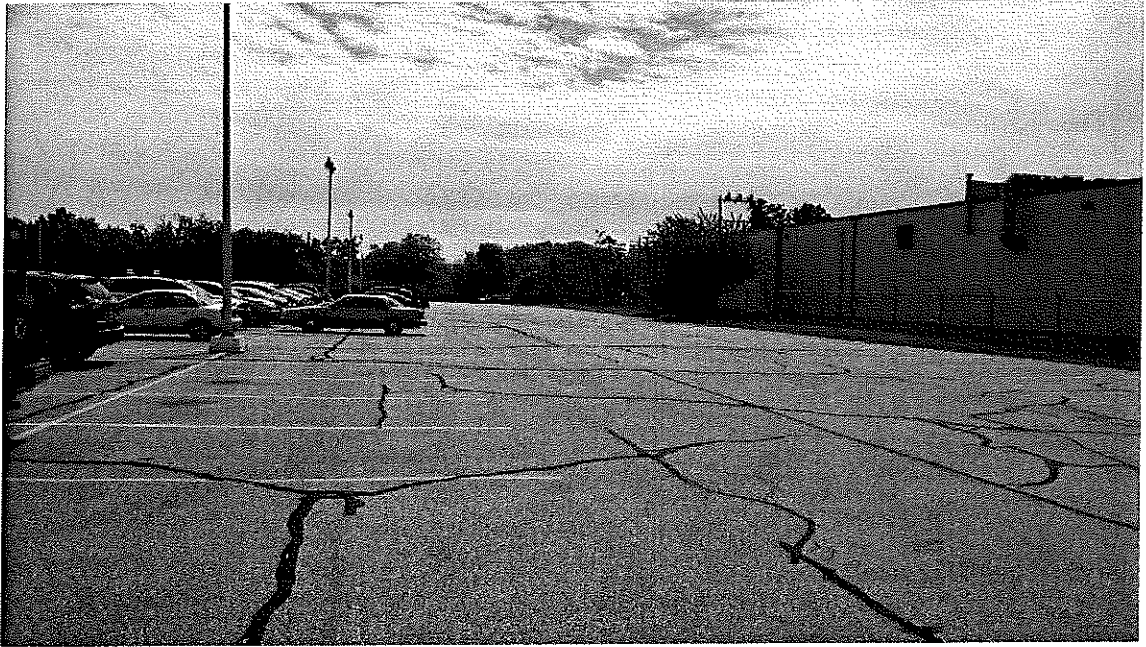
1. Approximately 5 acres of paved surface parking exist on the southern side of the building. Pavement is in fair to poor condition, with significant cracking. No evidence of a subsurface stormwater management system (i.e. catch basins) was observed in the parking area, and chute structures, apparently intended to collect surface runoff and directly discharge to Mashapaug Pond, were observed on the eastern side of the parking area. Soil in the landscaped perimeter between the parking lot and the chute in one site was exposed, with a loss of grass cover, and evidence of sediment transport toward the adjacent pond.

D-13: Southern parking lot surface

Recommendation: Evaluate whether a change in use or anticipated site improvements will necessitate stormwater management improvements under Rhode Island Pollutant Discharge Elimination System (RIPDES). Resurfacing of the asphalt parking lot may be warranted at some point in the near future.
