**RE: Division Docket No. D-11-94
National Grid Hurricane Irene Response Assessment
Responses to Division Data Requests (Set 2)
Section I. Engineering & Design**

SUBJECT L14 Failure Analysis

Analysis of L14 Pole 54 Failure

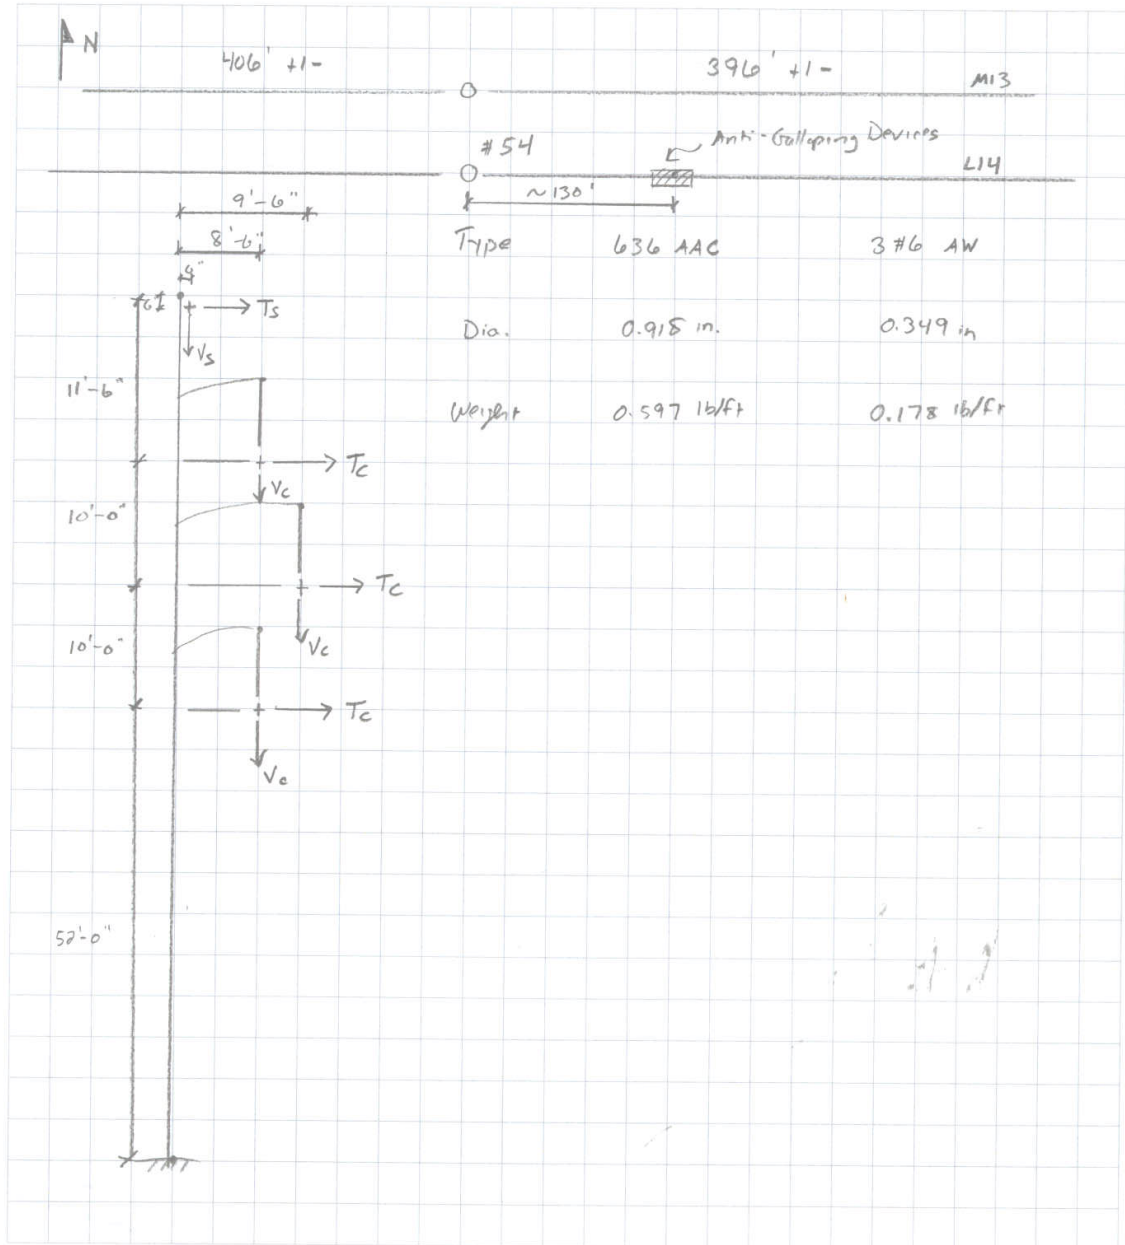
- 5.0 As shown in the attached calculations, the maximum stress occurring at the ground line for Rule 250B loading is approximately 7,530 psi. For Rule 250C loading, the maximum stress at the ground line is approximately 4,640 psi. Therefore, the pole was properly designed for the 1977 edition of the NESC.

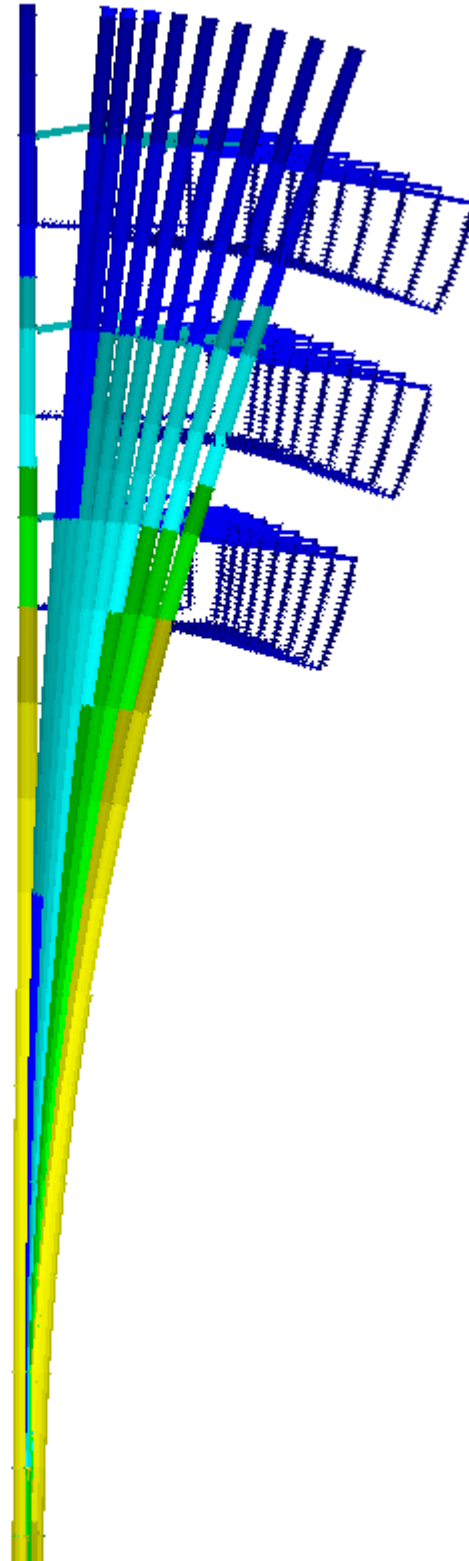
Figure 1 Model of Structure Behavior Under Various Wind Loads

- 7.1 Identify the maximum stress, and the location of the maximum stress, using PLS-POLE
 - 7.2 Calculate the probability of overload under this stress for an undamaged pole using the wood pole properties presented in ANSI O5.1.2008 and assuming wood pole strength variation is normally distributed
- 8.0 The results of the analysis are shown below. For the wind speeds observed during Tropical Storm Irene, the probability of overload for an undamaged pole is quite low. Therefore, it can be concluded with a high degree of certainty that the primary cause of failure was pre-existing damage, deterioration or defect, and not inadequate design.

Wind Speed (mph)	Applied Stress (ksi)	Distance from Top (ft)	Average Fiber Strength (ksi)	Standard Deviation (ksi)	Probability of Overload
40	1.9	26.8	6.8	1.4	0.02%
50	2.1	41.5	6.8	1.4	0.03%
60	2.5	41.5	6.8	1.4	0.08%
70	3.1	46.5	6.9	1.4	0.27%
80	3.8	51.5	7.1	1.4	0.95%
90	4.5	56.5	7.2	1.4	3.18%
100	5.3	56.5	7.2	1.4	9.59%
110	6.3	61.5	7.4	1.5	23.73%
120	7.3	61.5	7.4	1.5	46.61%

- 9.0 The broken pole was not retained, and no photographs of the broken area of the pole were taken, so any discussion of the specific type of damage present would be speculative at best. Given that the failure occurred well above the ground line, decay seems unlikely. Fatigue stress on the pole due to repeated wind loading cycles may be possible. Acute mechanical damage due to wood pecker nesting or some other cause could also be possible.
