**RE: Docket No. D-11-94 – Review of National Grid Tropical Storm Irene Preparedness,
Response, and Restoration Efforts
National Grid Response**

**Response to Rhode Island Division
of Public Utilities and Carriers'
Review of National Grid Tropical
Storm Irene Preparedness,
Response, and Restoration Efforts**

Docket No. D-11-94

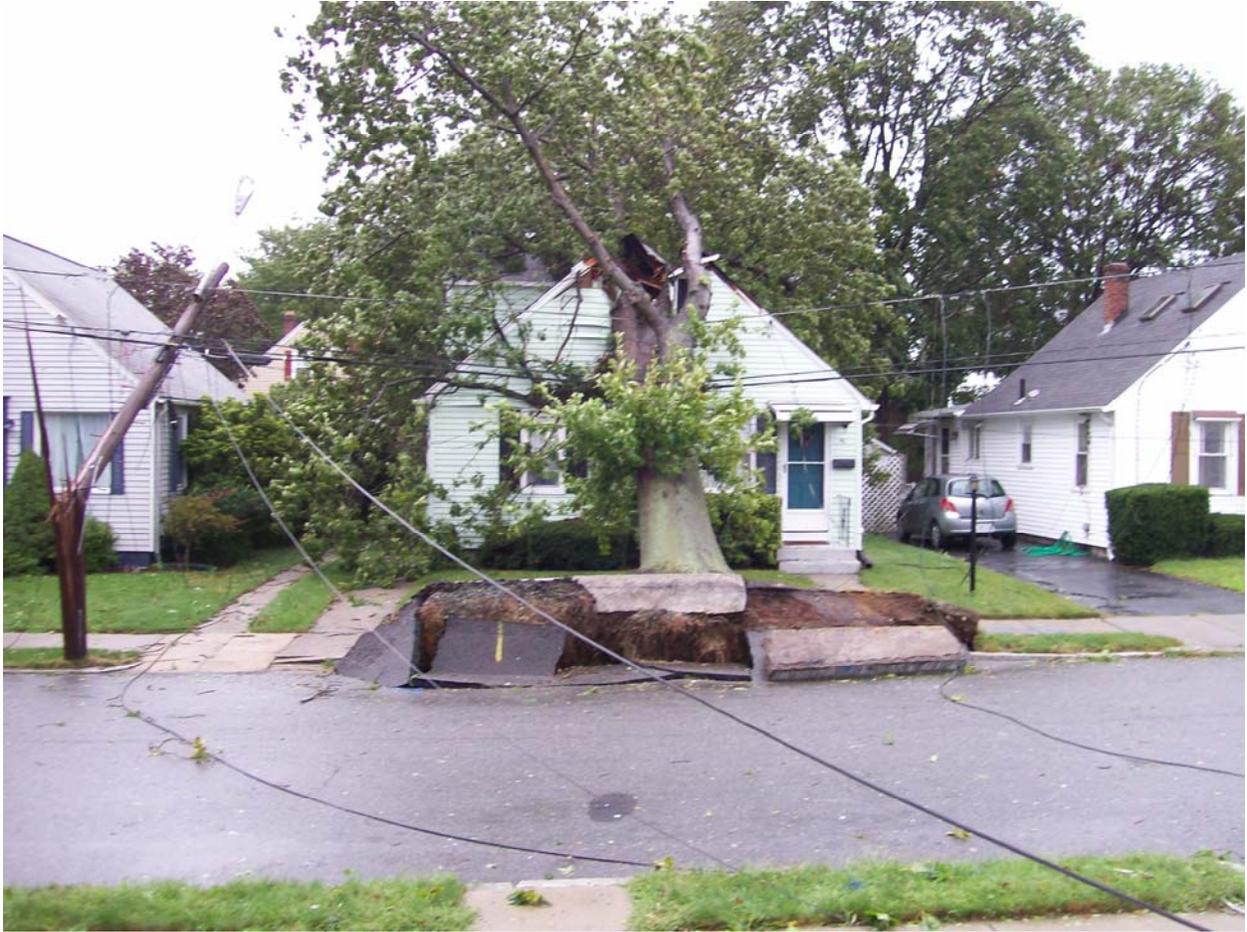
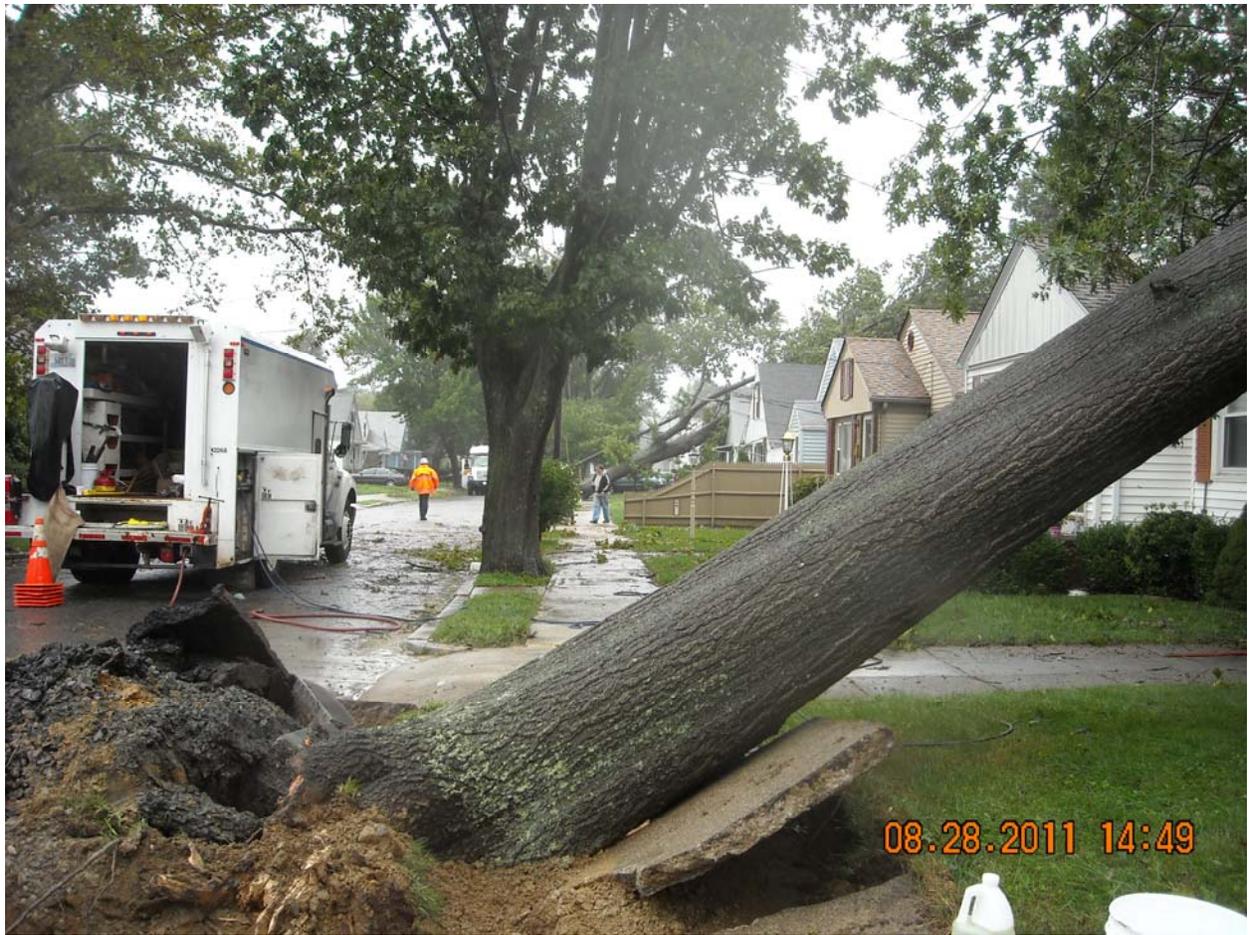
**PHOTOGRAPHS OF TREE DAMAGE
ROME AVENUE, PROVIDENCE, RI**

In support of this broad assertion of insufficient engineering design standards, the Booth Report relies on a photograph of a broken distribution pole.⁸ Based on this photograph, Mr. Booth concludes that "it is obvious the damaged facilities . . . were not designed, constructed, and maintained to proper industry standards."⁹ The pole shown in this photograph was broken by the impact of a tree on the wires of the line, and not by the wind force exerted on the poles and wires. The tree was near or behind the position from which the photograph was taken, and may not have been readily apparent from this photograph. The conductors normally rest on top of the insulators on the cross arm and at the top of the pole, and are held on the insulators with tie wires that are tied around the top of the insulator and along the conductors in either direction from the insulator. This arrangement holds the conductor to the top of the insulators for all design conditions. The fact these tie wires can break under the impact of a tree is neither a design deficiency nor an installation deficiency. One of the three wires at the top of the pole is still attached to the pin insulator; one wire has pulled off its supporting insulator and one wire was broken, but is not visible in the photograph. This type of damage is consistent with a fallen tree, and not with a failure caused by high winds. The photographs in Appendix A further illustrate the type of damage caused by fallen trees. These unquantifiable stresses associated with the impact of trees are beyond the scope of routine design.
