Attachment DIV 2-1 (Electric) Asset Condition FY 2013 Electric Infrastructure, Safety, and Reliability Plan Responses to Division's Data Requests – Set 2 Page 1 of 1

### Narragansett Electric Company

Subject: Equipment Condition Eldred No.45

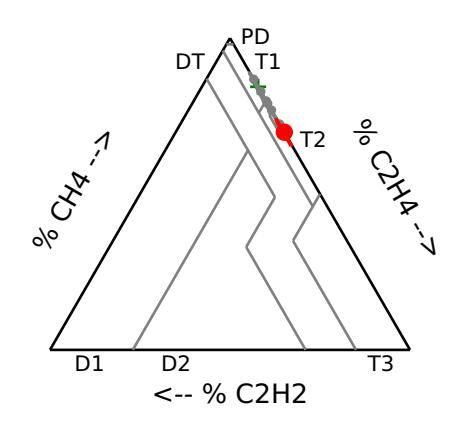
Triangle Diagnosis: T2 Rogers Diagnosis: ?

Low breakdown kV. There may be polar contaminants or excessive moisture. Consider reconditioning the oil.

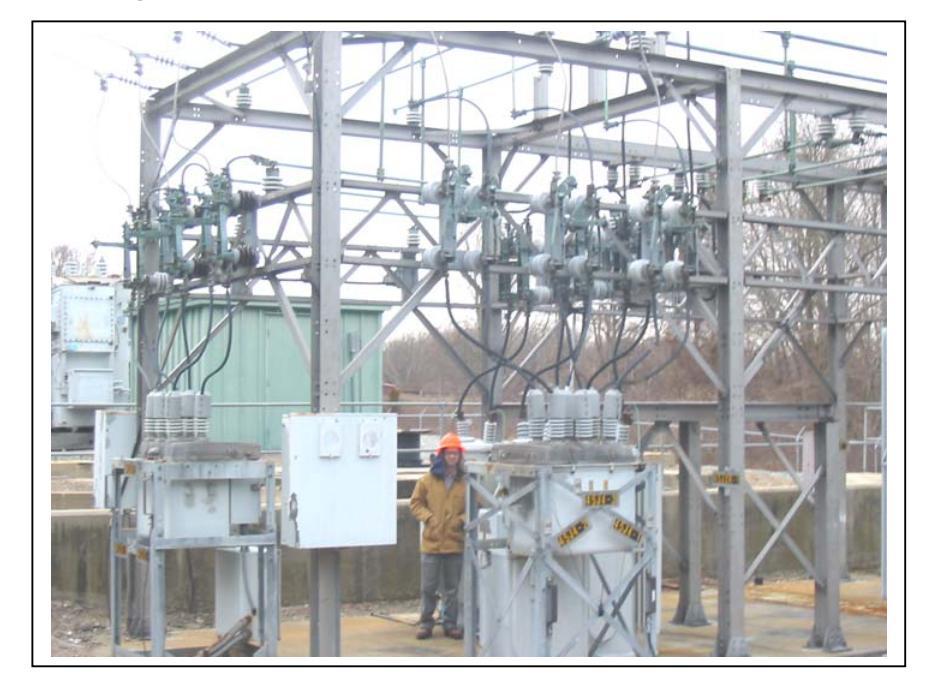
#### Station Clearances at 4.16kV : 6'6" to top regulator bushings, 7'6" to top of breakers

The regulators and breakers at the station do not meet EDP-SUB- 41 part 5.0 required vertical clearances of 8'6" to bottom of porcelain bushings. There are some PT sensing transformers on the side of the structures that do not meet EDP-SUB-41 part 5.0 for clearances if you approach the structure from the retaining wall. It is recommended that these clearance issues be resolved.

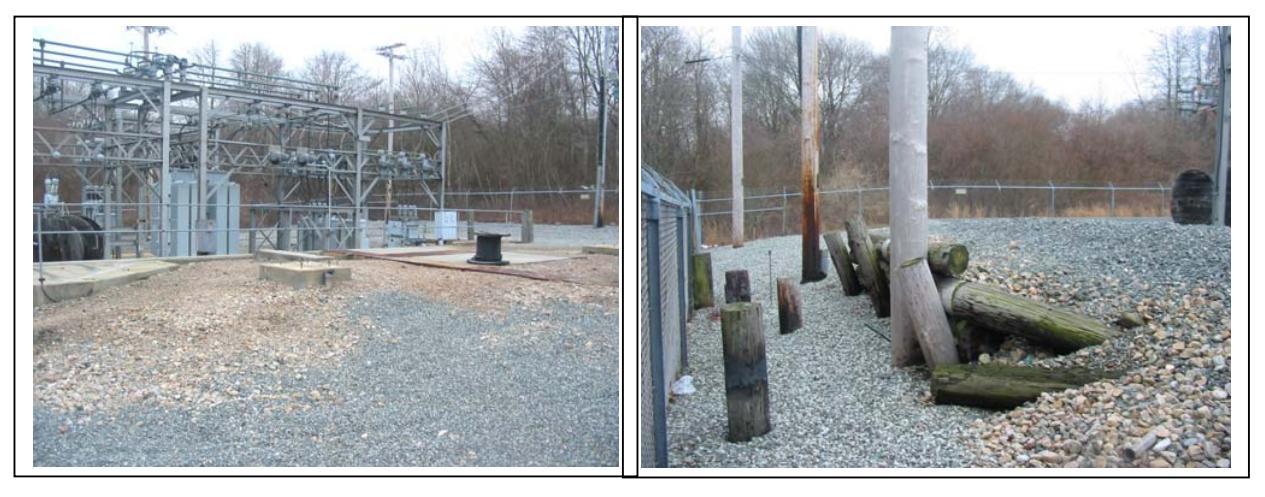
Abandoned foundations <u>Fence</u> **Retaining Wall**

The visual condition of the steel bus structure is good. The bus structure and all the equipment in service sits on one big concrete slab that appears to be in good condition. The control house is in good condition visually. There are foundations that are no longer utilized that have become tripping hazards in the yard. It is recommended that these hazards be removed. The yard also has areas where retaining walls are failing. It is recommended that they be replaced or the yard be revamped in order to remove them.

The fence height is less than 6 feet on two sides.

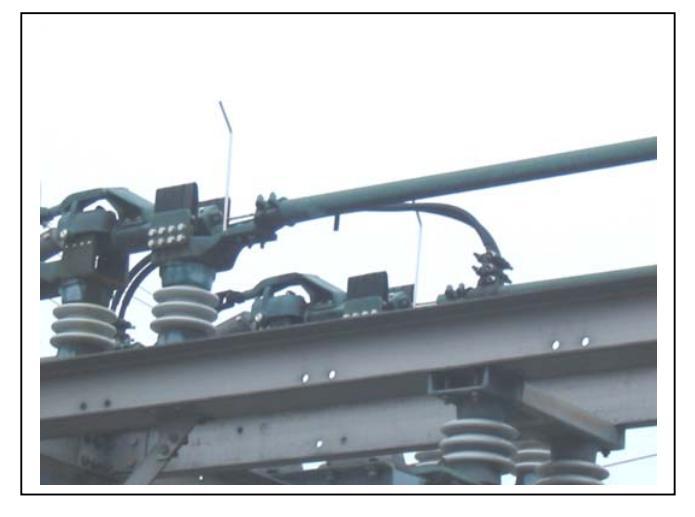
4500-1 – out of service middle phase jumpered

The switch is out of service. It is recommended that it be replaced or removed.

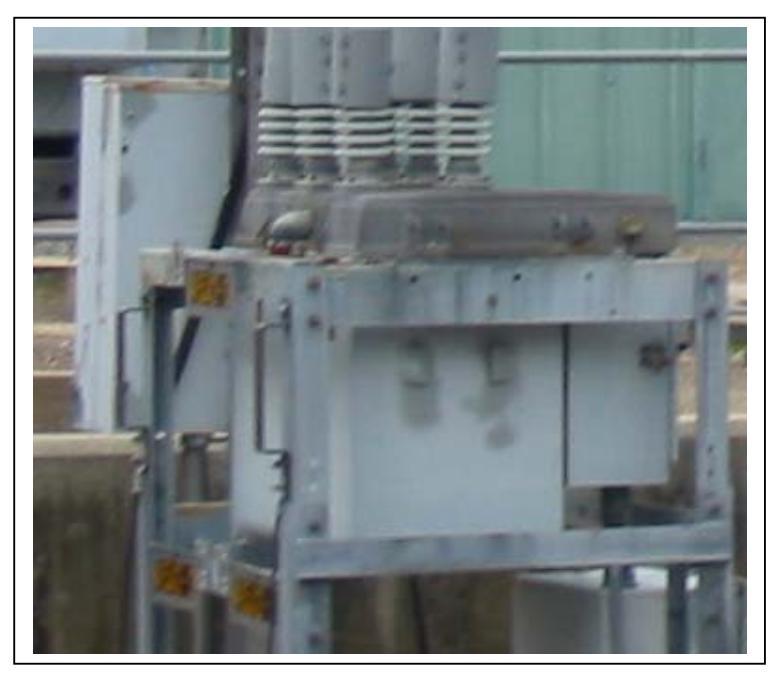
#### 45J2, 45J4 - Westinghouse PR-560 Manf. 1973

There are 11 Westinghouse PR type station reclosers in the NGRID NE system. The maintenance department in this area would perform internal inspections of this equipment after only a few breaker operations. The oil quality was known to quickly deteriorate. These breakers have control cabinets that are in poor condition due to the location of the station near the ocean. It is recommended that the breakers be replaced.

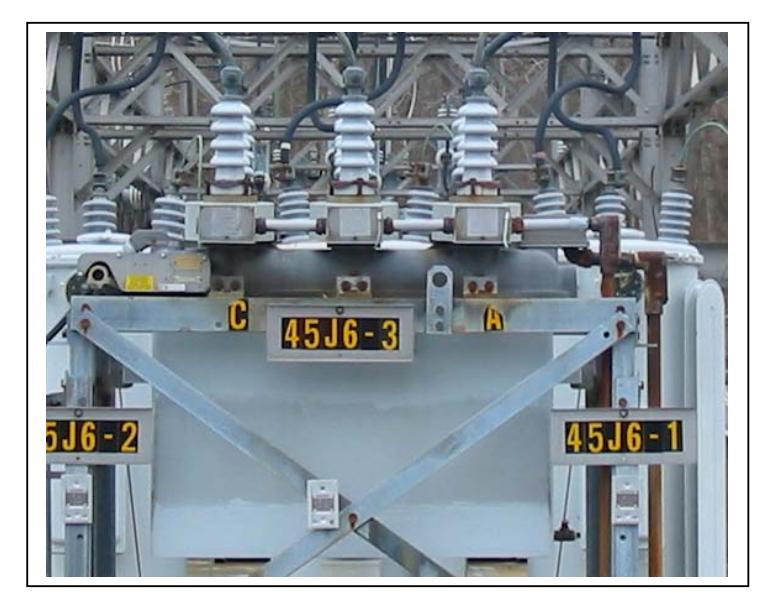
45J6 Mcgraw Edsion – WE 560 amp

There are hundreds of these type reclosers in the NGRID NE system. All but ten of these type reclosers are installed on lines. The trouble history for this family has been good and there are no noted problems with this installation.

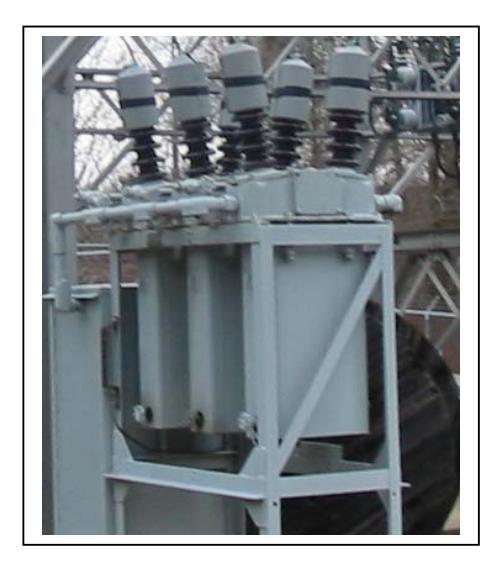
### 4520 Allis Chalmers OZ-210 23kV 600 amp Manf. 1952

There are 45 A-C OZ-210 type OCBs in the system. The OZ family of breakers under 23kV generates about two equipment related trouble reports a year due to moisture ingress into tank or mechanism problems. Confirmation was obtained from Siemens

(Larry Sudbeck) and High Voltage Supply Website (only moving/stationary contact) that parts and support are not readily available. There are currently only 5 replacement bushings in stock for this family of breakers. Replacement bushings can not be located on the ABB website that are compatible with the 9.5" 4 hole bolt circle of these bushings. If more replacements are needed an adapter plate would have to be fabricated. It is recommended that the breaker be considered for replacement.

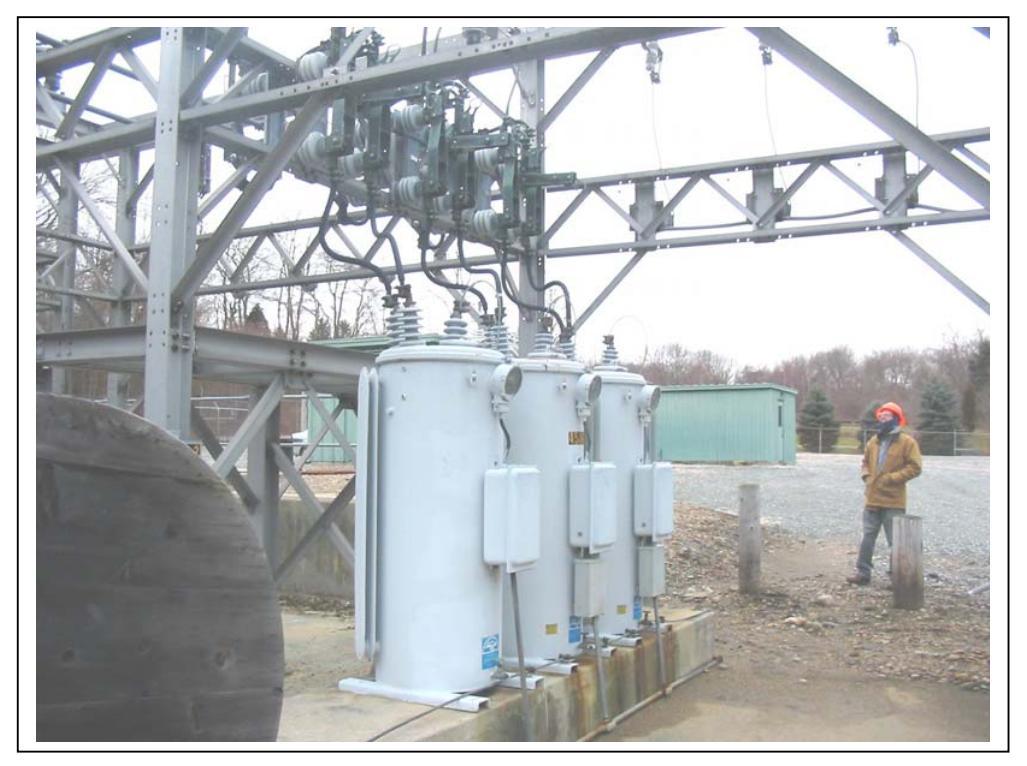
45J2R – GE ML32 Manf. 1973 operations 400k 235k, 241k 45J6R - GE ML32 Manf. 1970 operations 240k, 390k, 280k

There is no reason to believe that the regulators would not be able to continue in service for many years to come. The GE published minimum number of operations is 1.5 million for this size and type regulator. The oil dielectric test values in 2000 were good.

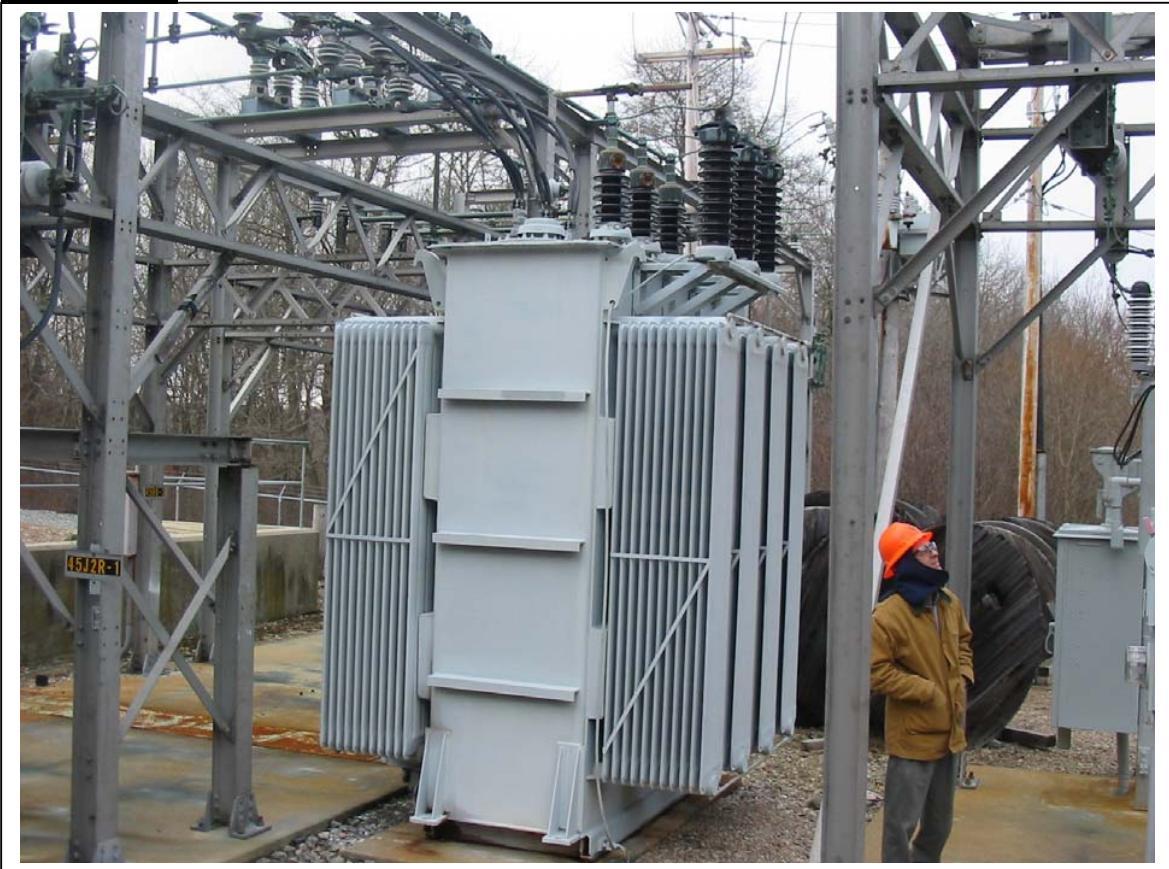
NO. 2 REF# 023185- Westinghouse Manf. 1970

ITE Serial # 20116-A1 - 5.6\ 7 MVA ONAN\ONAF Manf. 1970 22.9kV delta/ 4.16kV wye

- a) Gas in Oil Combustible gas values are fair for this unit. Ethane level tripled on 11/04 DGA
- b) Oil Quality Oil quality values are good.
- c) Power Factor The insulation power factor results are poor for a test done in 1998. (Ch-2.26%, Cl 6.68%, Chl-8.64%) The bushings all tested good. The value for Cl in 1998 is double the value of a prior test (Cl -3.66%).
- d) Infra red No issues.
- e) Site Inspection The paint is in good condition. There are no leaks on the unit. All gauges are in working order. There are no alarms at the station. There are fans controlled by liquid temperature gauge (no winding temperature gauge). There is no fault pressure relaying protection on the unit.

Diagnostic testing indicates there are insulation issues with the transformer windings. It is recommended that it be replaced.
