20-YEAR INFRASTRUCTURE REPLACEMENT PLAN 2011-2030

PROVIDENCE WATER SUPPLY BOARD

INFRASTRUCTURE REPLACEMENT PLAN For Fiscal Years 2011 Through 2030

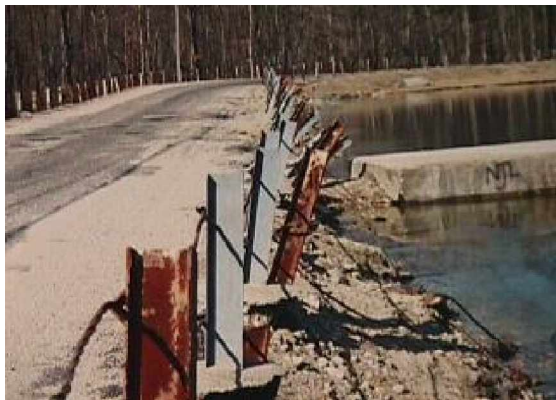
Construction is complete for the rehabilitation of Ponaganset Reservoir. Work included repair of dam erosion and placement of riprap, construction of a downstream buttress, restoration of the gate structure and outlet works, improvements to the discharge channel, and reconstruction of the road and drainage system over the dam

Ponaganset Reservoir before rehabilitation

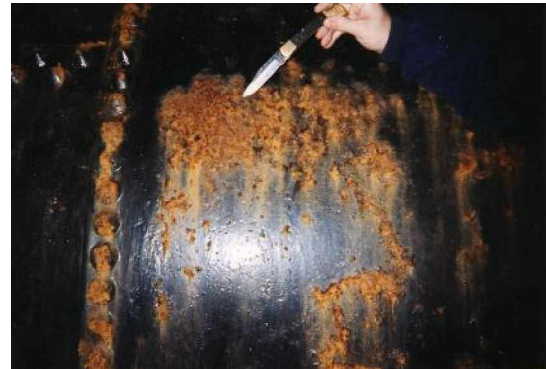
Construction was completed to rehabilitate and recoat the 900 feet long exposed portions of the twin 60 inch riveted steel transmission mains in the meter chamber. Rust was removed, the pipes sandblasted, and protective coatings applied. The exposed portion of twin 60 inch mains inside the junction chamber structure were sandblasted and protective coatings applied to protect against corrosion. In the process two lead joints that were found leaking were resealed. Construction has been completed to provide cathodic protection to 1000 feet of the underground portion of the twin mains. Four impressed current anode beds have been installed to complete the protection system.

Corrosion on 60 inch main prior to rehabilitation

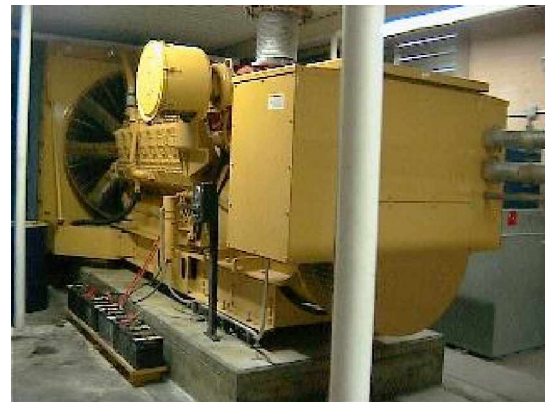
In March 1996, the engine of the old diesel generator failed and became inoperable. The unit was obsolete and the cost made it unfeasible to further repair the generator. In December 1996 a new 2000 kW generator was installed to replace the old 1750 kW generator. This generator has the capacity to power the entire treatment plant and raw water pumps in the event of an emergency power outage.

New Raw Water Booster Pump Station generator for backup power to treatment plant

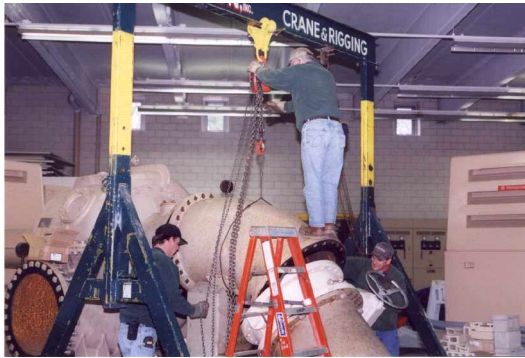
All eight (8) of the suction and discharge valves for the booster pumps in the pump station failed to provide a complete seal when closed. Construction has been completed in which all eight (8) valves and the four (4) actuators for the discharge valves were replaced.

Installation of spool piece after valve installation

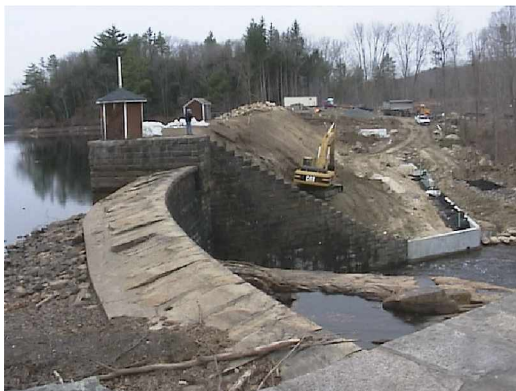
Construction is complete at Barden Reservoir. Work consisted of improvements to the inlet/outlet structures (including replacement of the gates at the inlet structure), the discharge channels, the spillway area, the crest of the dam to accommodate design flood flows, erosion protection along the upstream slope, and stabilizing the dam by flattening the downstream slope of the dam.

Repairs to the downstream slope of the dam

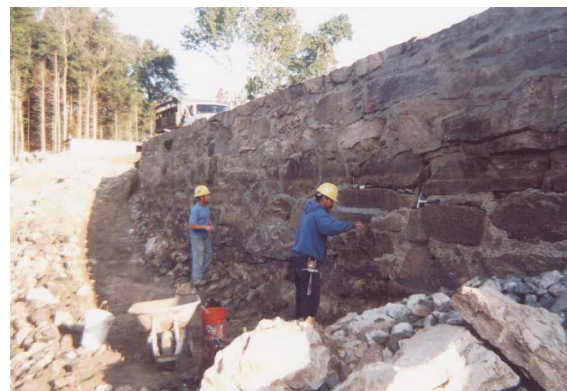
Repairs to upstream wall at Barden Dam

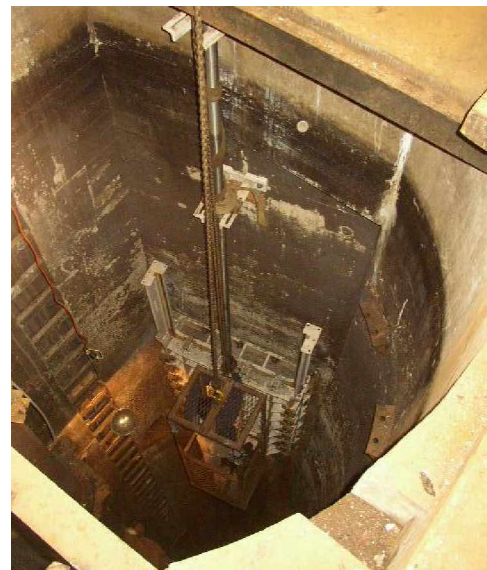
Construction is complete for replacing all nine (9) sluice gates, all seventy (70) stop shutters, and two (2) drain valves. Nine (9) new electric actuators were installed to operate the sluice gates. The bar grating and trash racks were also replaced under this project.

Installation of new sluice gate

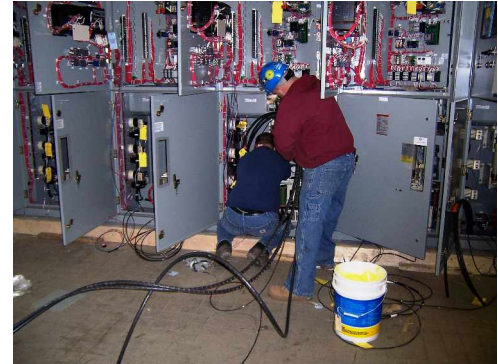
The project to replace the motor control center at the RWBPS is complete. The motor control center dated back to the original construction of the pump station in 1966 and needed to be replaced as parts have become obsolete. The project consisted of new 2300-volt switchgear, pump starters and controllers, new feeders to the motor controls, and a new incoming service feeder. The new motor control center will provide reliable pump control during low reservoir levels and power outages.

Installation of new motor control center

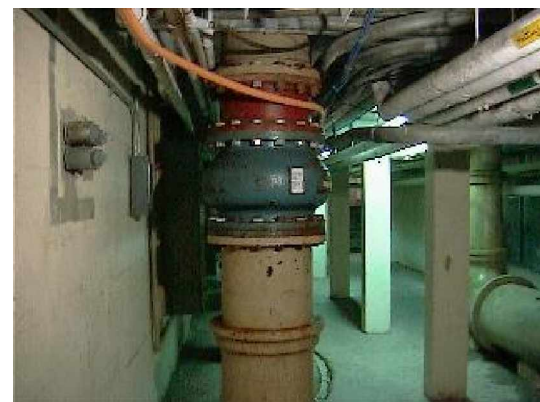
Two 18" check valves on the washwater pump suction lines were replaced. The old check valves experienced leakage and were not capable of holding prime to the pumps.

New check valve installation

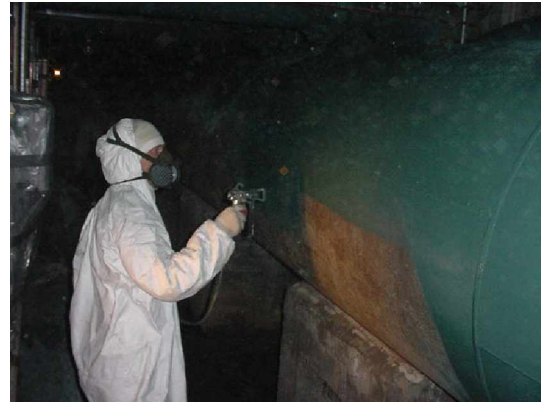
Recoating of the 48" dia. filter backwash wastewater pipe and associated lateral piping, located in the Pipe Gallery of the treatment plant was completed. The old coating system was considerably deteriorated, threatening the integrity of the pipe. The coating was mechanically removed and a new moisture cured two-coat urethane paint system was applied.

Painting of 48" Wastewater Main

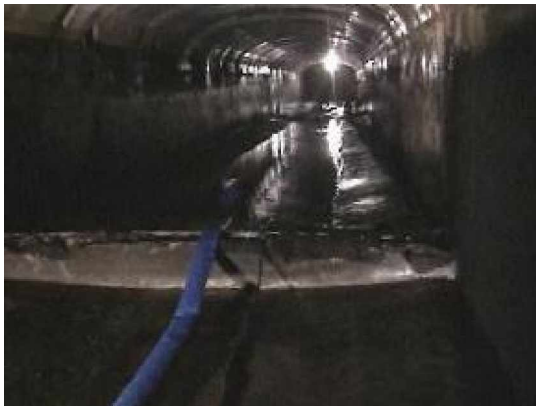
Construction is complete to rehabilitate the interior of the clearwell. Work consisted of rehabilitating eroded concrete surfaces and cracks, and leaking construction joints inside the interior of the structure. Also included in the scope of work was the structural rehabilitation of two cast-in place concrete 72" x 42" effluent venturi meters. The instrumentation has been fully restored with a new pressure sensing diaphragm type system replacing the annular rings. New process piping and signal wiring has been installed to carry the signal flow to the SCADA system.

Interior of the clearwell

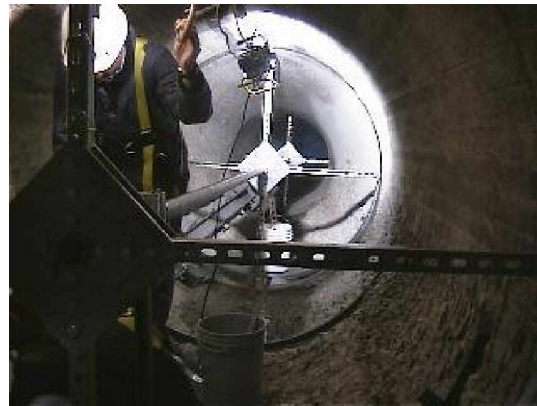
Concrete reconstruction and installation of new instrumentation in treatment plant's 72" x 42" effluent venturi meter

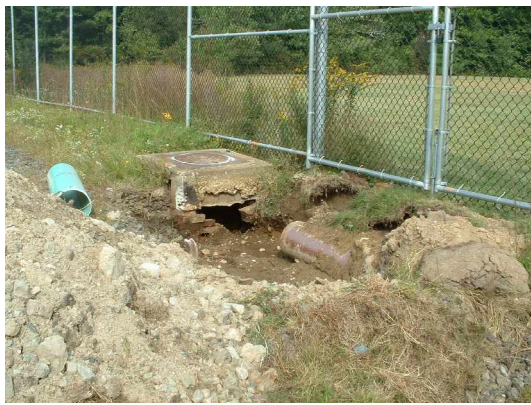
1,986 feet of 12" storm drain pipe was inspected with remotely operated closed circuit television equipment and cleaned through a water jetting process. The inspection identified several areas with blockages and cracks that required rehabilitation.

Section of vitrified clay pipe replaced with PVC

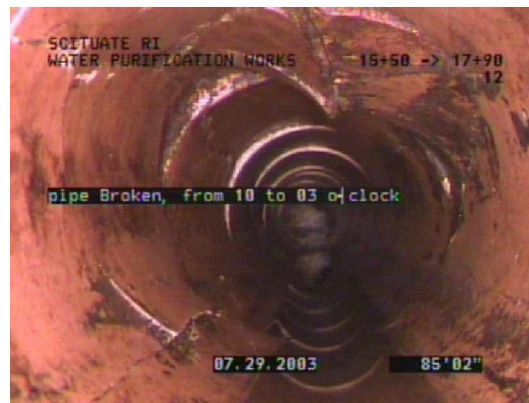
Screen shot of pipe inspection – Broken Pipe

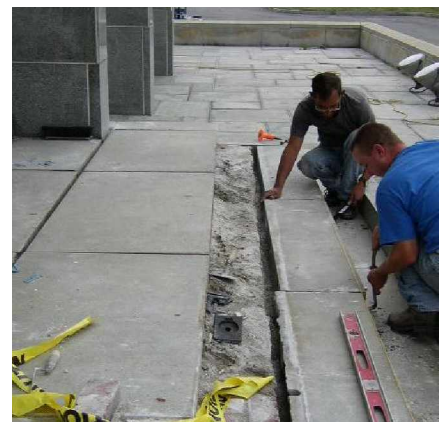
Construction is complete for the rehabilitation of the limestone and granite facade at the Treatment Plant. The Treatment Plant's limestone and granite facade was constructed during the 1960's and had deteriorated over time as a result of weathering and exposure from freeze-thaw cycles. The scope of work also included repair of mortar joints and spalled areas, cleaning of the limestone panels, parapet wall, and the brick chimney. The granite terrace and stairs were rehabilitated by removing and resetting sections of stone.

Resetting sections of stone on the stairs

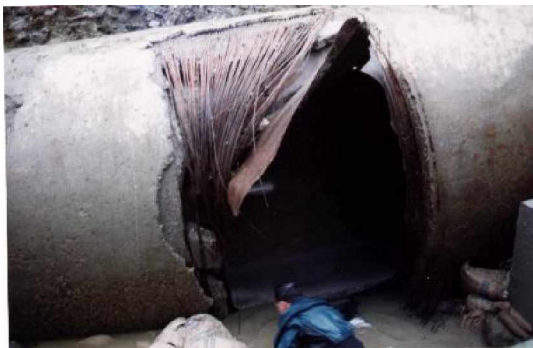
A portion of the 102" transmission aqueduct failed in November 1996. A failure analysis was conducted to determine the cause of the failure and corrective measures needed to prevent future failure. A risk assessment and internal inspection was performed between March 1998 and April 1998. The inspection and risk assessment resulted in recommendations to rehabilitate portions of the 102" main. In November 1998 work commenced on the 102" main consisting of exterior rehabilitation, internal reinforcing of sections of pipe with carbon fiber linings, installation of manholes for additional access points, and performing additional inspections of the main.

Rupture of the 102" Aqueduct – November 17, 1996

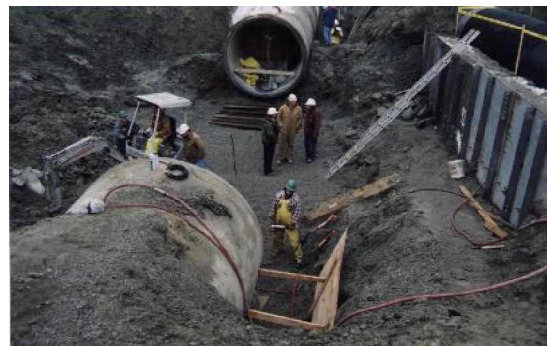
102" Aqueduct prepared for replacement sections

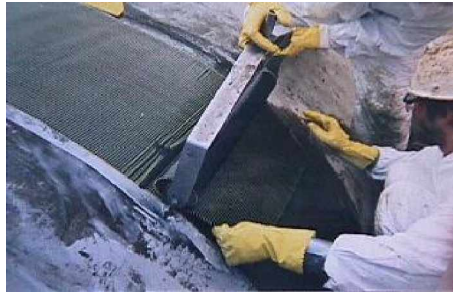
Application of carbon fiber to exterior of deteriorated section of 102" Aqueduct

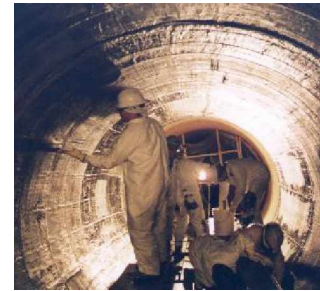
Crew applying carbon fiber lining to interior of deteriorated section of 102" Aqueduct

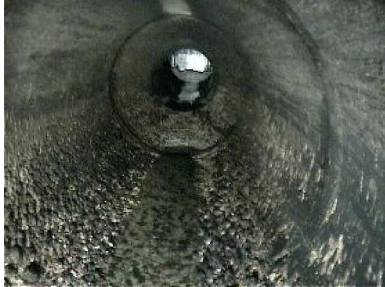
Extensive concrete corrosion damage was discovered in the treatment plant's 90-inch effluent conduit during the rehabilitation of the plant's effluent venturi meters. Subsequently, a video inspection in November 1999 revealed further extensive concrete corrosion damage continuing along the 90" aqueduct as it leaves the plant.

Concrete corrosion damage to the lower half of the effluent conduit

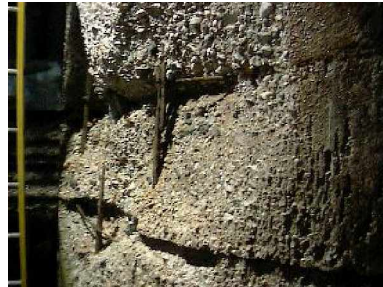
Extensive concrete corrosion damage in vicinity of south venturi meter

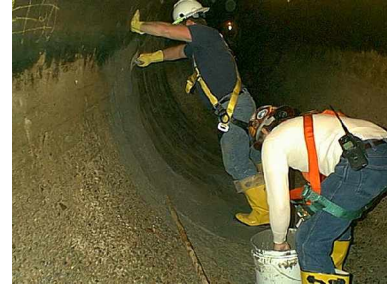
Concrete repairs to the interior of the 90" pipeline

Multiple methodologies and approaches for the rehabilitation of the 90" aqueduct were investigated and a work plan was developed that included the installation of a 90" butterfly valve in the aqueduct just downstream of the 78" aqueduct connection in order to enable the 78"/102" aqueduct to continue to function during an event in which the 90" is out of service. The installation of this valve made it possible to conduct the rehabilitative work on the 90". The interior of the 90" aqueduct was rehabilitated for a distance of 1000 feet from the Effluent Chamber to the West Portal using fast curing, potable water-safe, cementitious products.

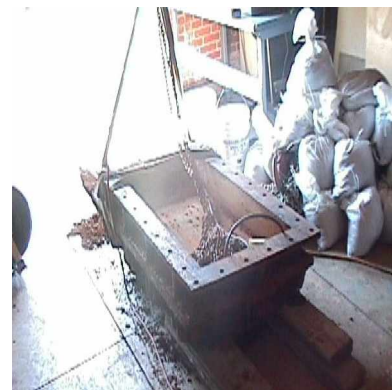
Construction is complete for the rehabilitation of the original section of Longview Reservoir. The rehabilitation work consisted of the application of a hot-applied reinforced rubber membrane sealant over the entire roof surface of the reservoir, sealing of all cracks and construction joints on the walls and floor of the interior of the reservoir, replacement of the sluice gate, and replacement of the stop shutters.

Old Longview Reservoir sluice gate being removed
