Study of Renewable Energy Installation Quality in Rhode Island *Renewable Energy Growth Program*

Presented by:
Shawn Shaw, P.E.

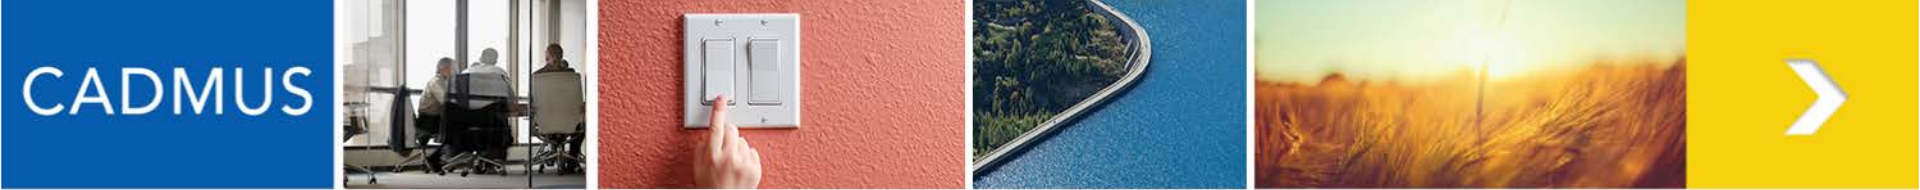
Research Questions and Methods

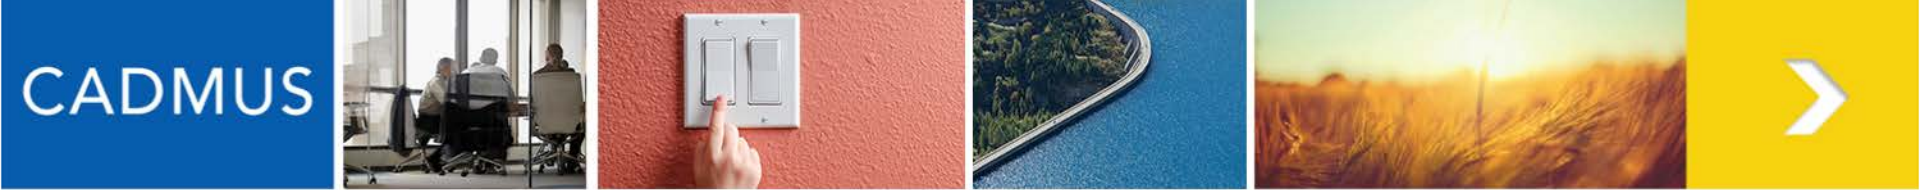
Research Questions and Methods

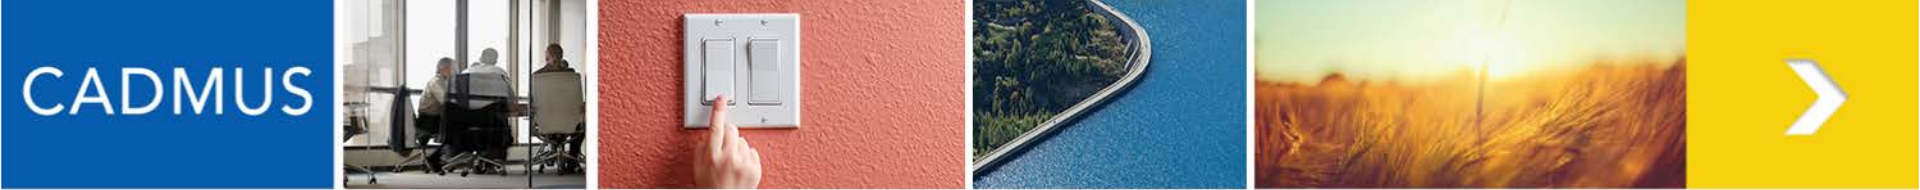
Research Questions and Methods

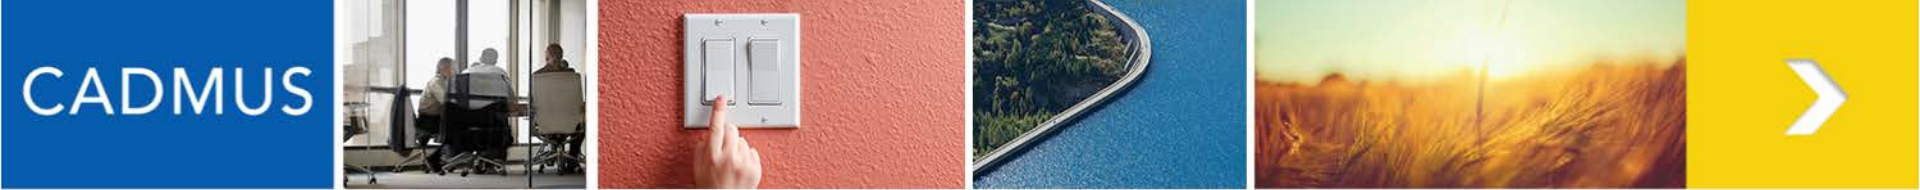
Site Visit Sampling Targets

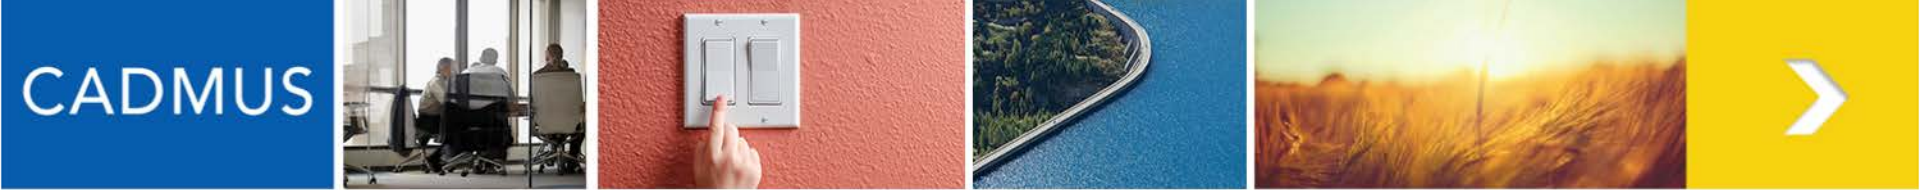
Data Aggregation and Analysis

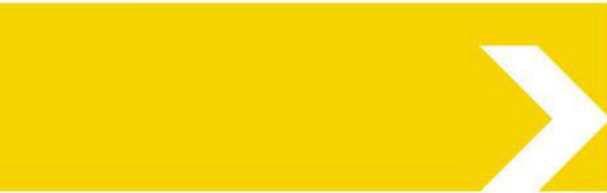
Results from Onsite Inspections

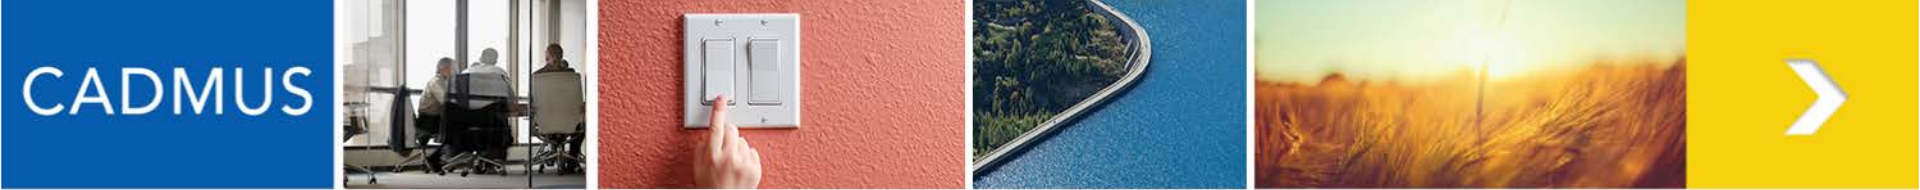
Preliminary Inspection Results Comparison

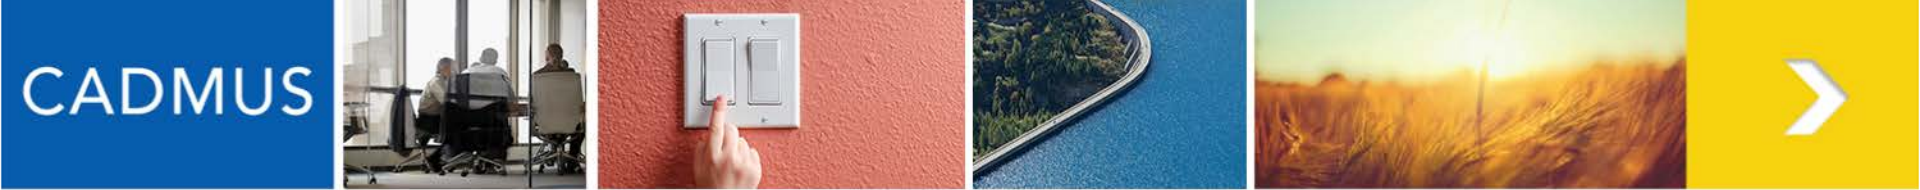
Preliminary Results by Element

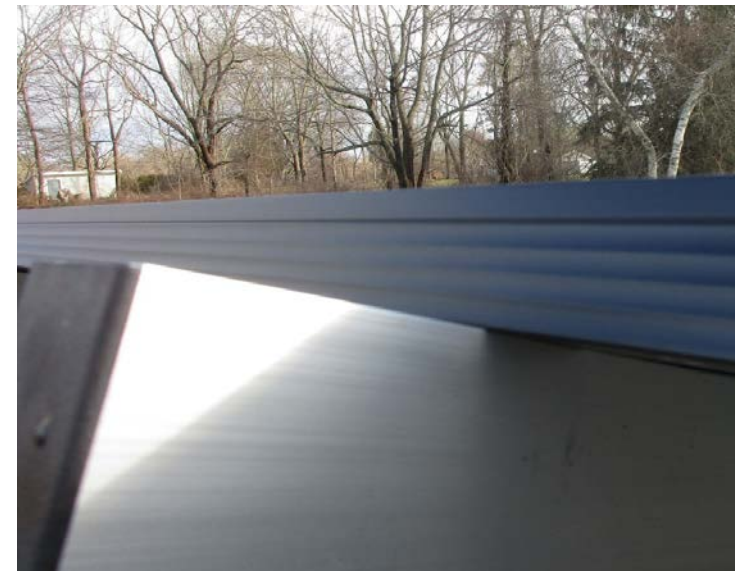
- **Racking**
 - *89 occurrences*
 - 20% contained **major** structural/module issues
 - Physical racking not installed properly (too short)
 - Modules not properly secured (missing or improperly-sized clamps)

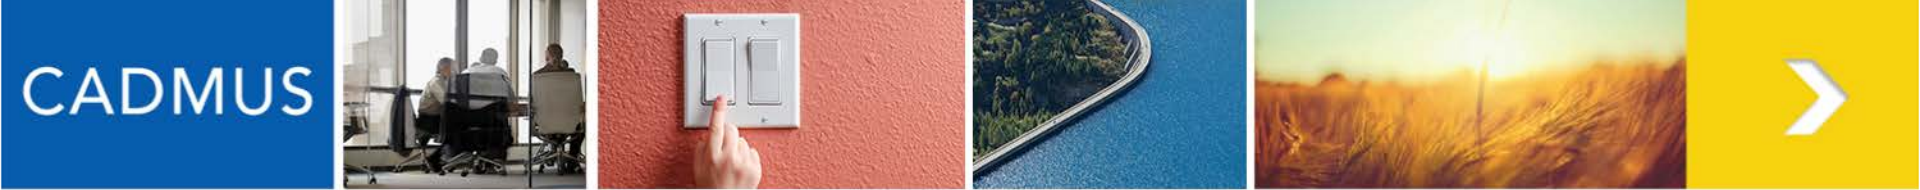
Preliminary Results by Element

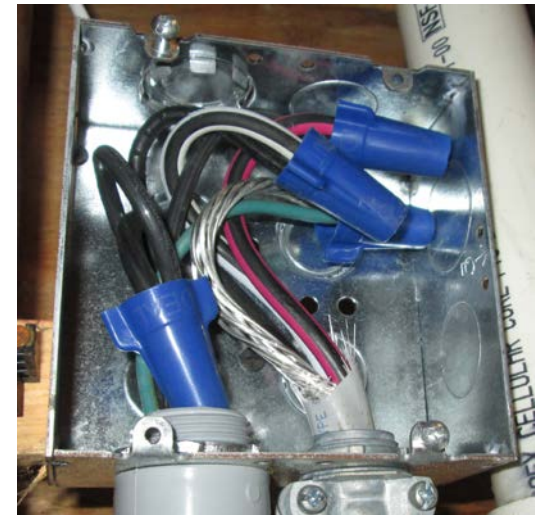
- **Junction Box**
 - *10 occurrences*
 - 4 contained improper splice methods (**minor-major**)
 - 4 contained other **minor** issues
 - 3 were not properly-secured (**minor**)
 - 1 was not grounded

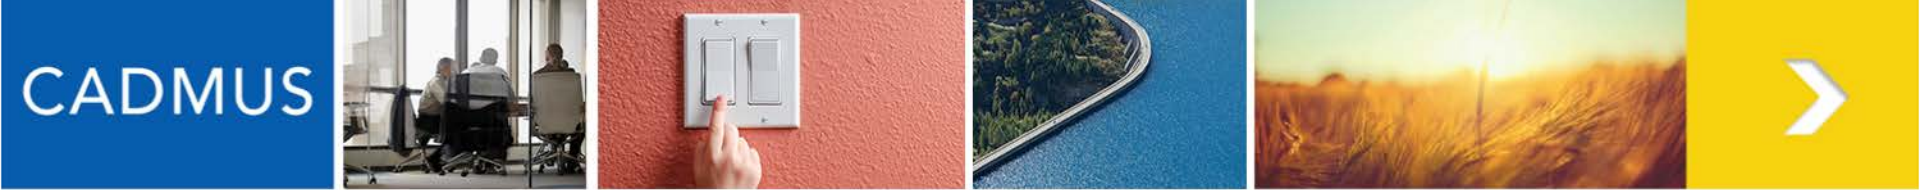
Preliminary Results by Element

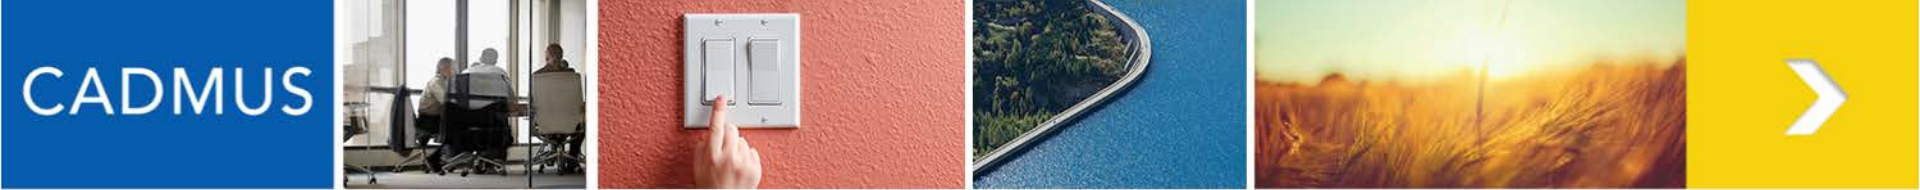
Preliminary Results by Element

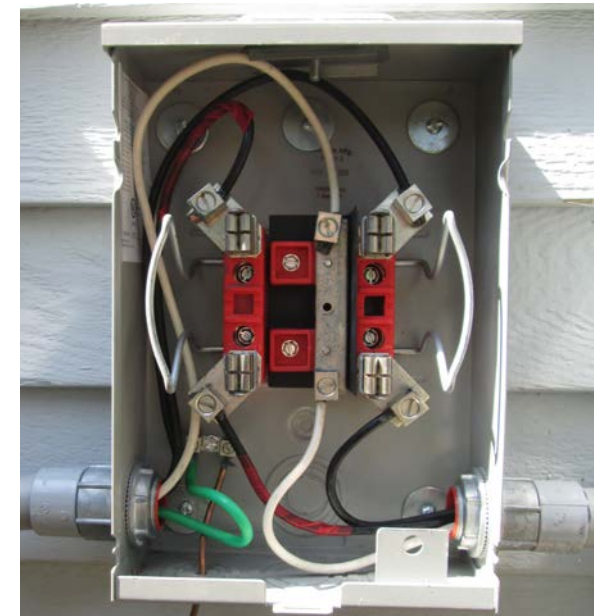
- **Production Meter (customer-owned)**
 - *34 occurrences*
 - Minimal issues observed, single occurrence:
 - Grounding
 - Terminal rating
 - Conduit fittings
 - Conduit support

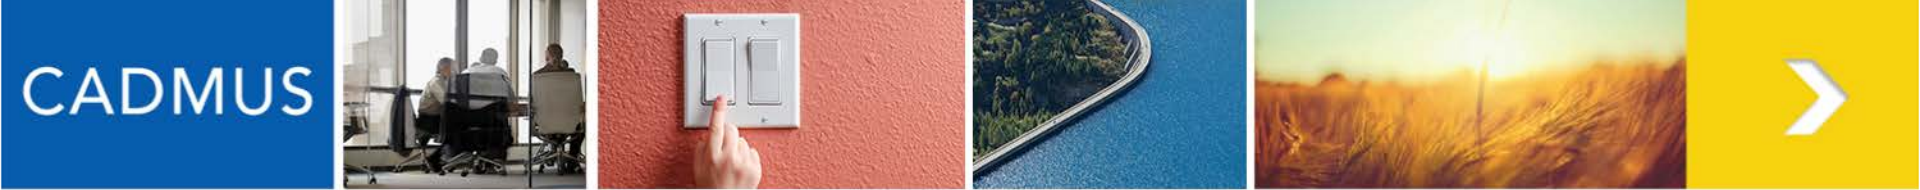
Preliminary Results by Element

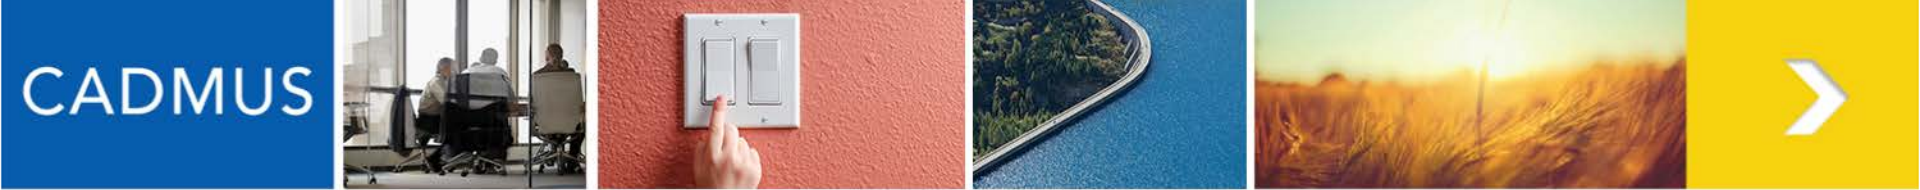
Preliminary Results by Element

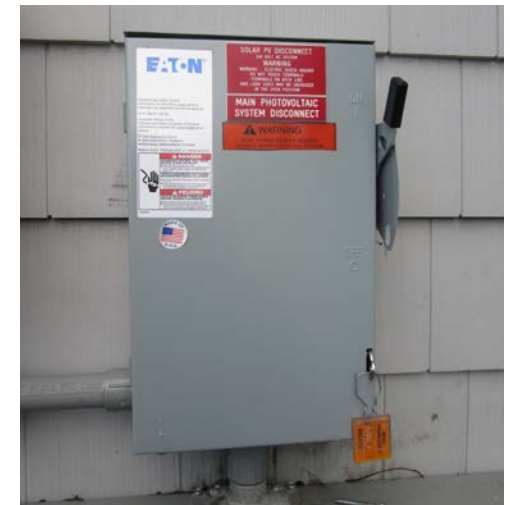
- **Supply-Side Connection**
 - 89 occurrences
 - 60% contained **incidental** labeling issues
 - 43% missing **incidental** directory/power source identification
 - 21% contained **major/critical** issues
 - Improper/missing grounding
 - Disconnect not rated for application
 - No fuses
 - Undersized conductors
 - 30% contained other **minor** issues
 - 26% contained **minor** grounding issues
 - 20% contained **minor** splice or conductor insulation issues

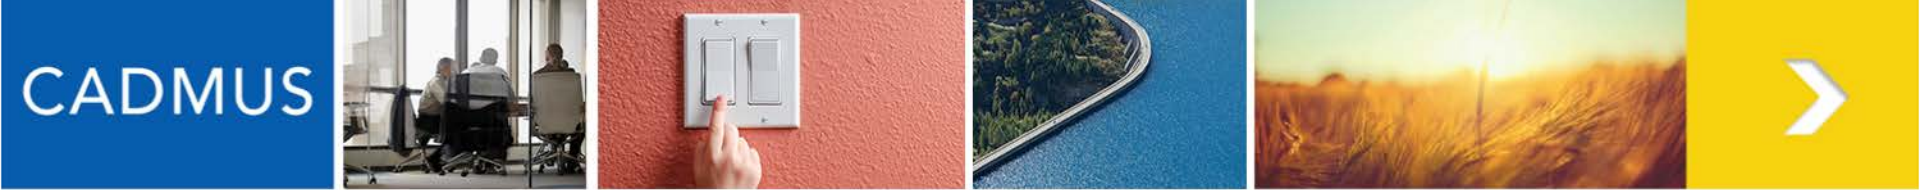
Self/Small Installers

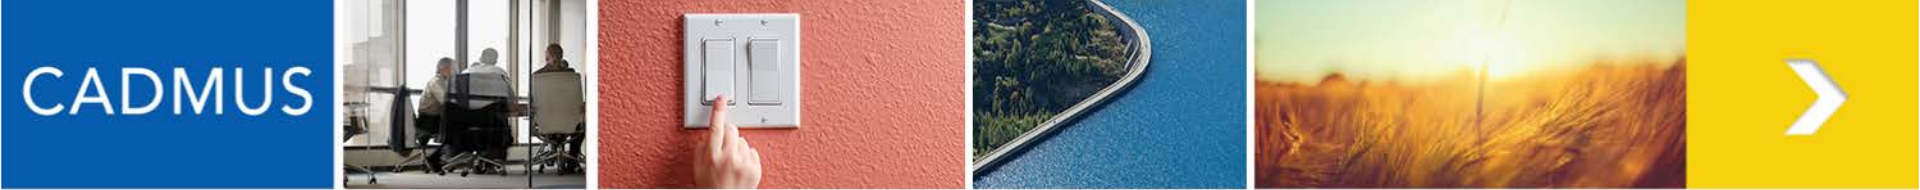
Self/Small Installers

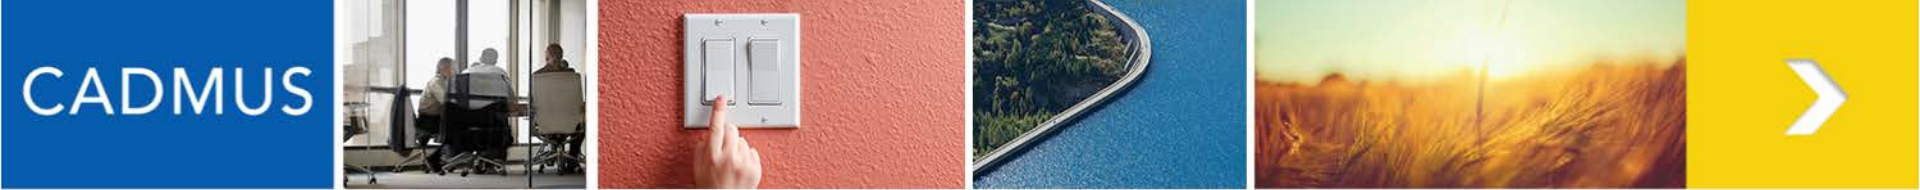
Self/Small Installers

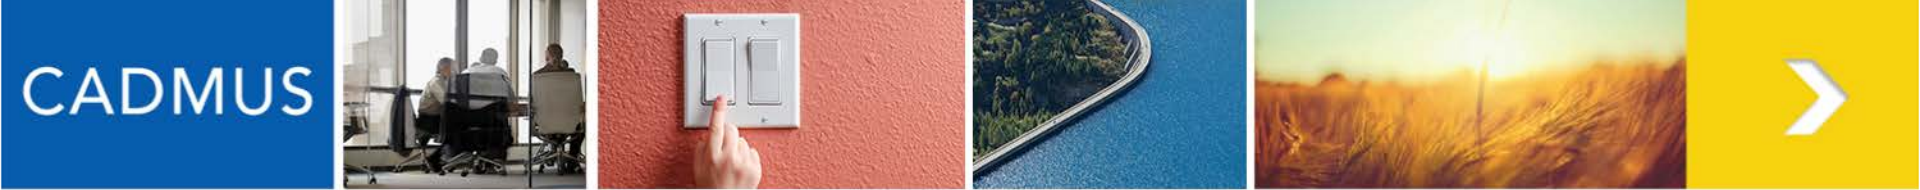
Example Array Issues

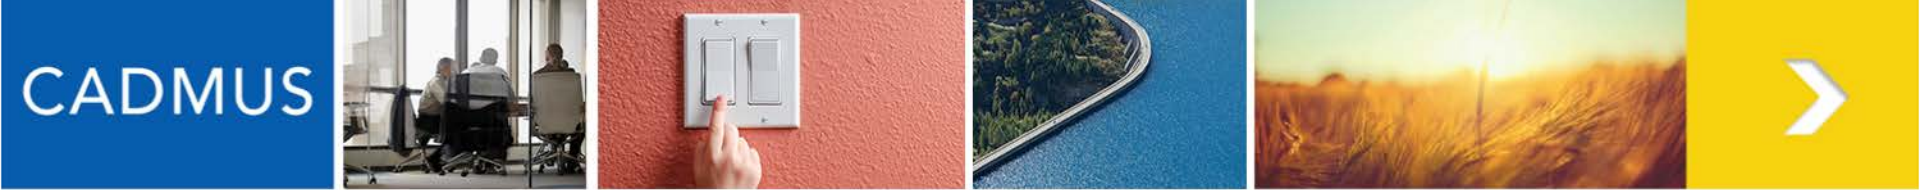
Example Array Issues

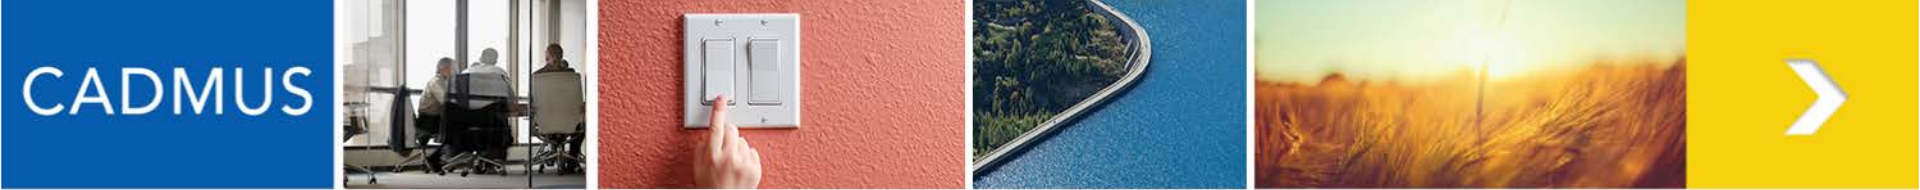
Example Array Issues

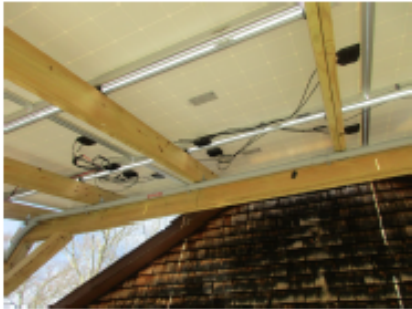
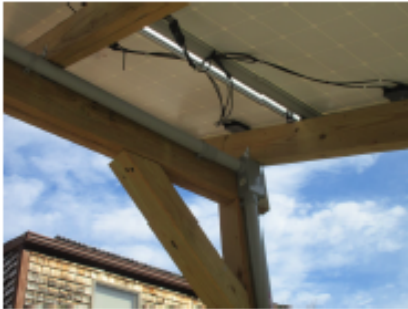
ID#	Defect Category	Deficiency Description
A_EL12	Minor	Circuit conductors are sagging and/or not supported and secured at least every 4.5' and within 12" of every outlet box, junction box, cabinet, or fitting, in violation of NEC Articles 338.10(B)(4) and 334.30.

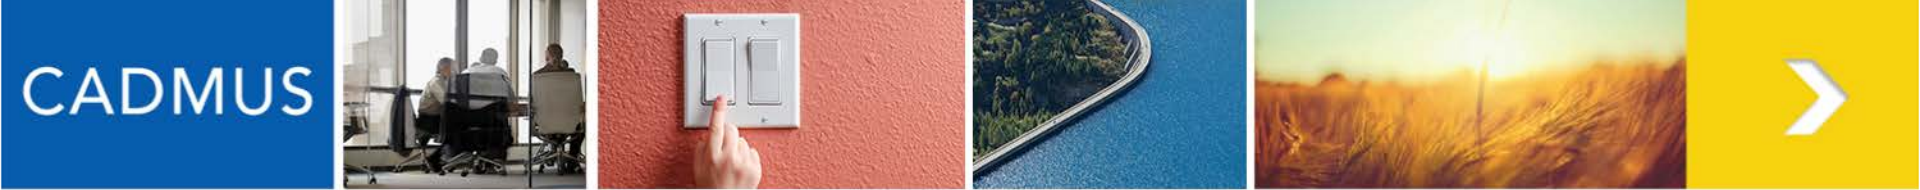
Example Array Issues

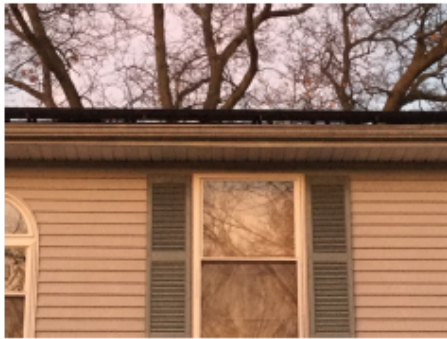
ID#	Defect Category	Deficiency Description
A_EL12	Minor	Circuit conductors are sagging and/or not supported and secured at least every 4.5' and within 12" of every outlet box, junction box, cabinet, or fitting, in violation of NEC Articles 338.10(B)(4) and 334.30.

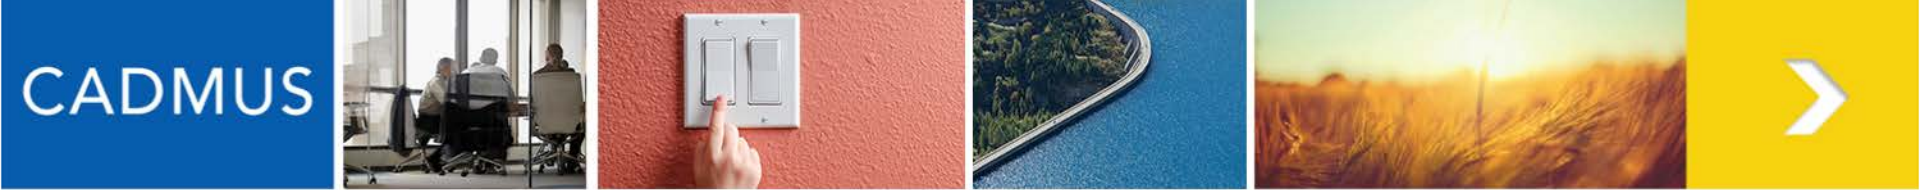
Example Array Issues

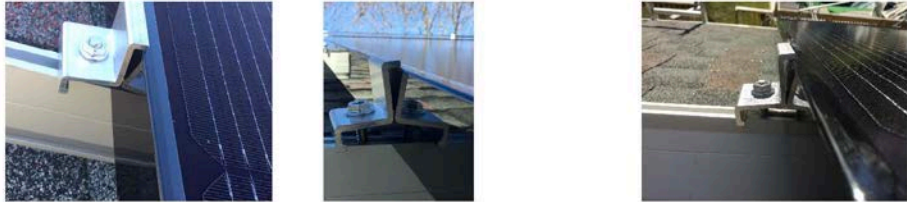
A_EL12	Minor	Circuit conductors are sagging and/or not supported and secured at least every 4.5' and within 12" of every outlet box, junction box, cabinet, or fitting, in violation of NEC Articles 338.10(B)(4) and 334.30.	PV wires were not supported anywhere under the array and were in direct contact of the roof.

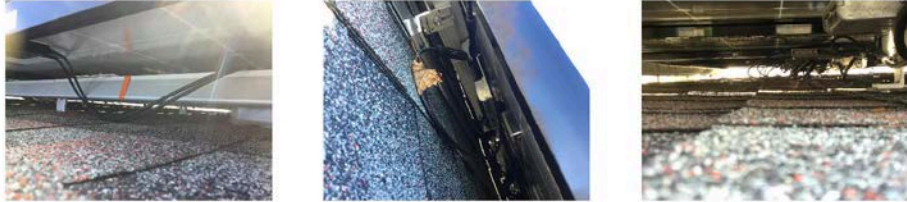
A_EL26	Minor	Exposed equipment grounding conductor is smaller than #6AWG and is not protected from physical damage, in violation of NEC Articles 690.46 and 250.120(C).

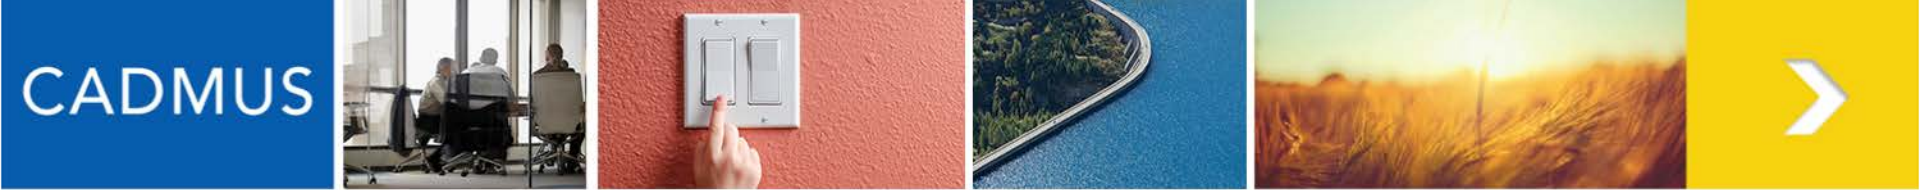
REG-Specific Interconnection

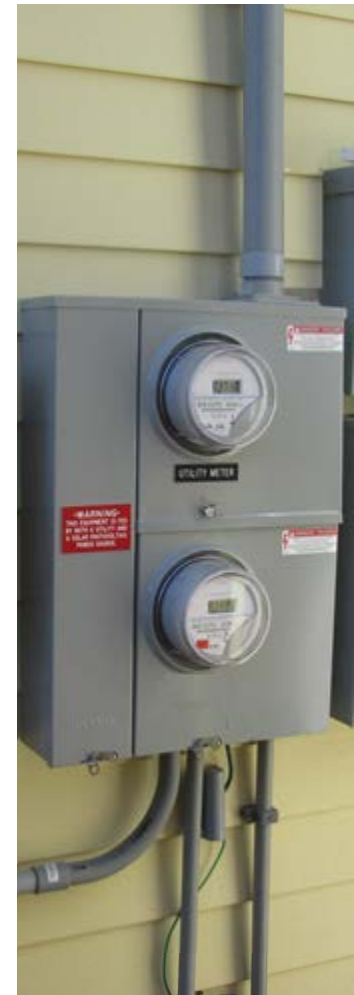
- Section 4 of the RE Growth Program Tariff document (RIPUC No. 2151) outlines a metering configuration
- Solar PV installation shall be on a new utility meter
- Absolutely no connection to load side of existing utility meter
- ***Intended for the installer to replace existing utility meter enclosure with multi-gang enclosure*** (i.e. replace existing 1-gang with new 2-gang)
 - Existing meter is utilized for existing service/loads
 - New PV system/meter is a new “tenant” in the building
- Consideration should be taken for new disconnect/fuse location and marking...

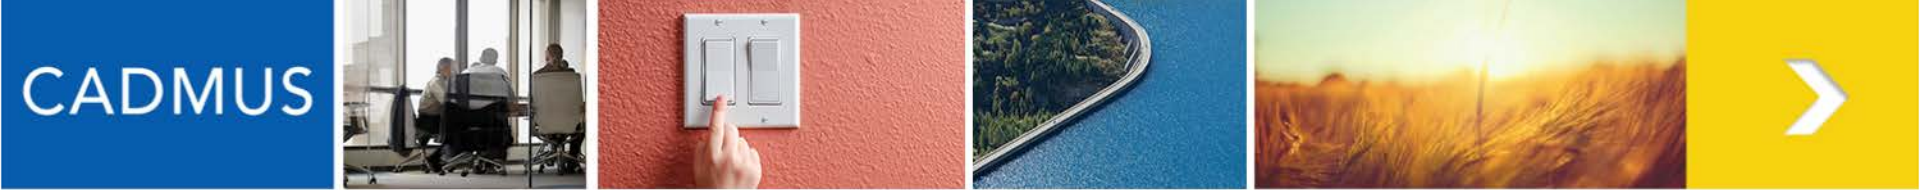
REG-Specific Interconnection

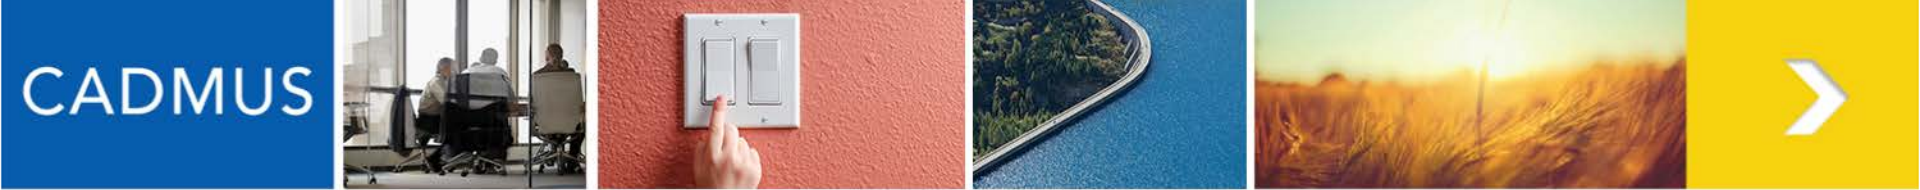
Connection at Service Point

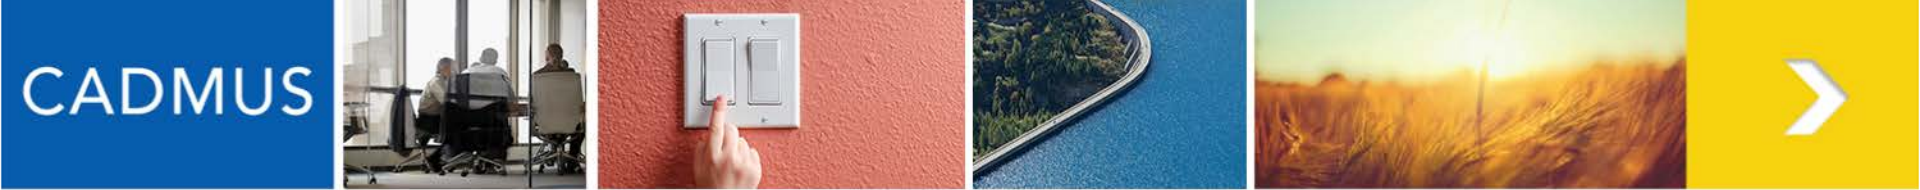
Connection at Service Point

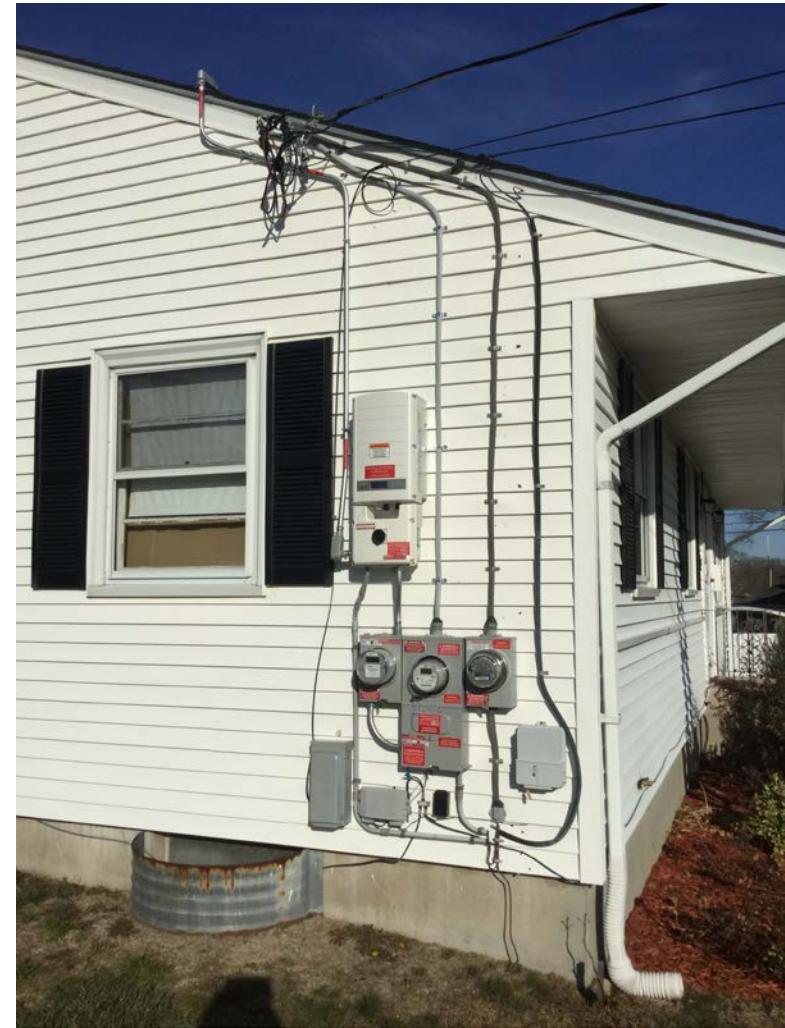
- Concerns:
 - Esthetics
 - Impairs existing service repair/upgrade
 - Available space
 - Connection method for three conductors

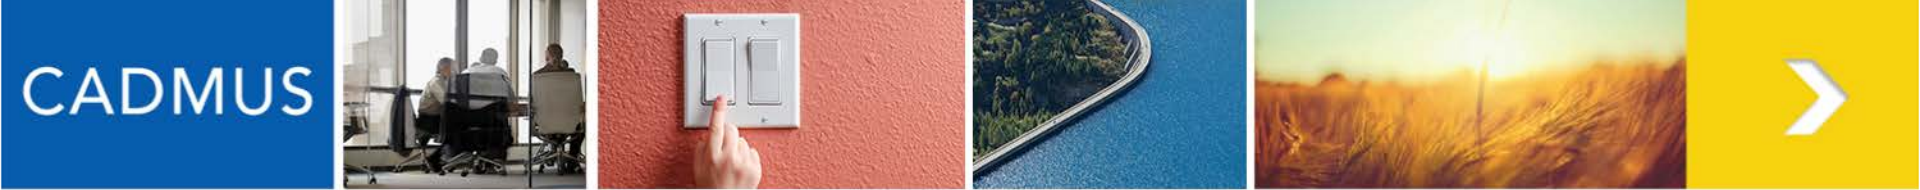
Tap Box in Overhead Service

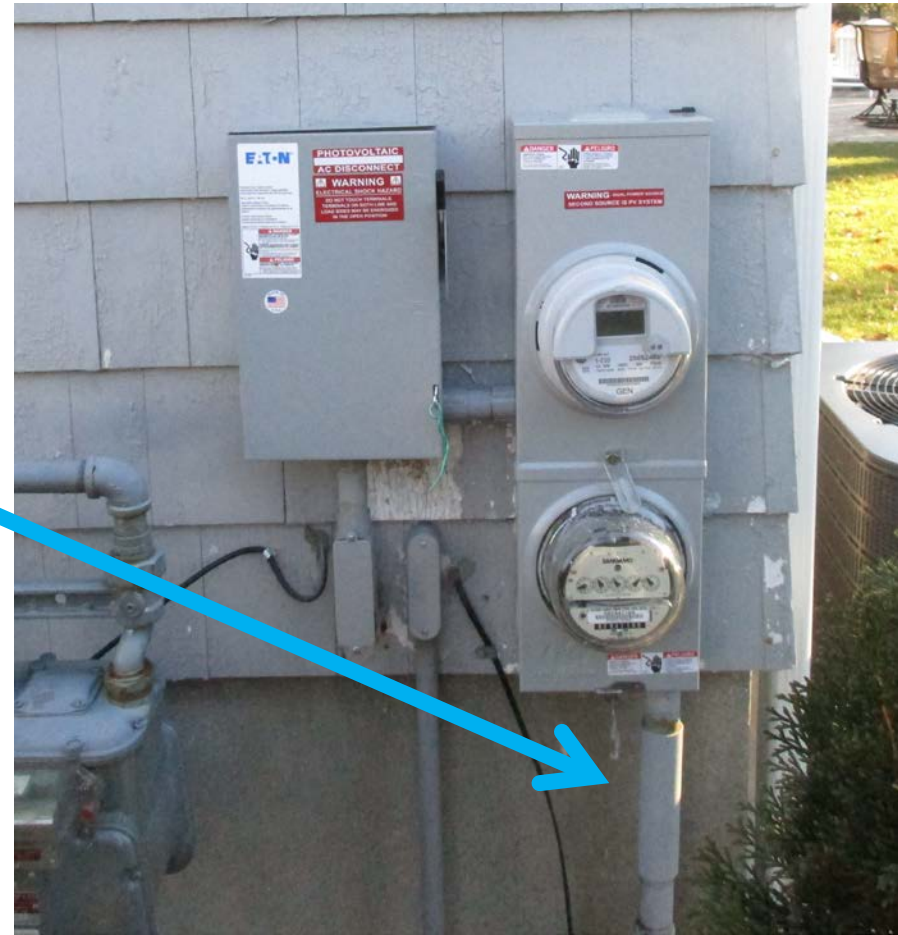
- Wrong type of meter enclosure used for underground service

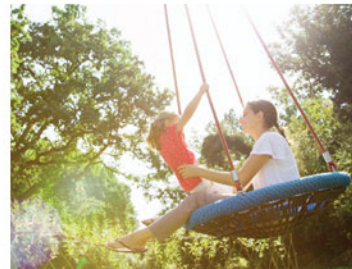
Common Violations Observed

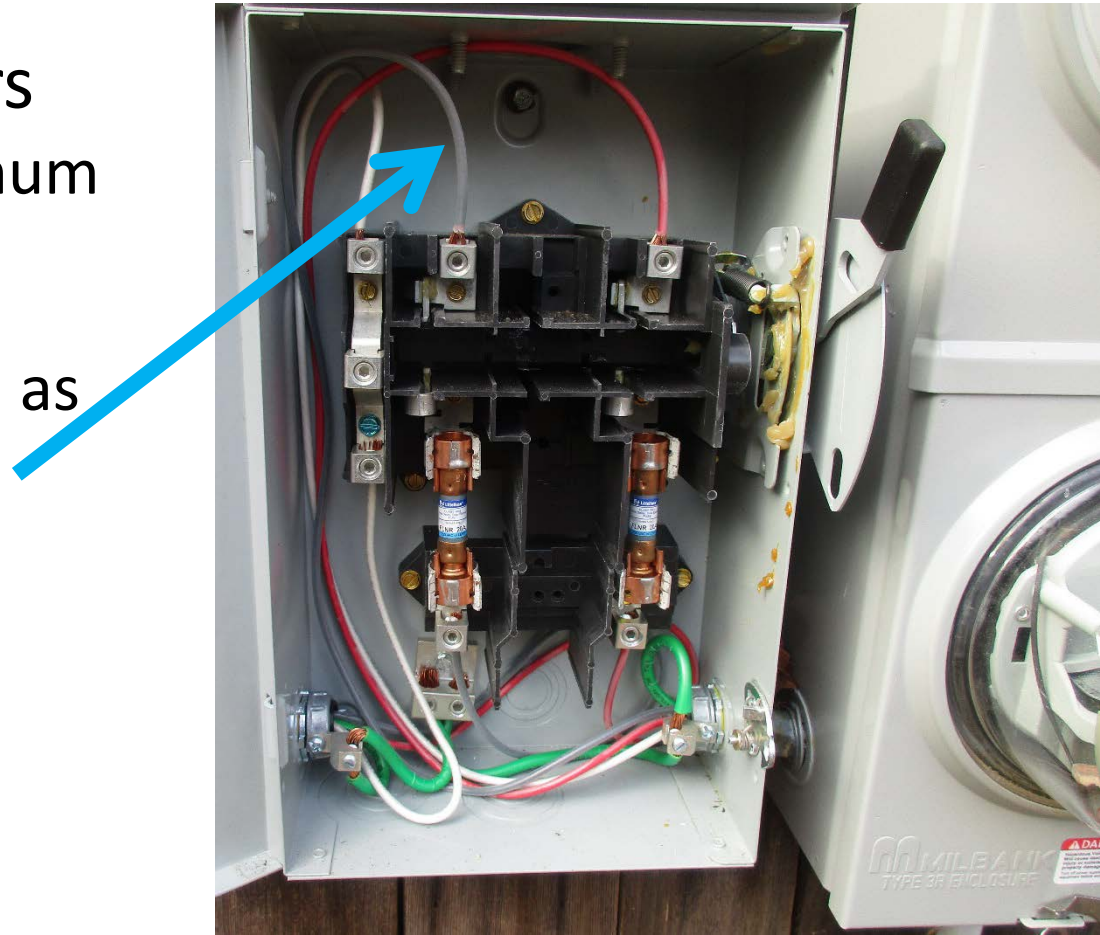
- Undersized service-entrance conductors
 - NEC requires minimum #6 AWG wire
 - Cadmus observed conductors as small as #10 AWG

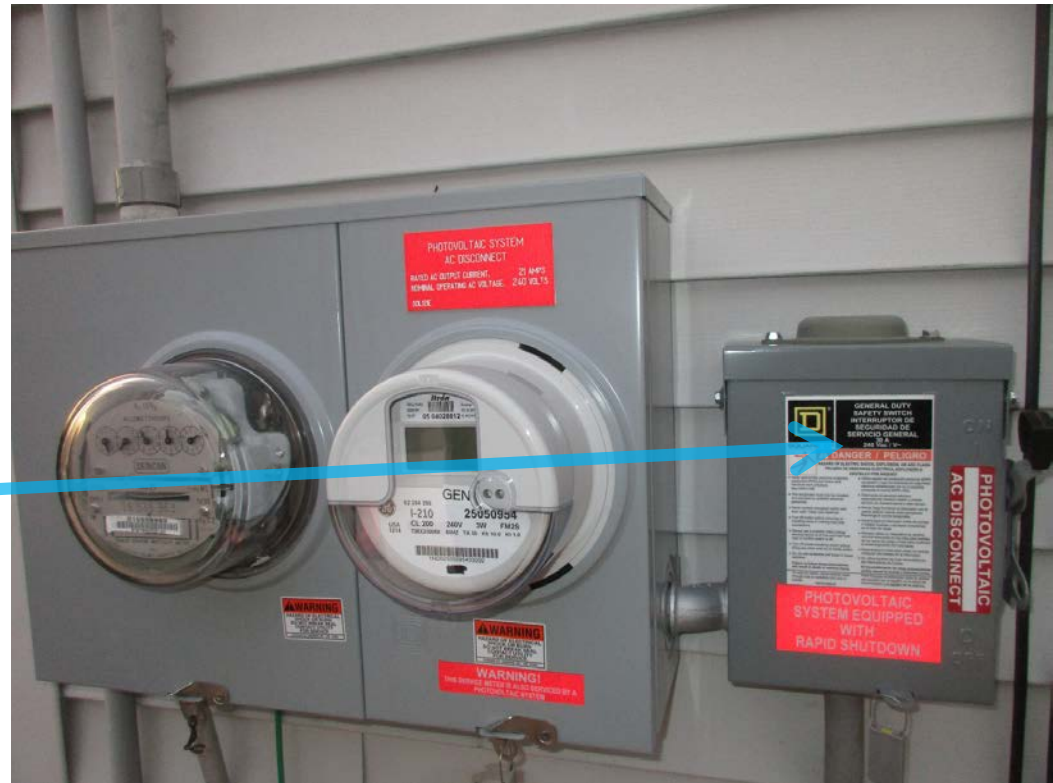
- Undersized Service Disconnect
 - NEC requires minimum 60A
 - Cadmus observed many 30A

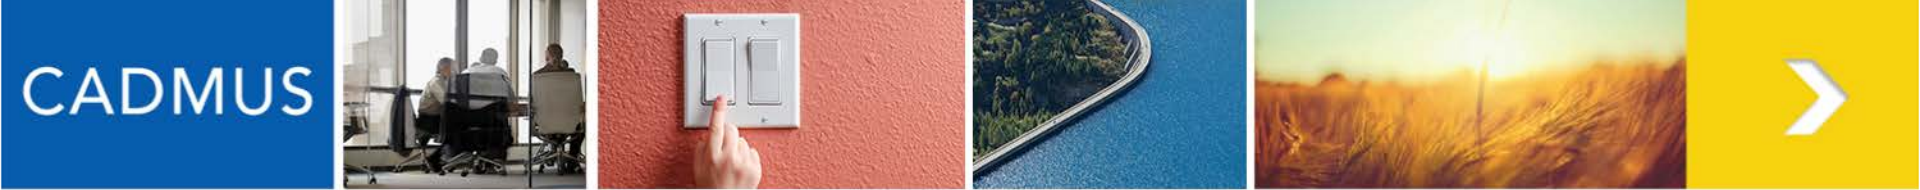
Installer/Inspector Feedback

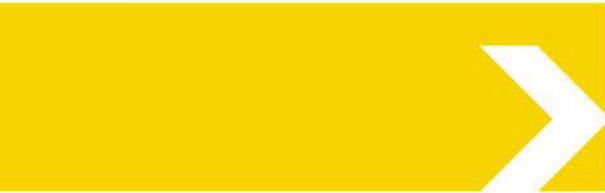
Results from Installer Responsiveness Tracking

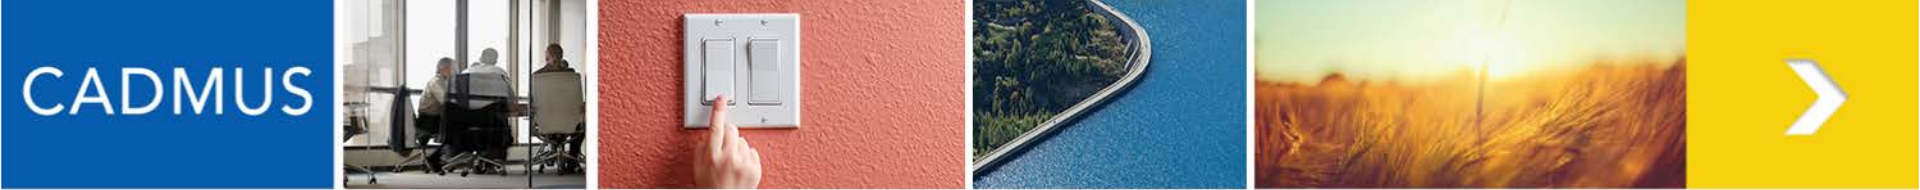
Further Analysis and Recommendations

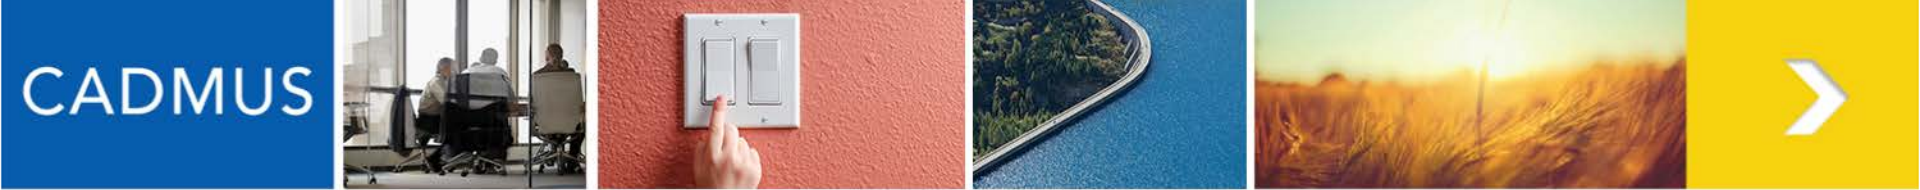
Further Analysis and Recommendations

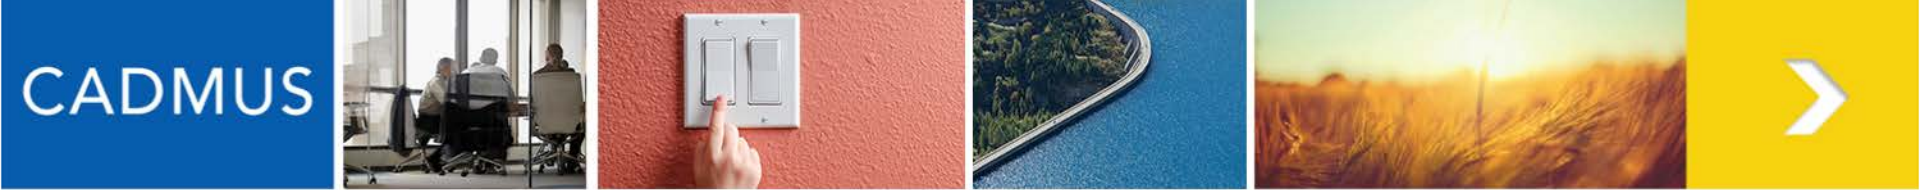
Ongoing QA Review for REG-funded Renewable Energy Systems

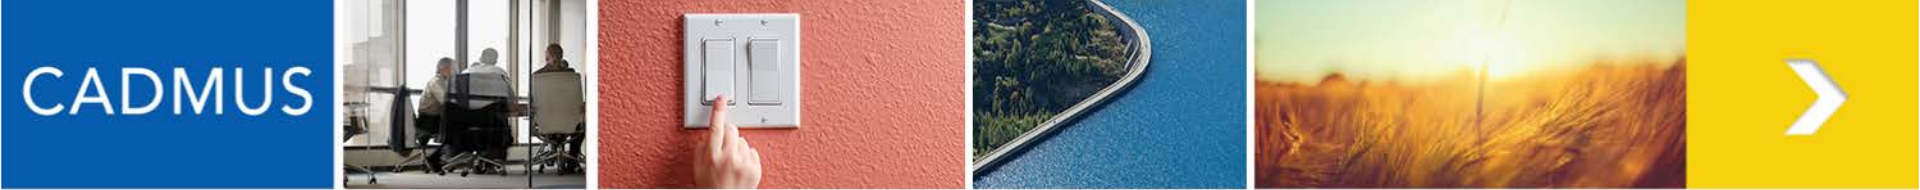
Next Step: REG QA Study Round 2
