November 16, 2018

Study of Renewable Energy Installation Quality in Rhode Island – Round 2 Final Report

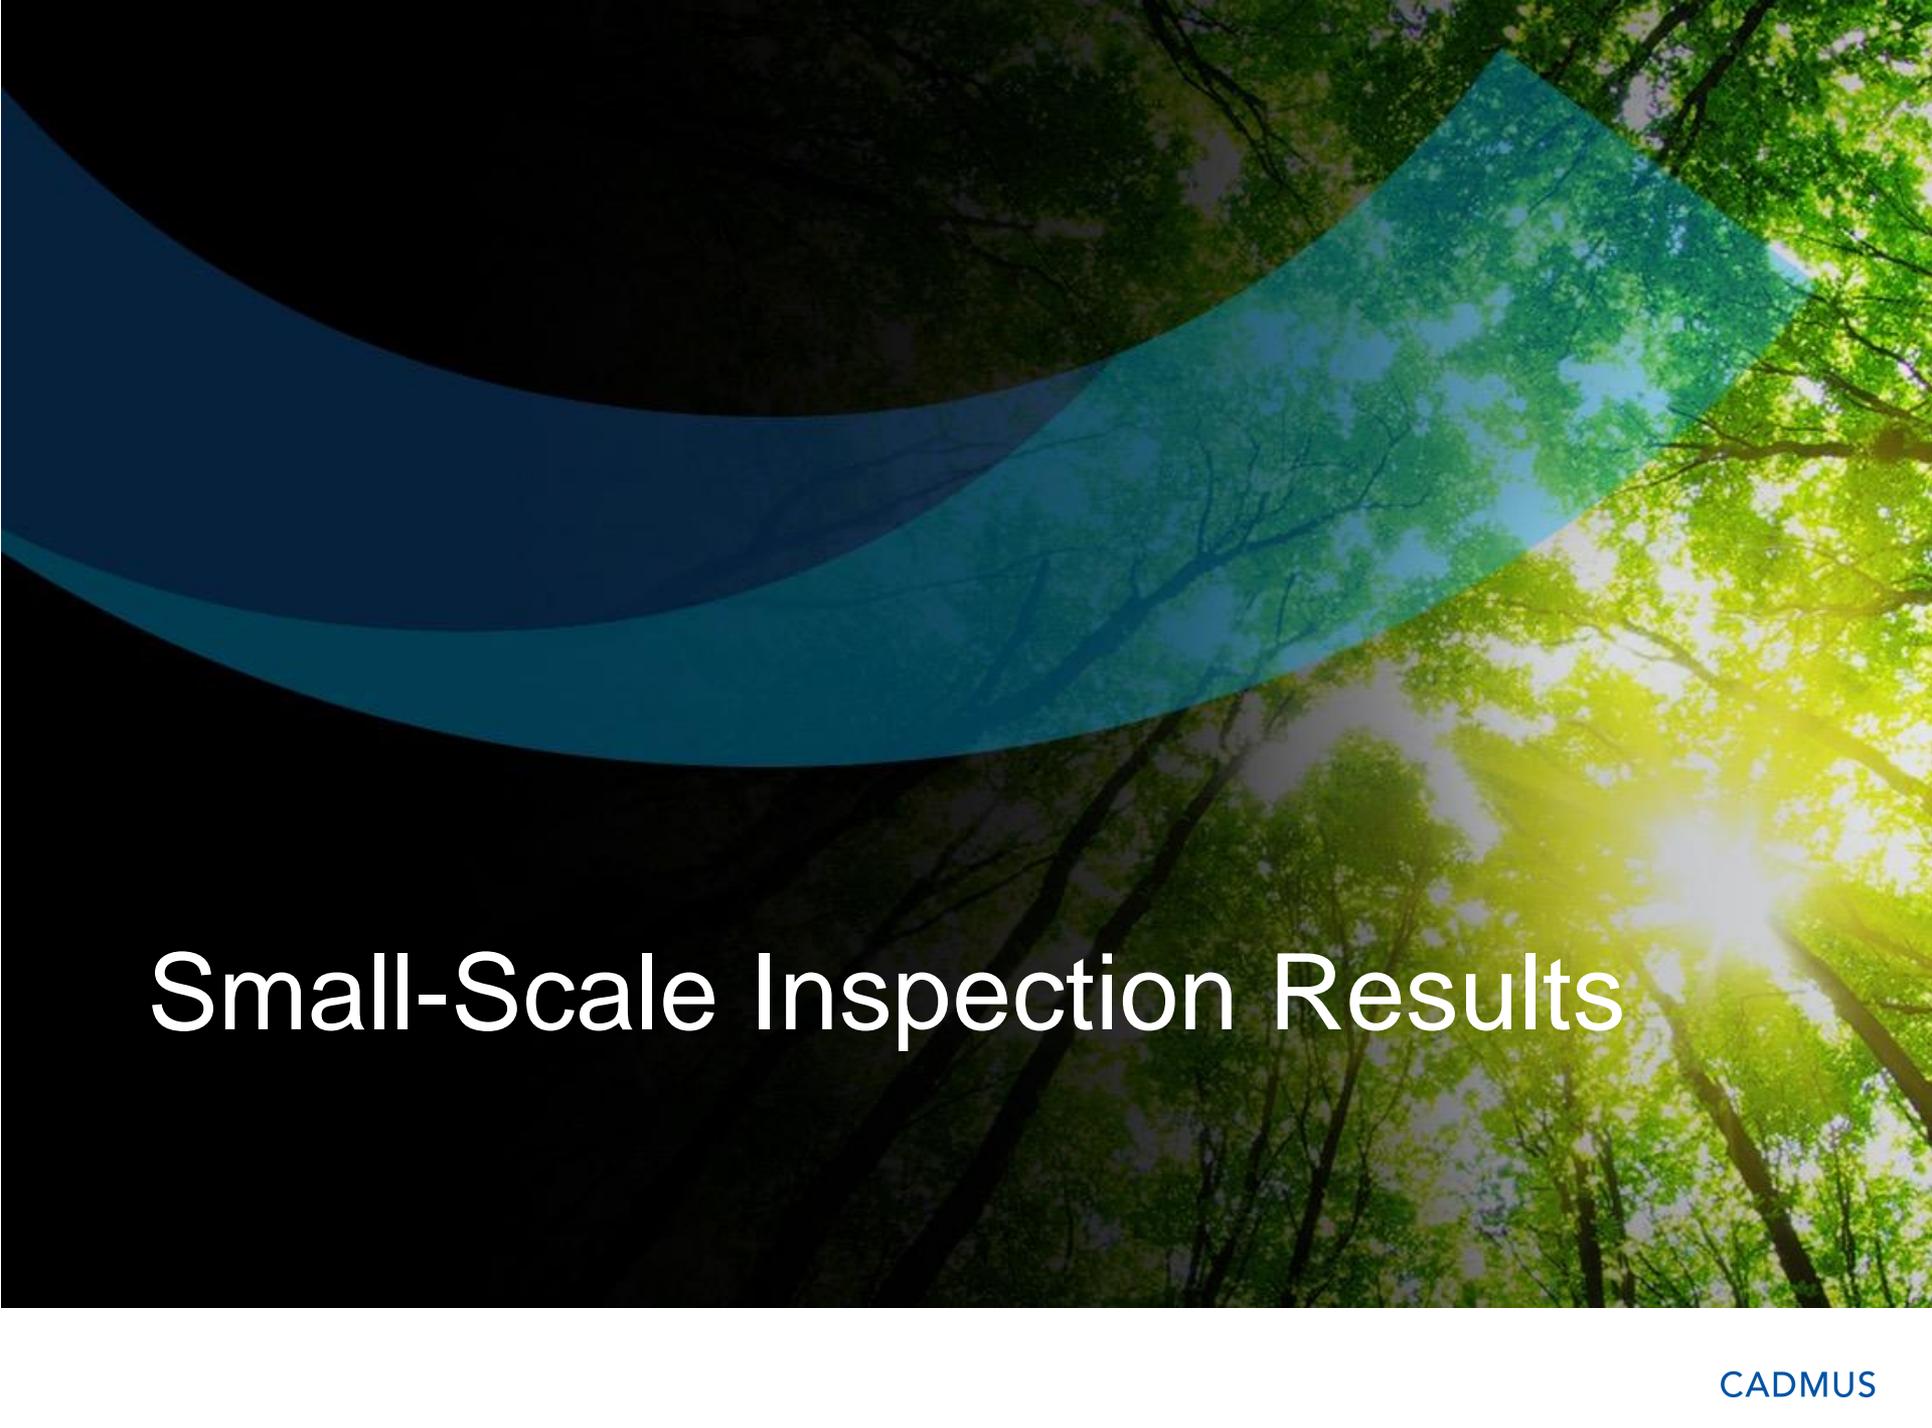
Small-Scale Inspection Results

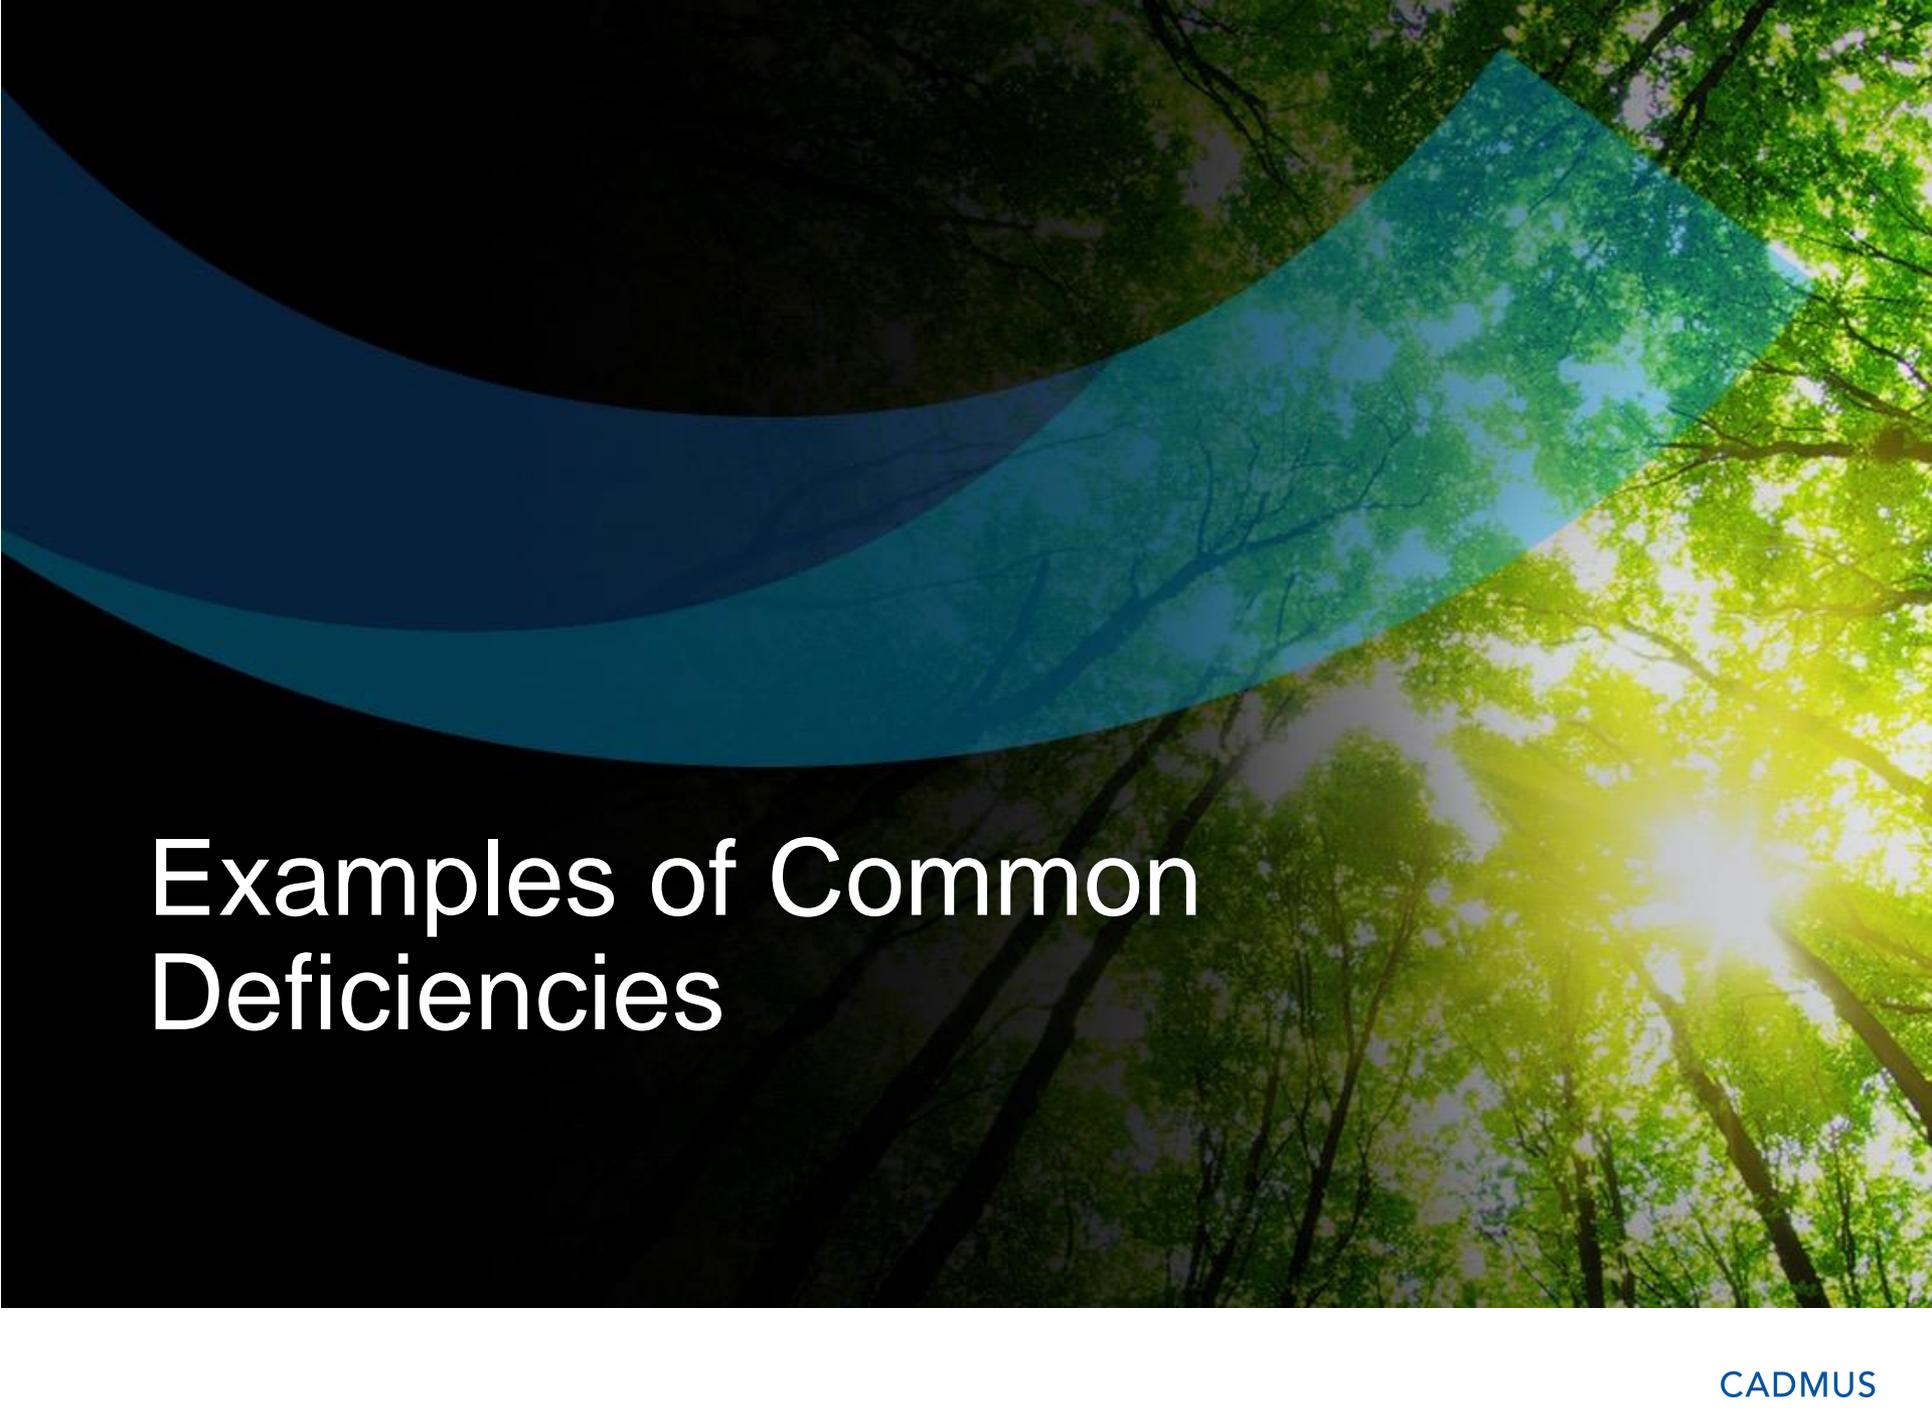
Examples of Common Deficiencies

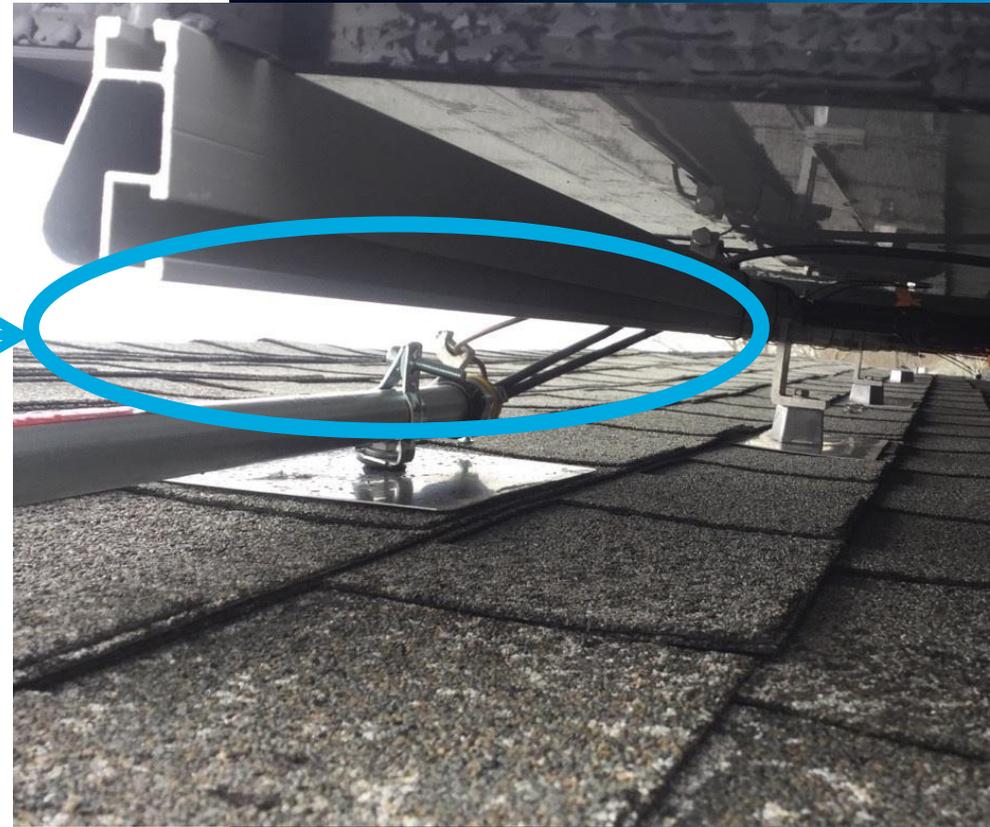
Improperly-Secured Modules

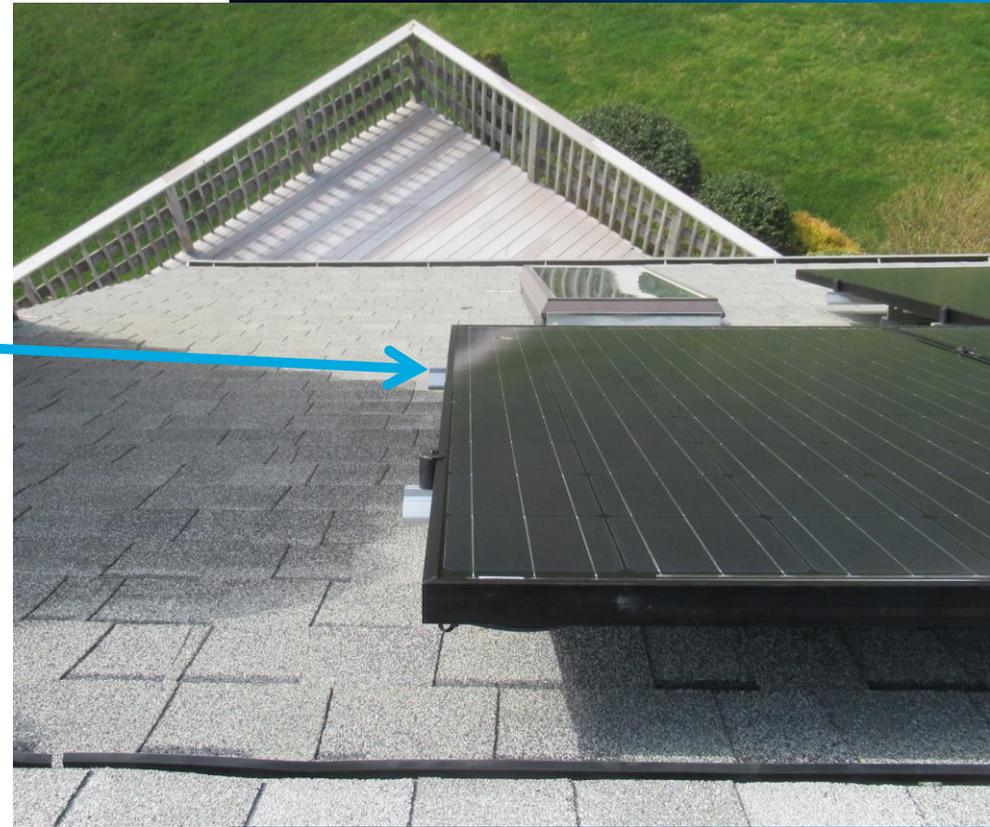
- PV modules improperly secured and fastened in place
- Missing, incompatible, or inappropriately-installed hardware
- Increased risk of module falling
- Example: missing support clamp

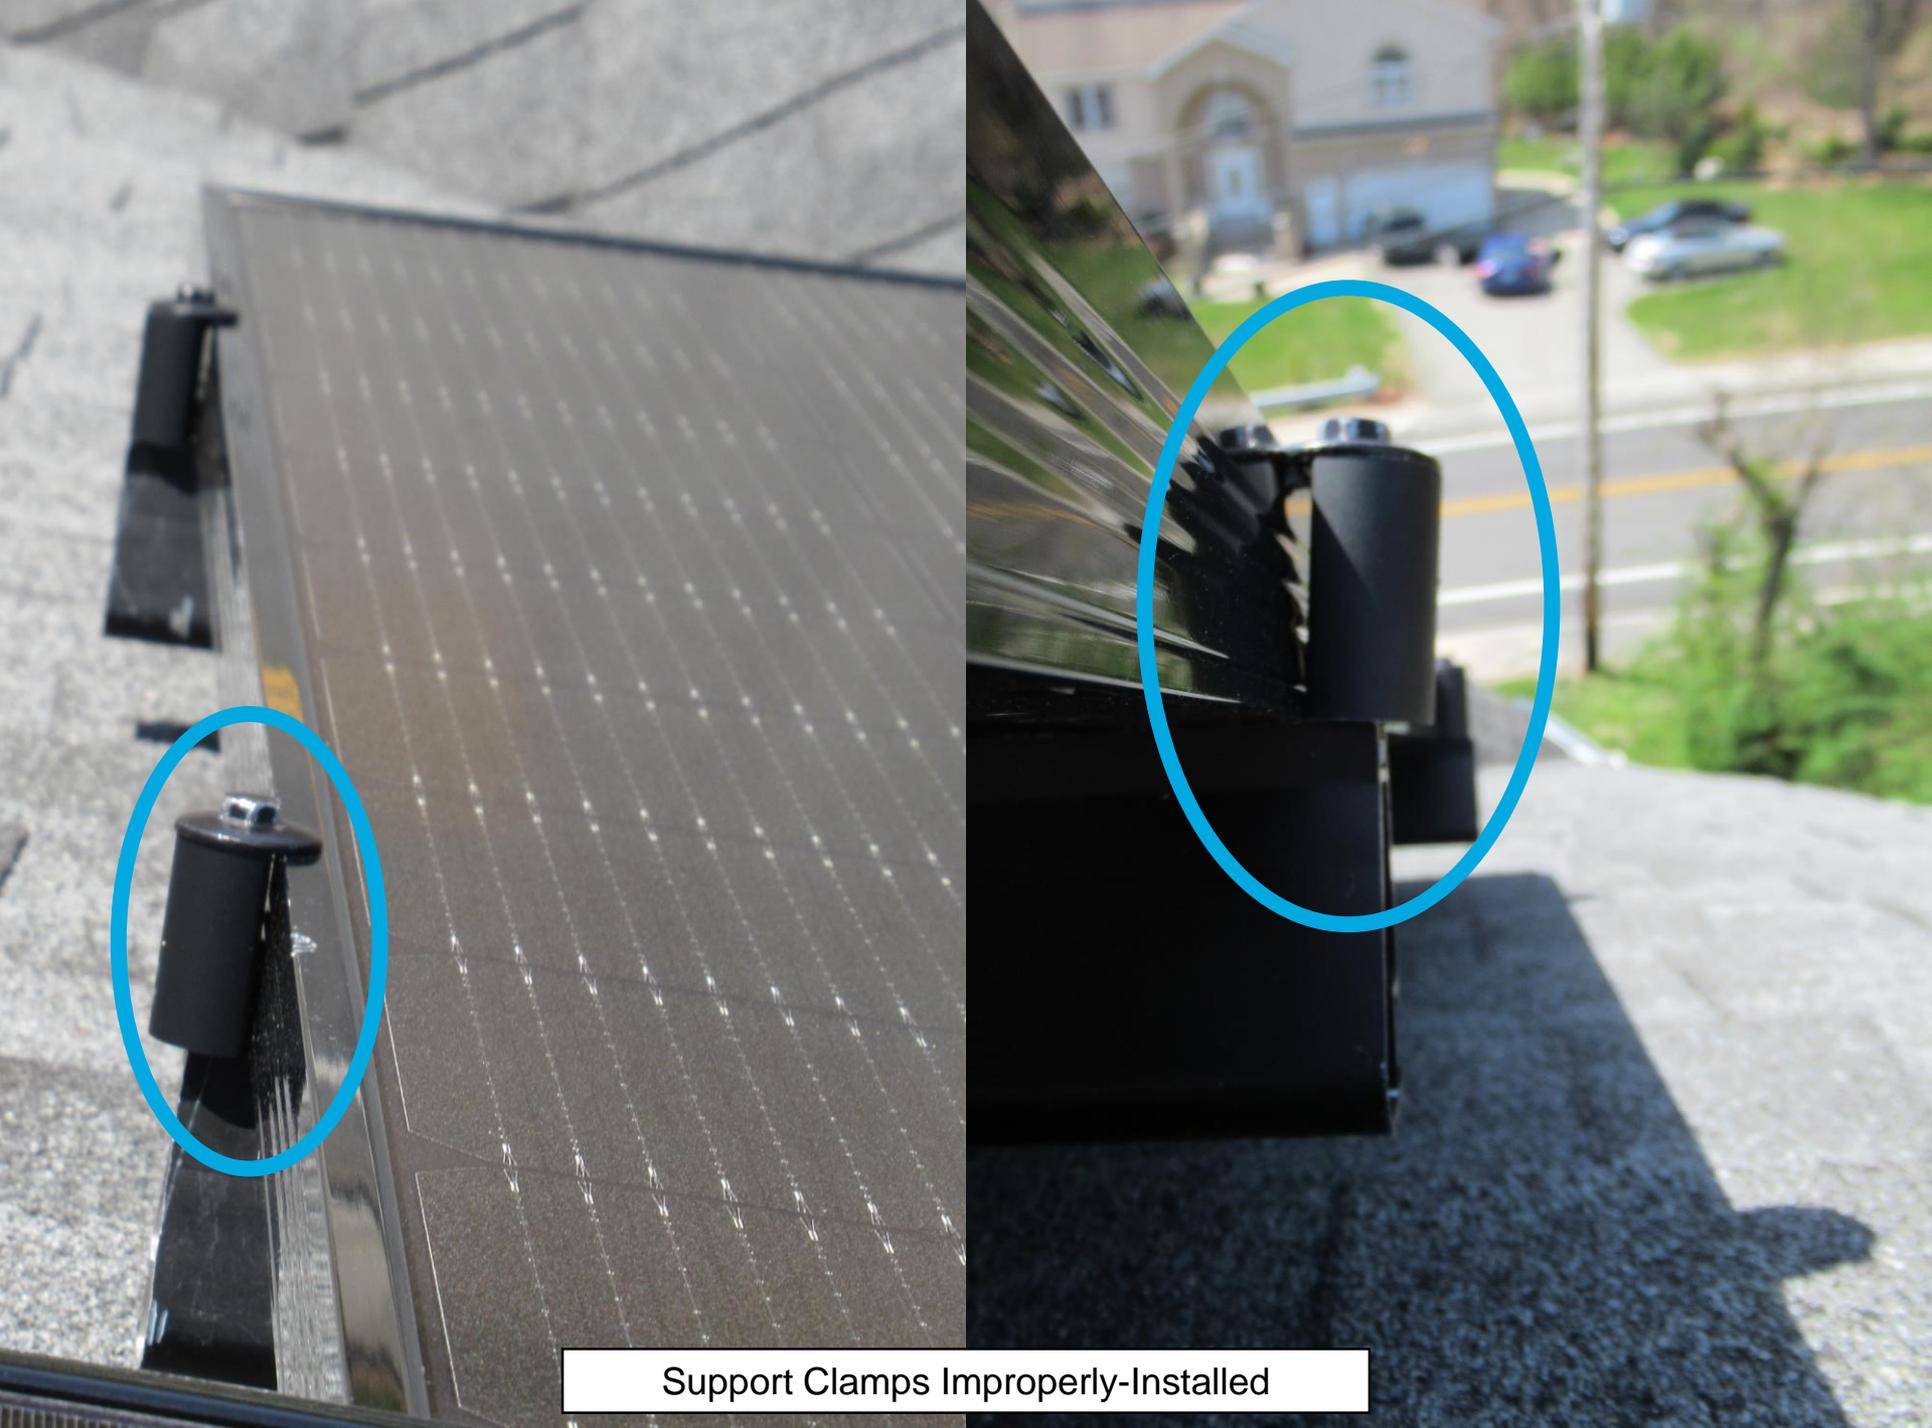
Support Clamps Improperly-Installed

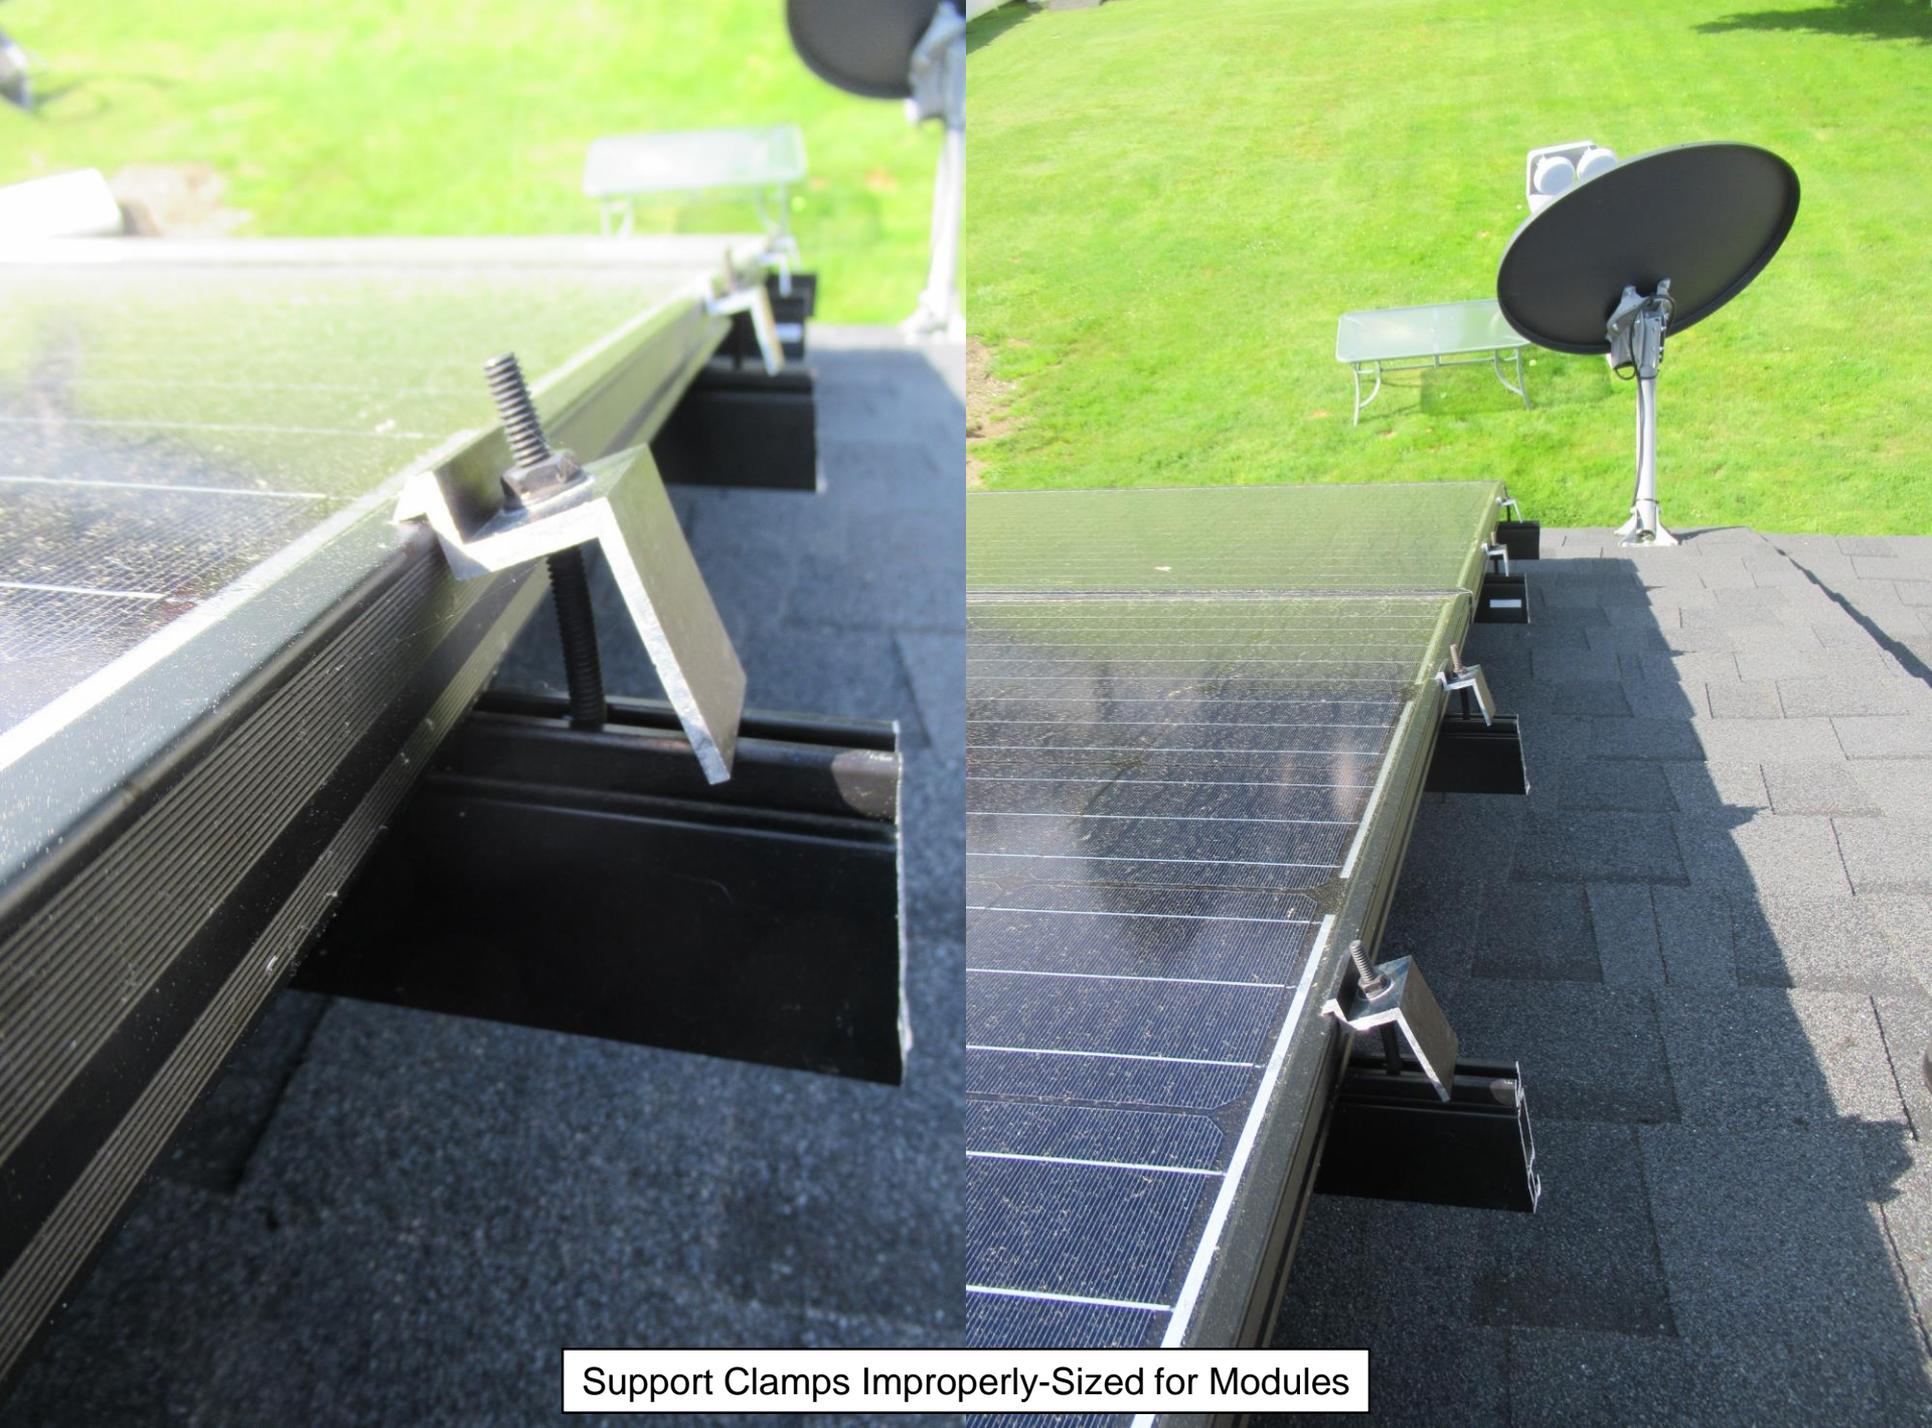
Support Clamps Improperly-Sized for Modules

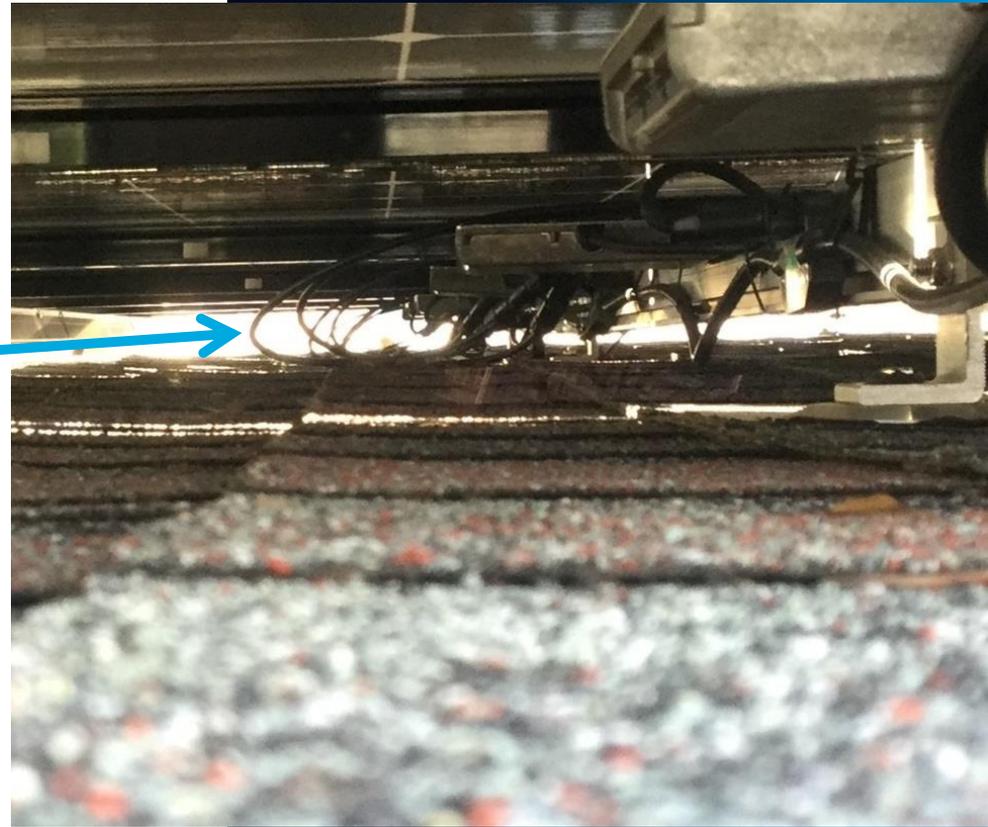
Module Frame Grounding

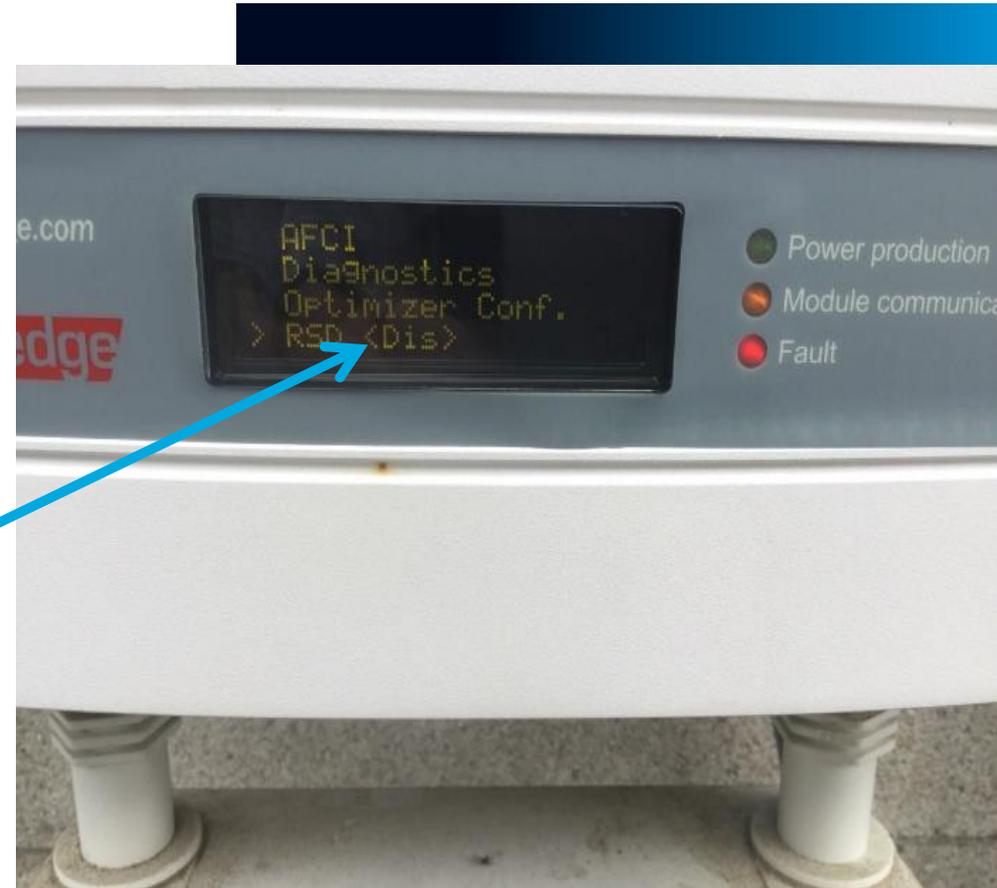
- Missing or Deficient Rapid Shutdown Function
- When the rapid shutdown function is not functional or provided, DC wiring may be energized up to 1,000V during daylight hours. This may hinder the ability to safely mitigate issues such as a building fire
- Examples: rapid shutdown function not enabled, or DC conductors exceed 10' limit from array without rapid shutdown function

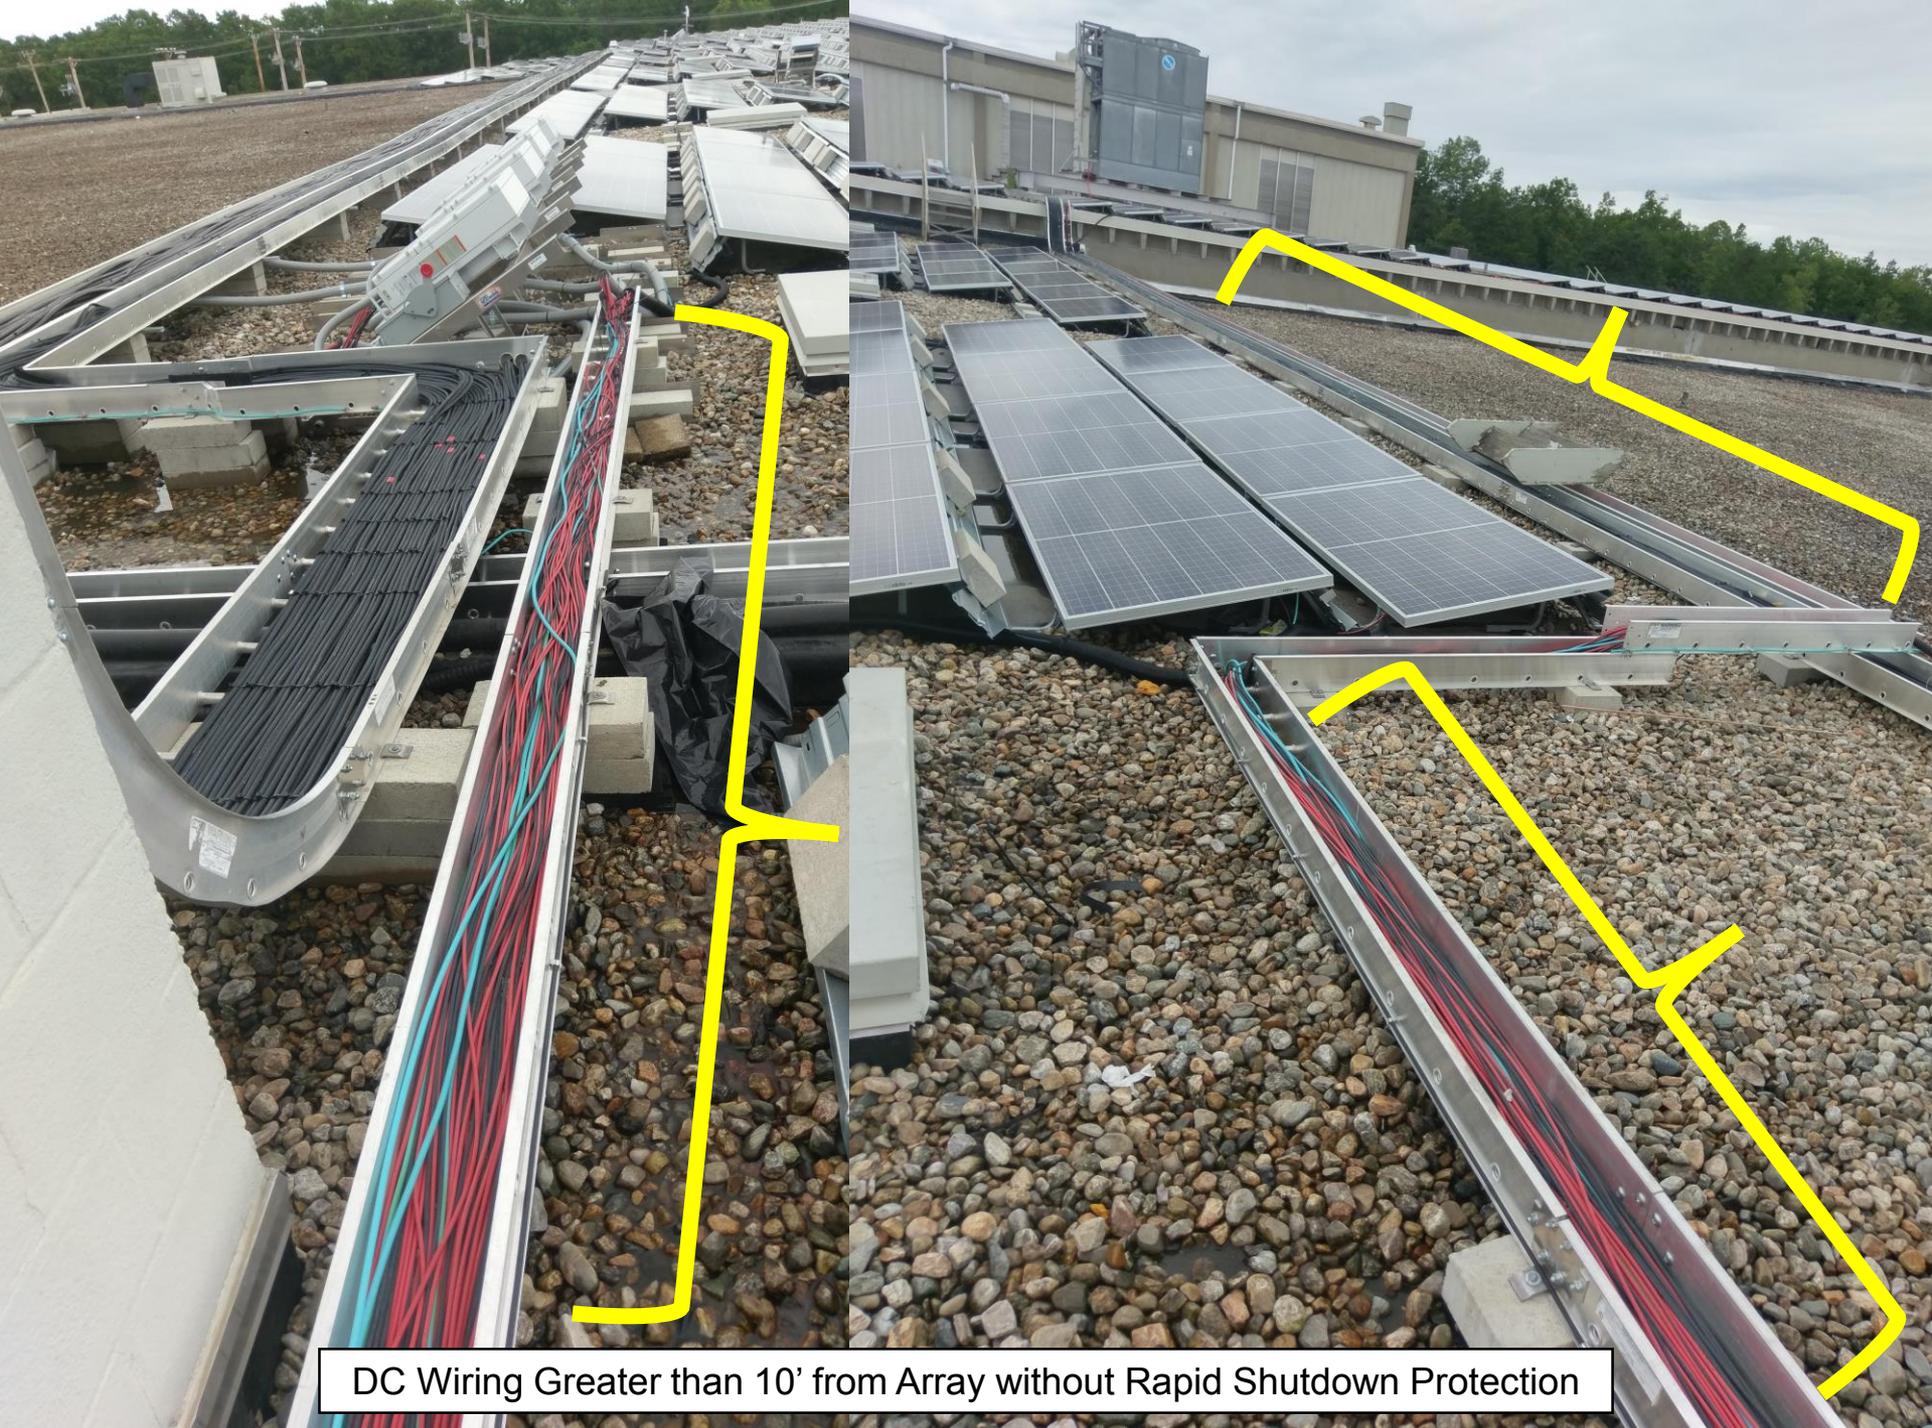
DC Wiring Greater than 10' from Array without Rapid Shutdown Protection

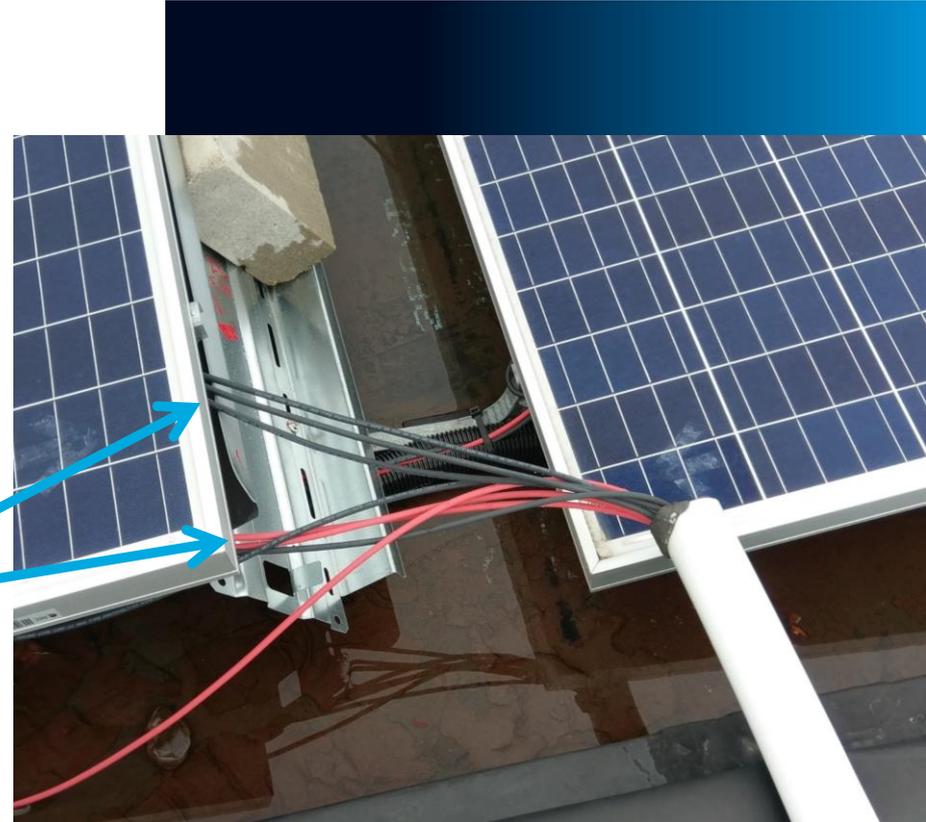
- Conductors are not protected from physical damage.
- Damaged conductors can lead to system failure, danger to workers and others, and fire hazards.
- Example: Conductors installed in a location exposed to physical damage
 - Internally from sharp edges
 - Externally from other sources

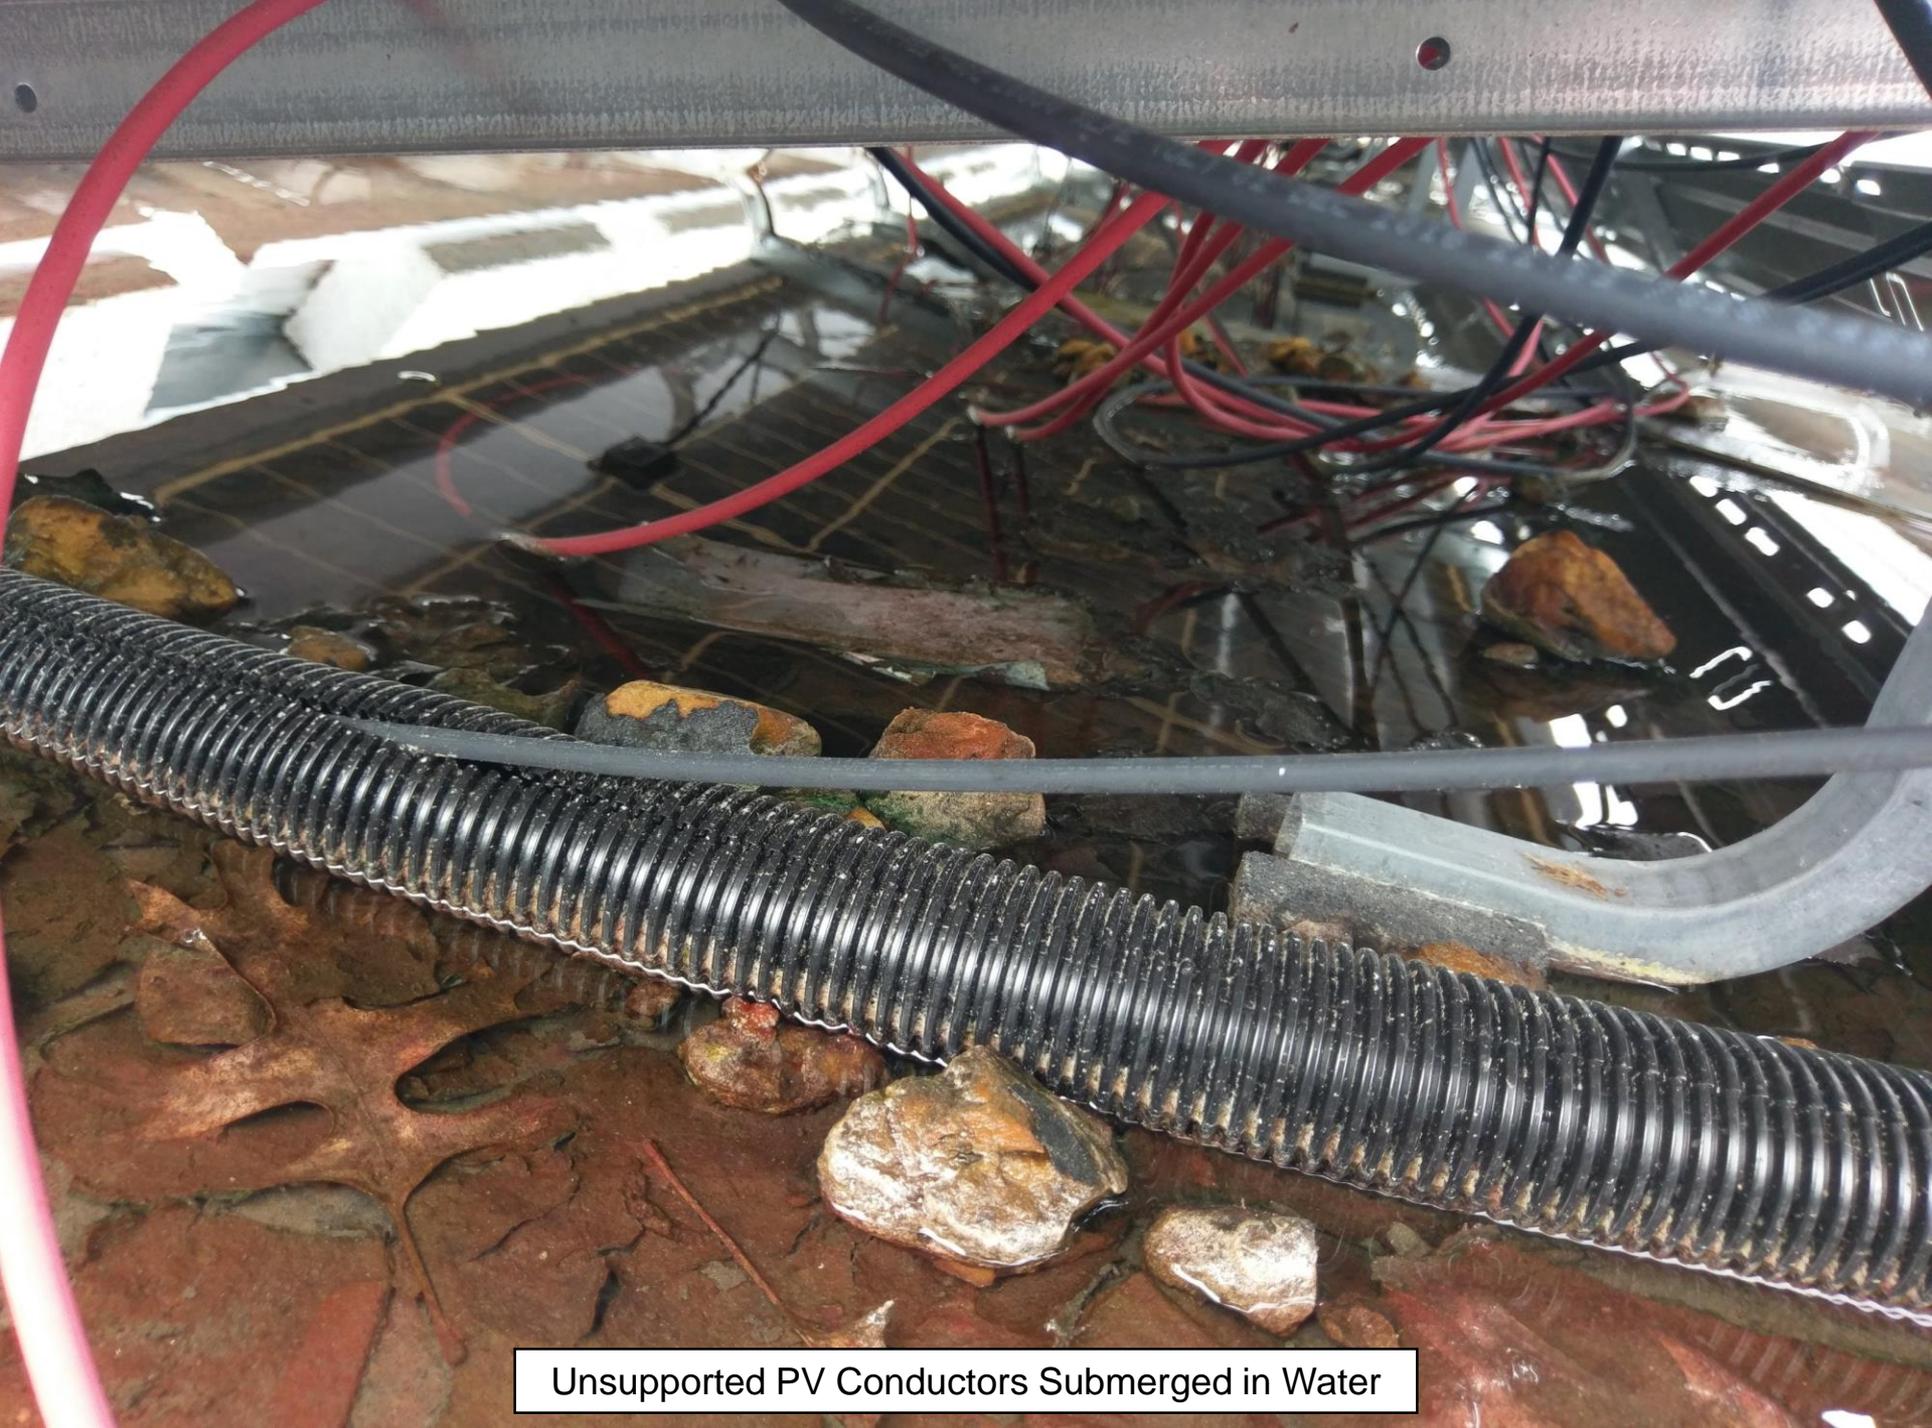
Unsupported PV Conductors Submerged in Water
