November 16, 2018

Study of Renewable Energy Installation Quality in Rhode Island – Round 2 Final Report

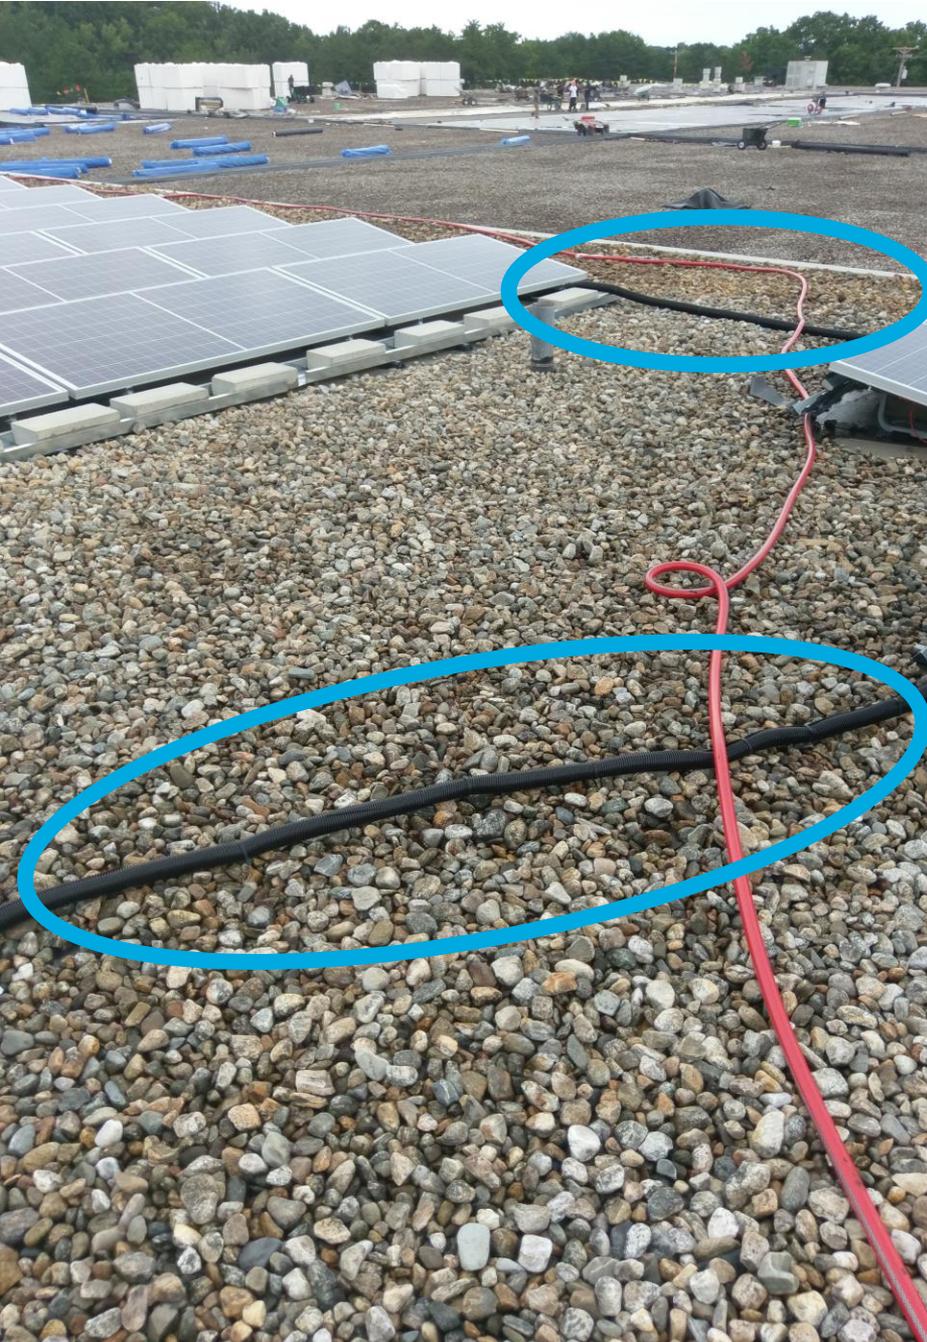
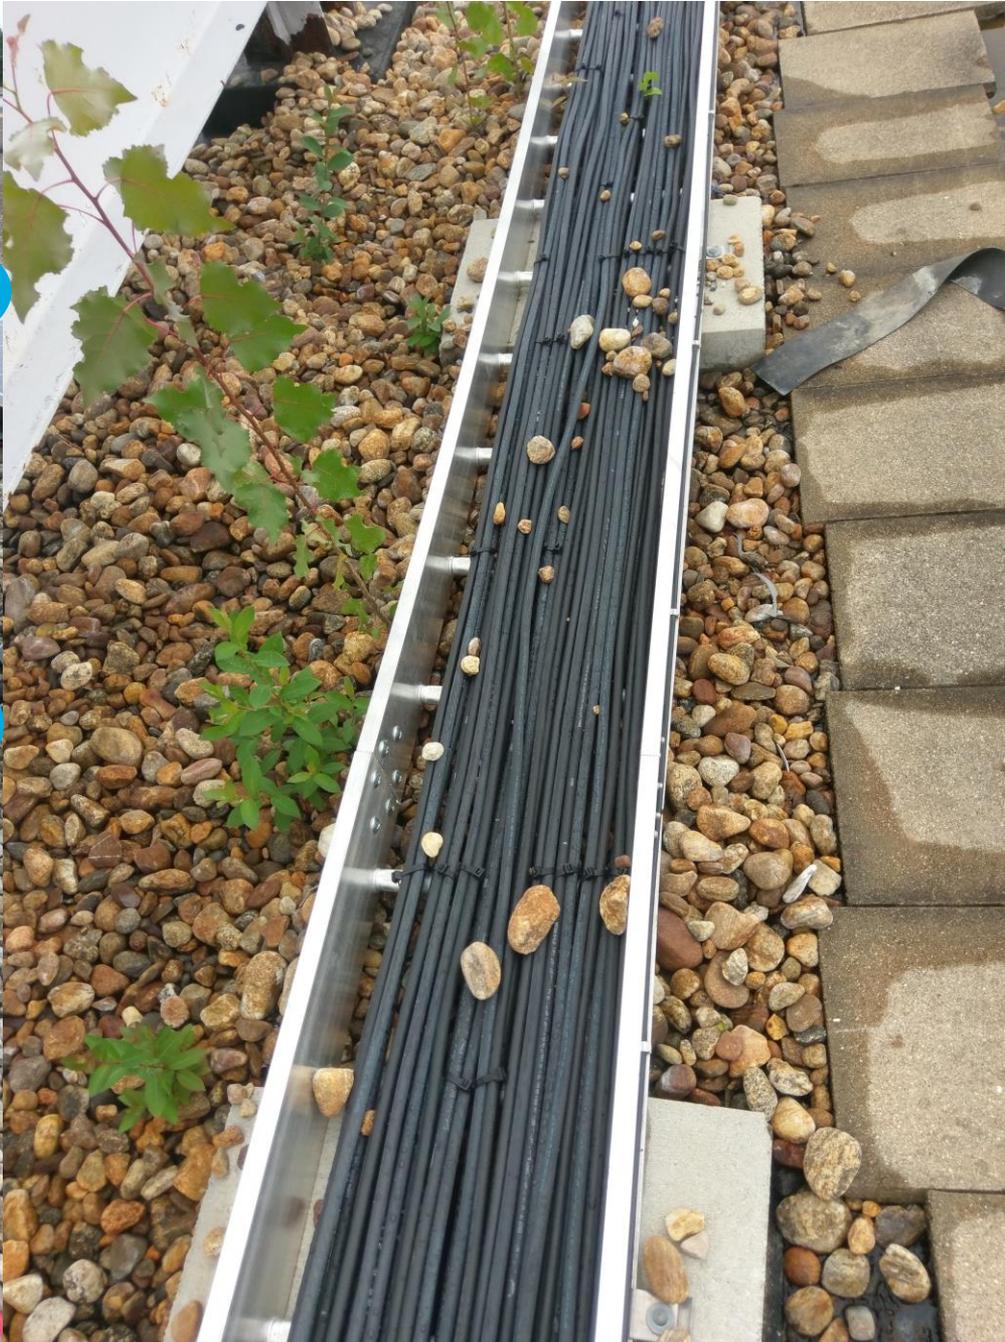
Unprotected Conductors Exposed to External Physical Damage

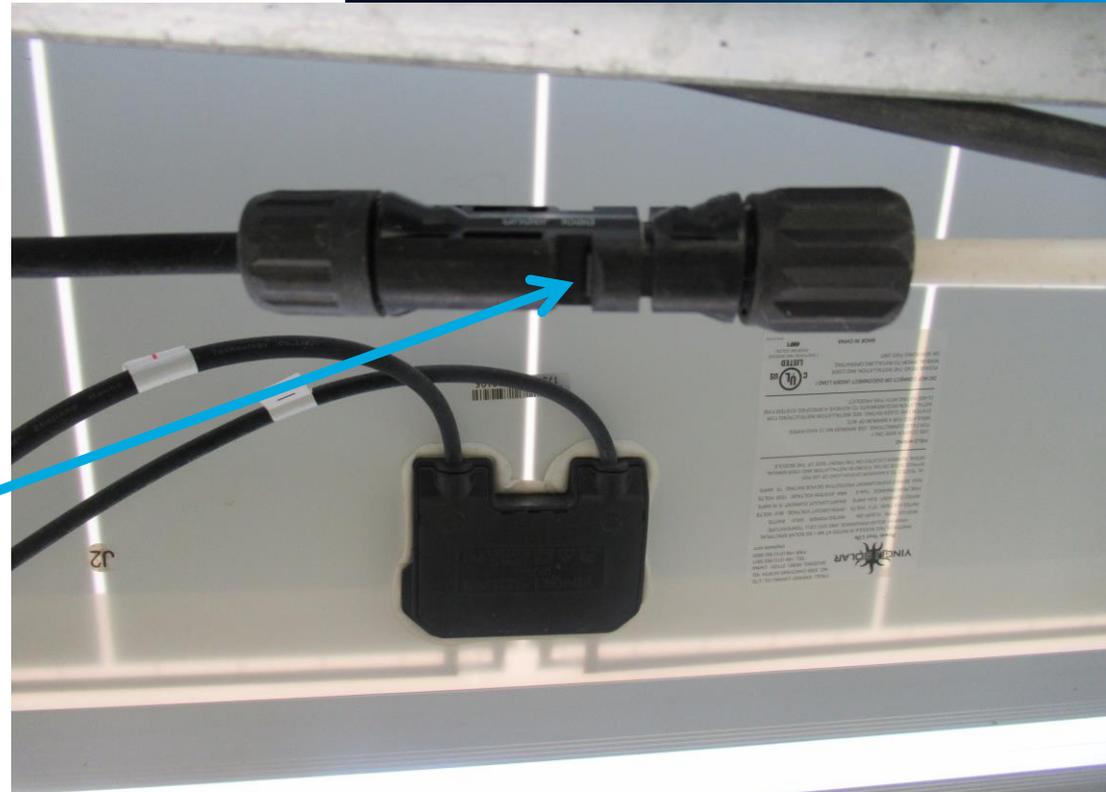
- DC connectors are not properly connected or used outside of the product listing.
- Hazards exist when DC connectors are not properly installed. Due to this DC current's physical nature, poor electrical connections can cause heat, arcing, or a thermal event.
- Example: Connectors that are not fully engaged can produce high temperatures, which can result in poor efficiency or fire.

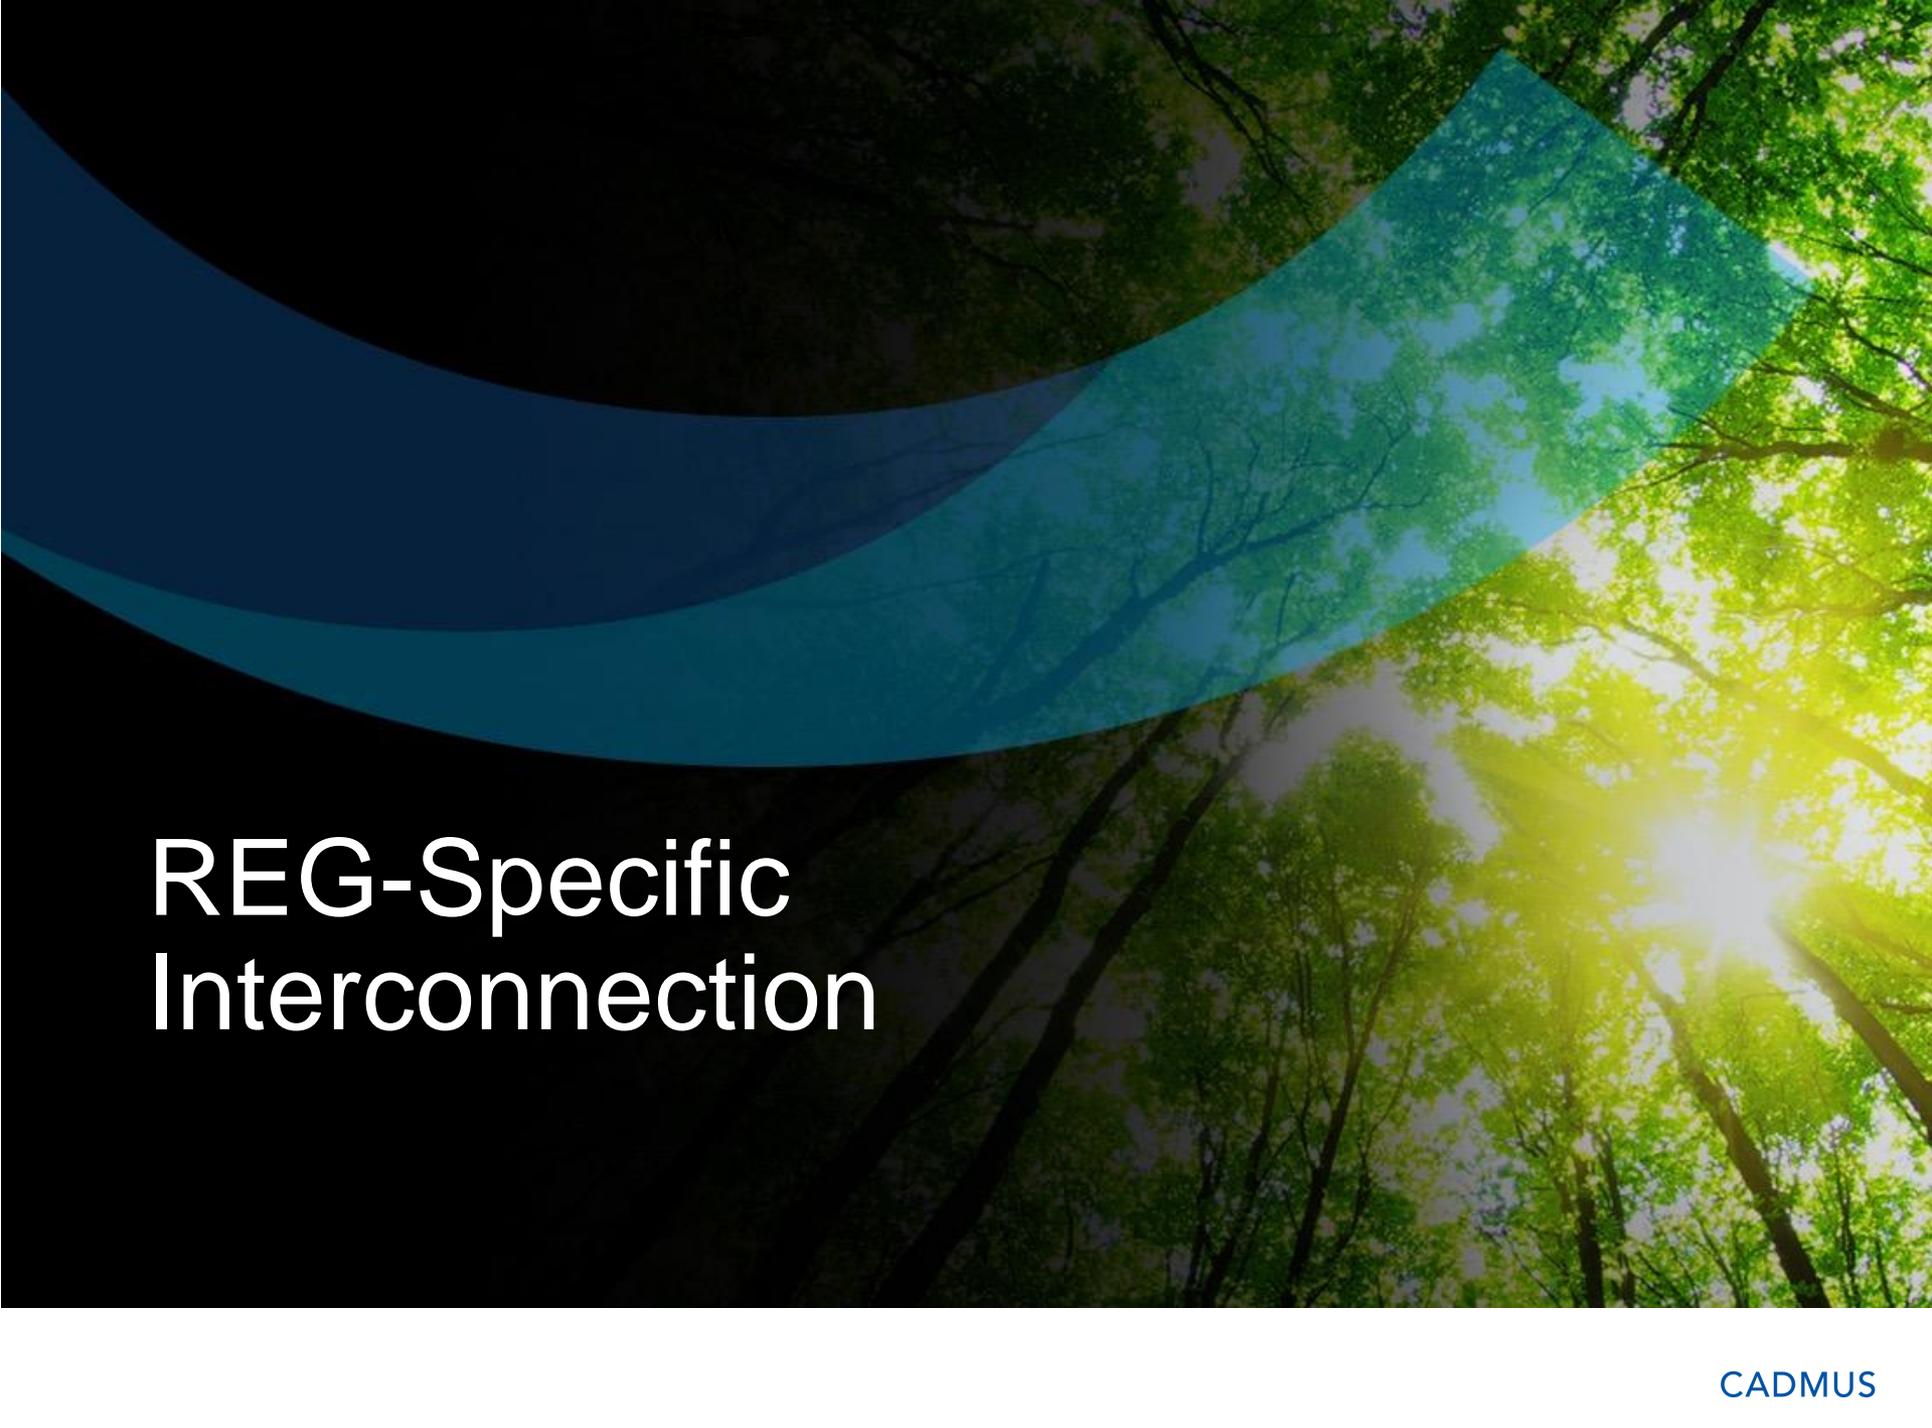
REG-Specific Interconnection

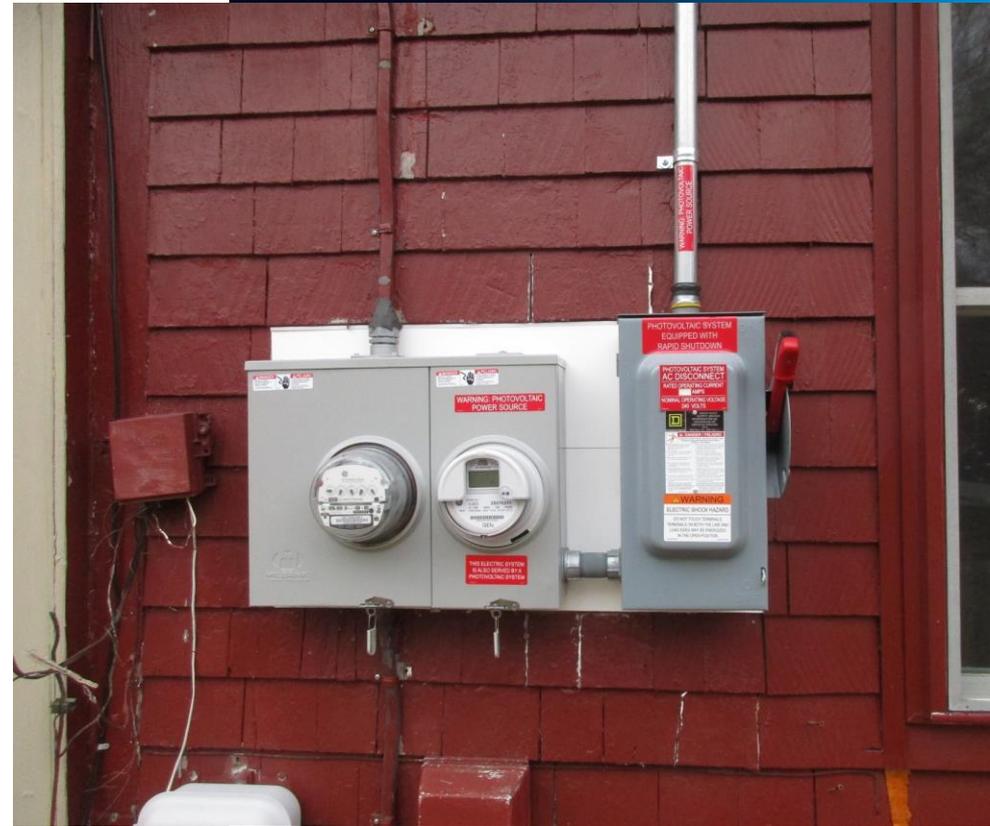
REG-Specific Interconnection

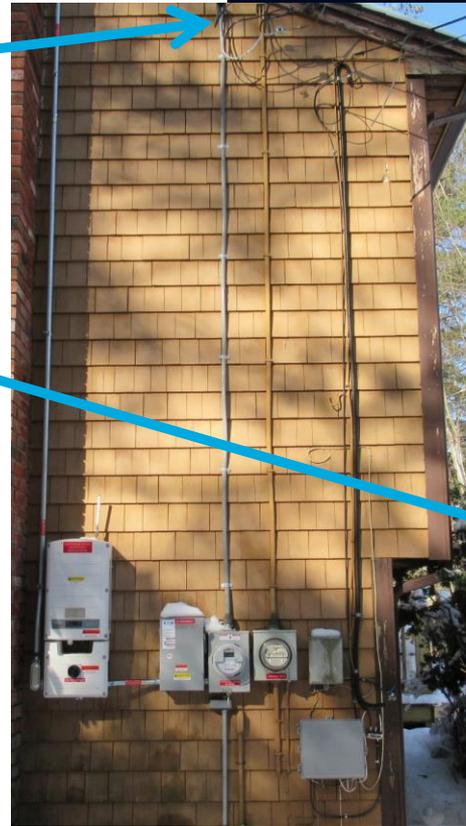
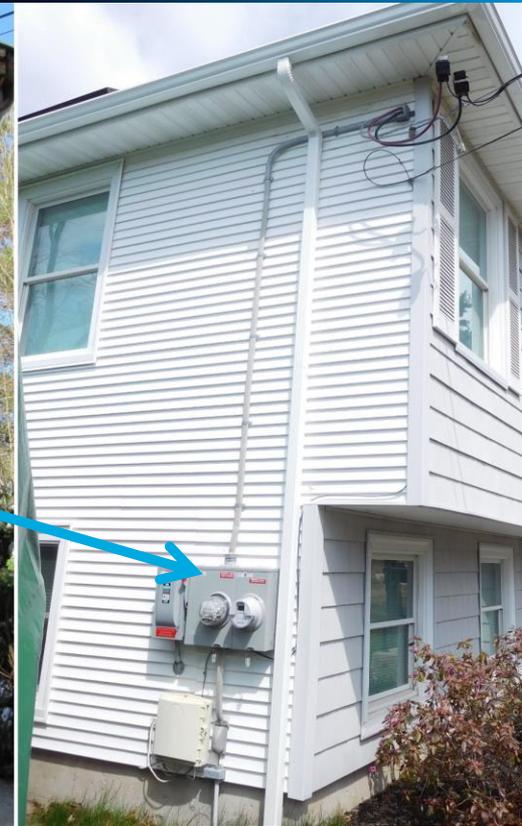
REG-Specific Interconnection

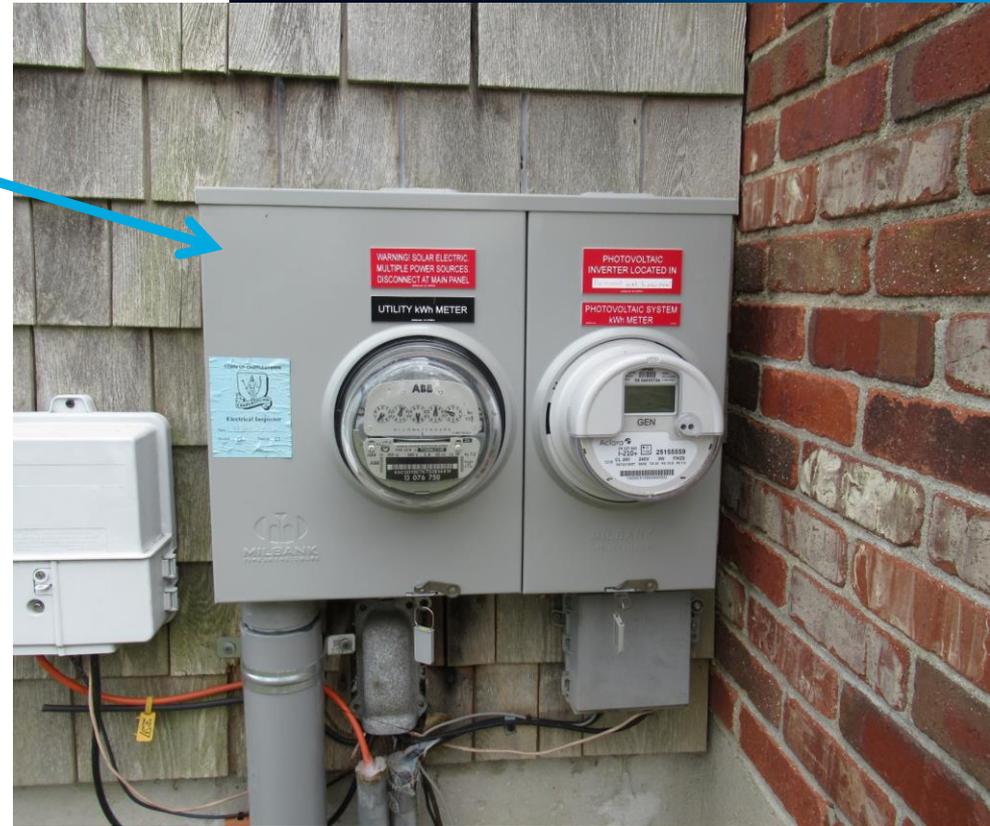
REG-Specific Interconnection

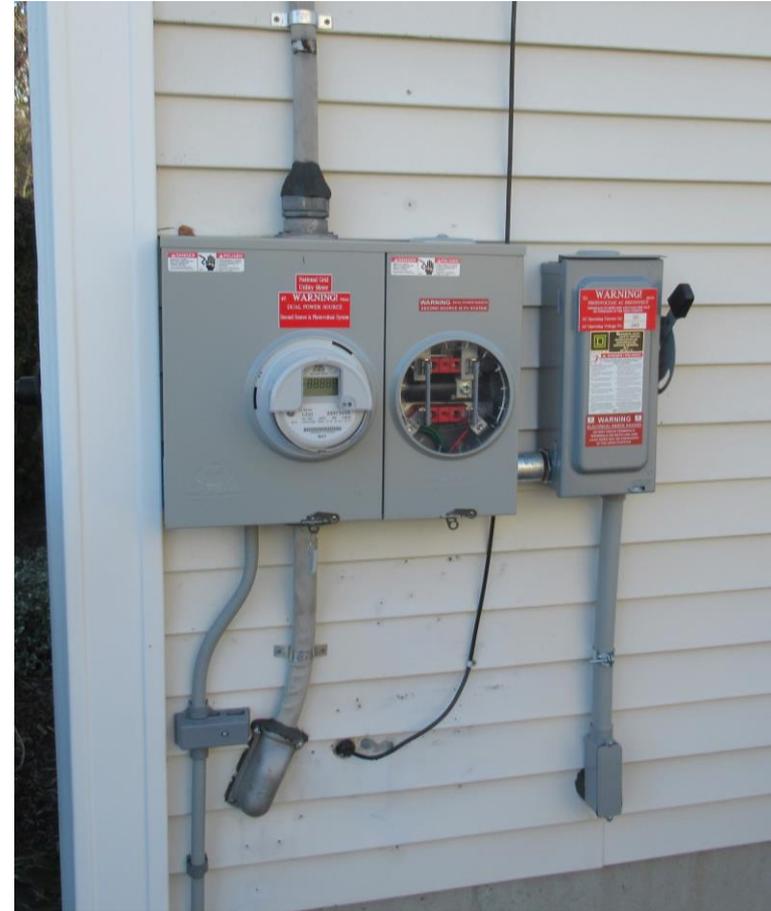
- PV connected through unmetered conductors
 - 3 residential
 - 1 commercial
- Installers and National Grid notified upon discovery
- Cadmus produced [guidance document](#) for installer clarification

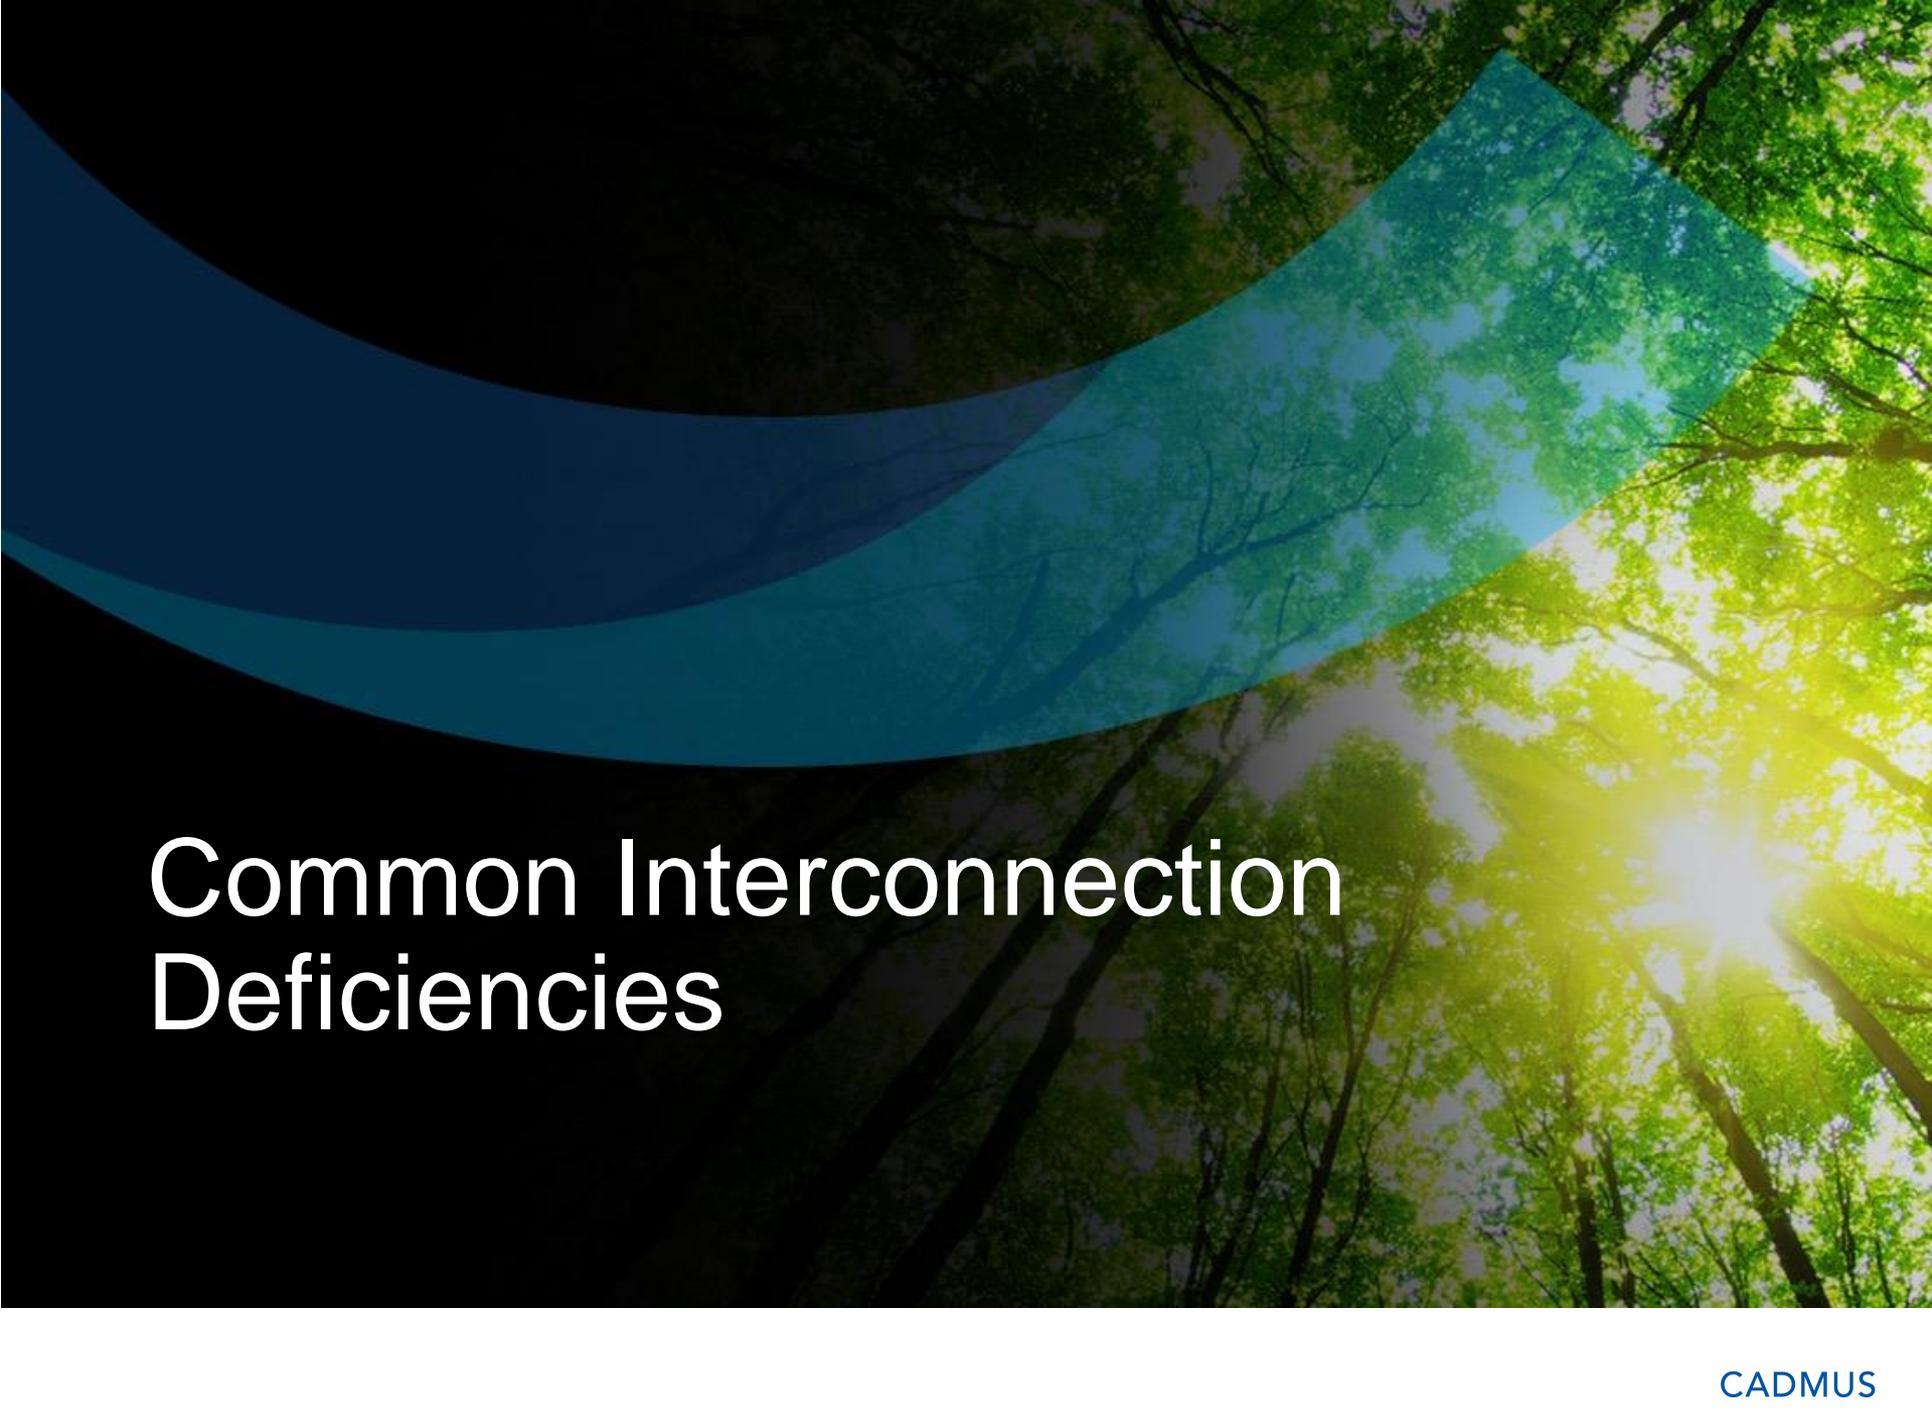
Common Interconnection Deficiencies

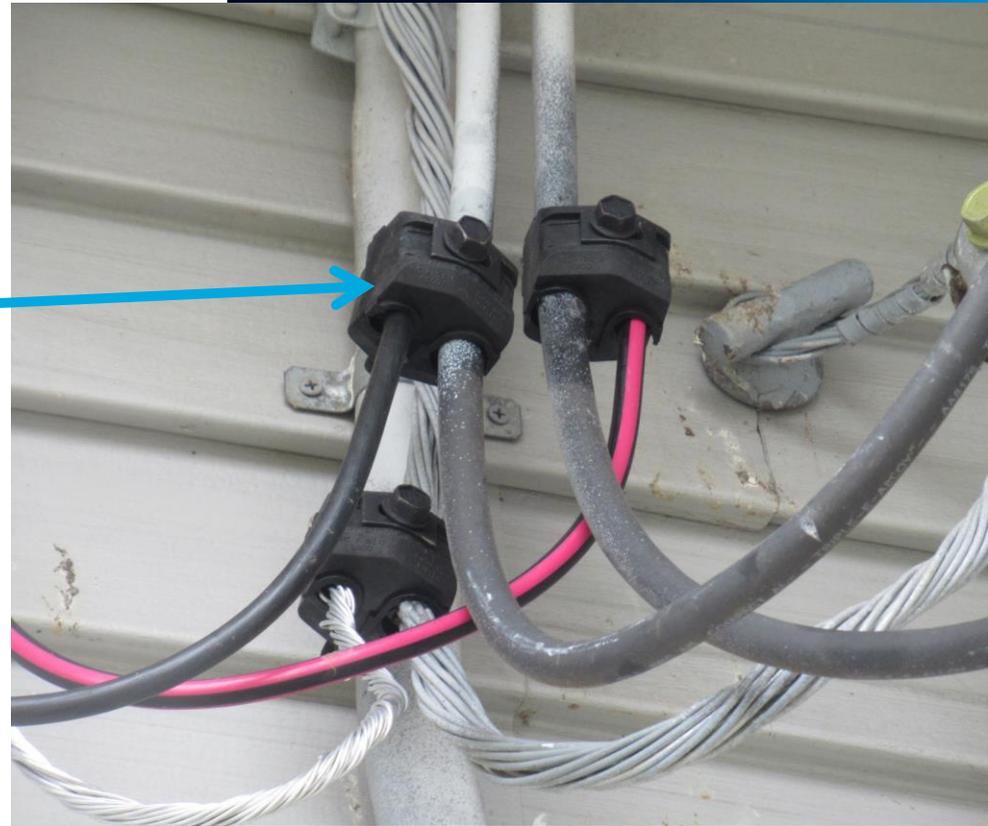
Examples of Common Deficiencies

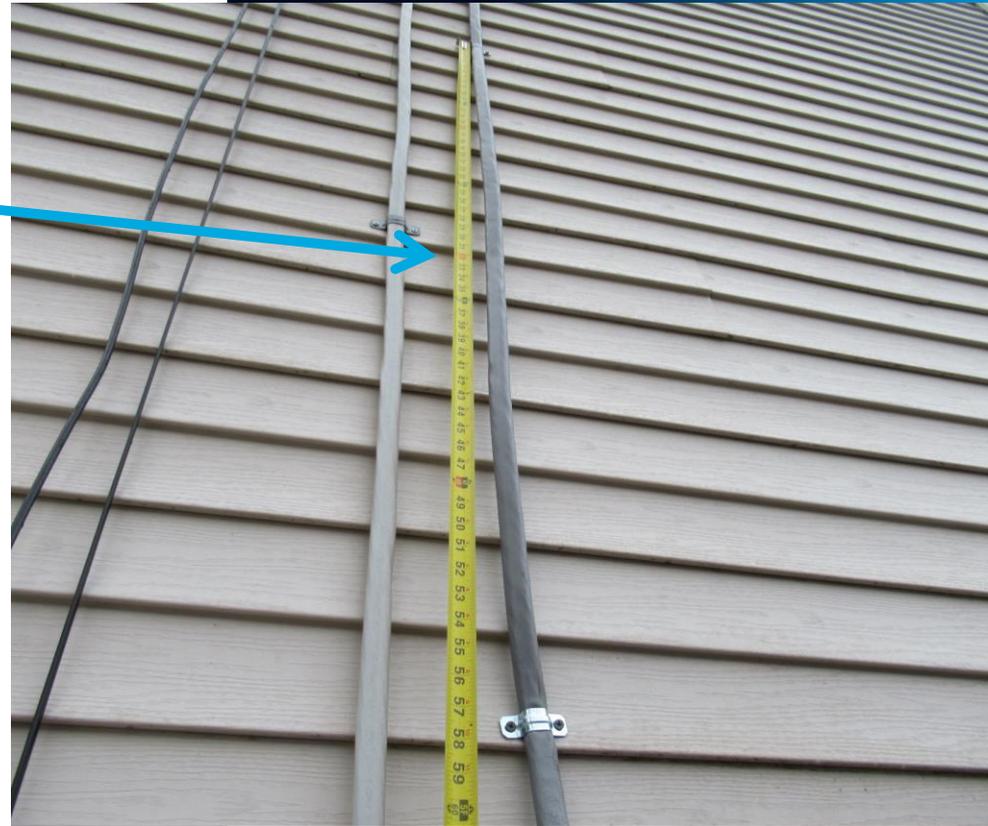
- Improperly-supported service-entrance cables
- Exceeding the minimum NEC support interval (30 inches) may lead to failure in the long-term, as well as poor aesthetics

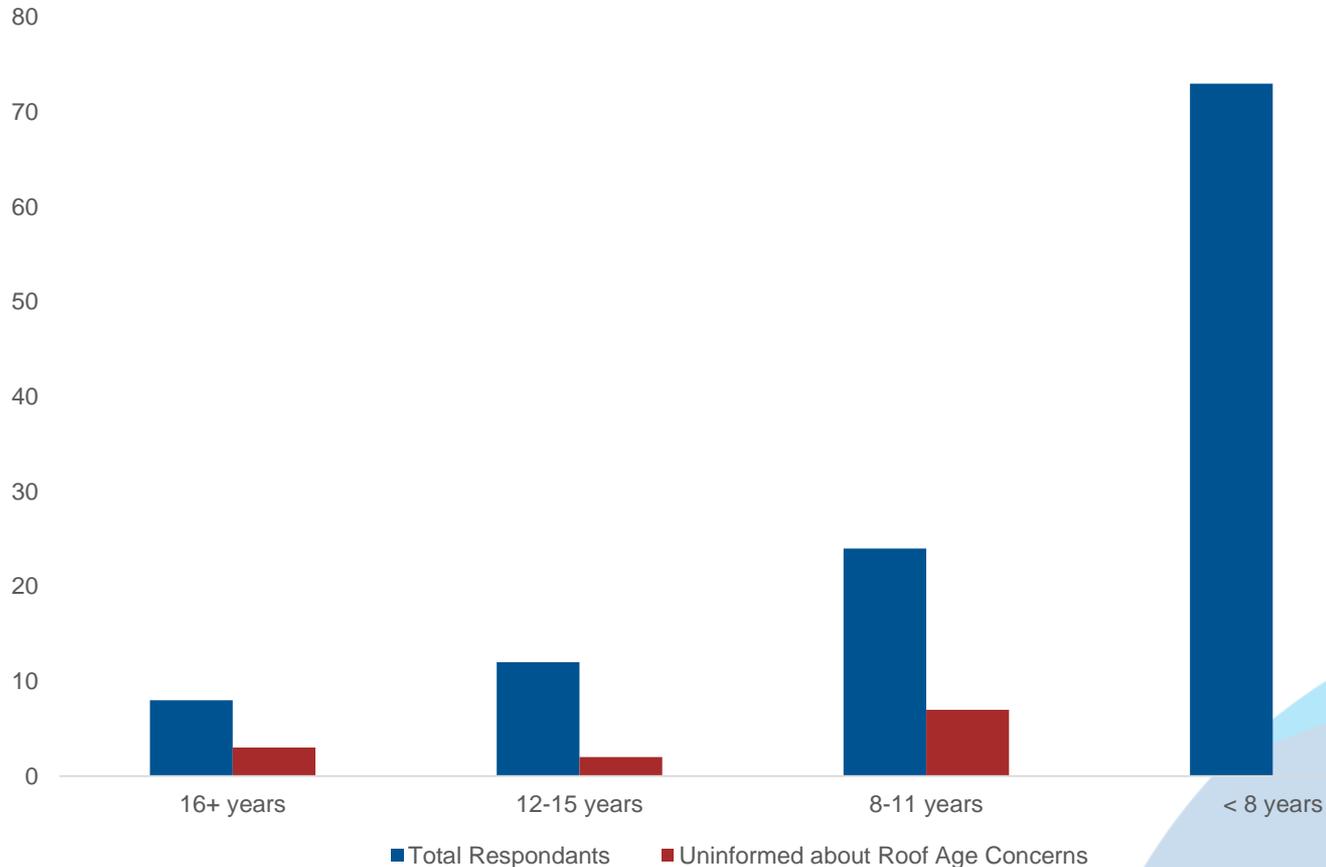
- 33% of survey respondents had solar PV systems installed when their roof was over eight years old, with some respondents' roofs over 16 years old at the time of installation
