Providence Water Docket 4994

Bristol County Water Authority Data Request – Set 1 January 28, 2020

20-YEAR INFRASTRUCTURE REPLACEMENT PLAN 2016-2035

Infrastructure/Capital Program Report 1996 - 2015

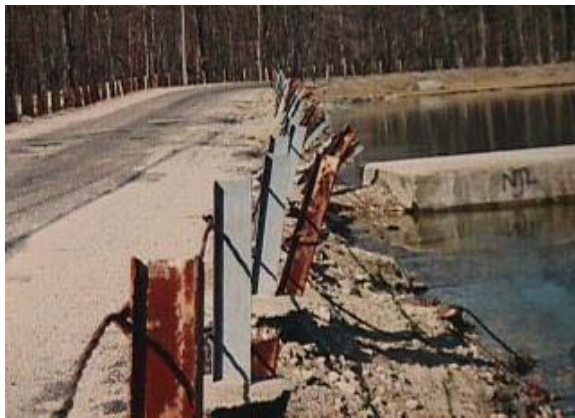
Construction is complete for the rehabilitation of Ponaganset Reservoir. Work included repair of dam erosion and placement of riprap, construction of a downstream buttress, restoration of the gate structure and outlet works, improvements to the discharge channel, and reconstruction of the road and drainage system over the dam

Ponaganset Reservoir before rehabilitation

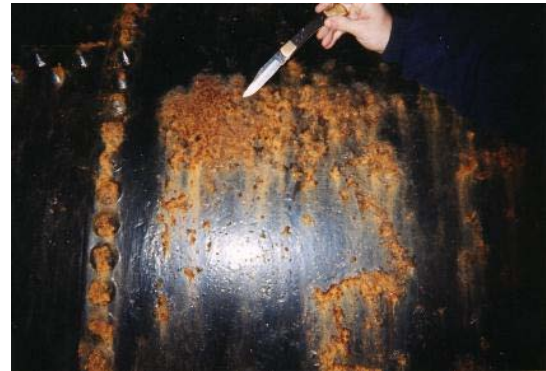
Construction was completed to rehabilitate and recoat the 900 feet long exposed portions of the twin 60 inch riveted steel transmission mains in the meter chamber. Rust was removed, the pipes sandblasted, and protective coatings applied. The exposed portion of twin 60 inch mains inside the junction chamber structure were sandblasted and protective coatings applied to protect against corrosion. In the process two lead joints that were found leaking were resealed. Construction has been completed to provide cathodic protection to 1000 feet of the underground portion of the twin mains. Four impressed current anode beds have been installed to complete the protection system.

Corrosion on 60 inch main prior to rehabilitation

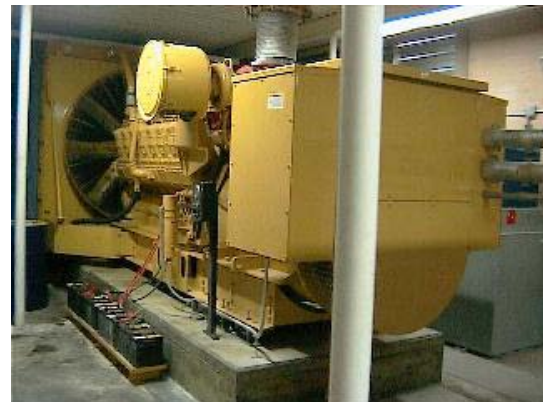
In March 1996, the engine of the old diesel generator failed and became inoperable. The unit was obsolete and the cost made it unfeasible to further repair the generator. In December 1996 a new 2000 kW generator was installed to replace the old 1750 kW generator. This generator has the capacity to power the entire treatment plant and raw water pumps in the event of an emergency power outage.

New Raw Water Booster Pump Station generator for backup power to treatment plant

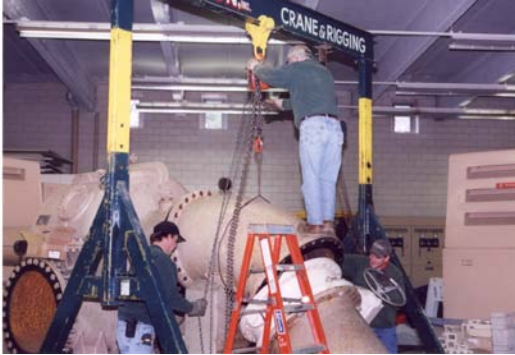
All eight (8) of the suction and discharge valves for the booster pumps in the pump station failed to provide a complete seal when closed. Construction has been completed in which all eight (8) valves and the four (4) actuators for the discharge valves were replaced.

Installation of spool piece after valve installation

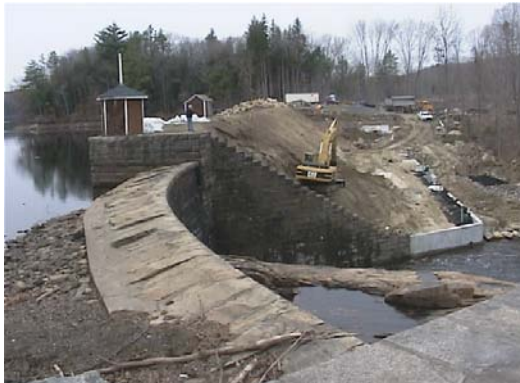
Construction is complete at Barden Reservoir. Work consisted of improvements to the inlet/outlet structures (including replacement of the gates at the inlet structure), the discharge channels, the spillway area, the crest of the dam to accommodate design flood flows, erosion protection along the upstream slope, and stabilizing the dam by flattening the downstream slope of the dam.

Repairs to the downstream slope of the dam

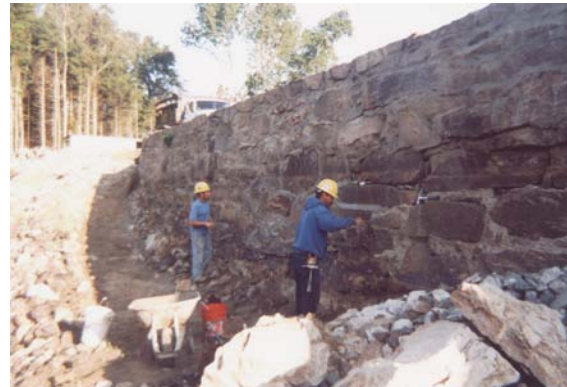
Repairs to upstream wall at Barden Dam

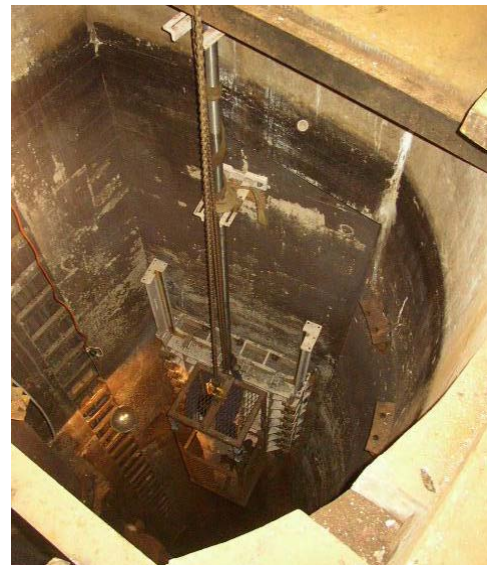
This project moved up in priority and schedule since it had to be completed to allow inspection of the 90" influent conduit in order to be able to safely isolate the conduit for inspection. Construction is complete for replacing all nine (9) sluice gates, all seventy (70) stop shutters, and two (2) drain valves. Nine (9) new electric actuators were installed to operate the sluice gates. The bar grating and trash racks were also replaced under this project.

Installation of new sluice gate

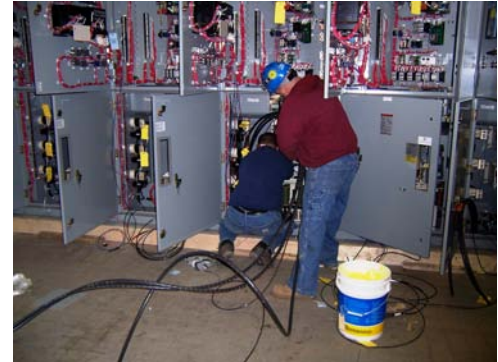
The project to replace the motor control center at the RWBPS is complete. The motor control center dated back to the original construction of the pump station in 1966 and needed to be replaced as parts have become obsolete. The project consisted of new 2300-volt switchgear, pump starters and controllers, new feeders to the motor controls, and a new incoming service feeder. The new motor control center will provide reliable pump control during low reservoir levels and power outages.

Installation of new motor control center

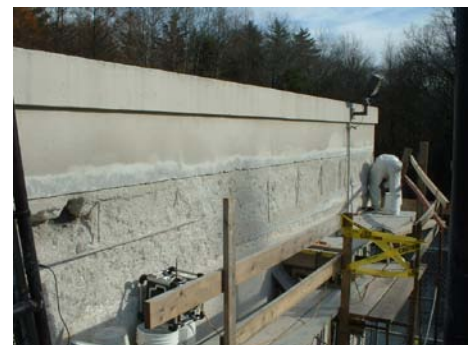
The contract for improvements to the meter chamber structure at the base of the dam is completed. The replacement of the exterior waterproof roof membrane, replacement of the roof ventilator, removing and replacing the damaged sections of fence along the roof, and injecting construction joints to stop leakage of groundwater

Concrete Improvements

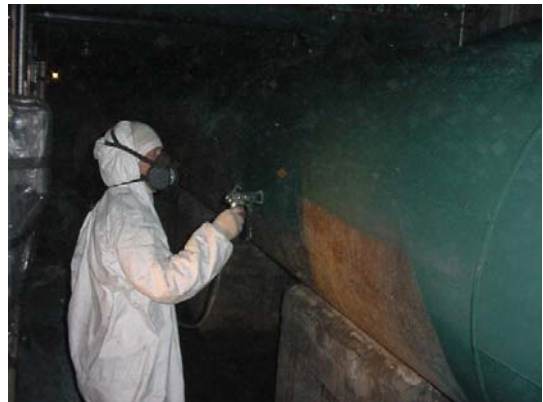
Recoating of the 48" dia. filter backwash washwater pipe and associated lateral piping, located in the Pipe Gallery of the treatment plant was completed. The old coating system was considerably deteriorated, threatening the integrity of the pipe. The coating was mechanically removed and a new moisture cured two-coat urethane paint system was applied.

Painting of 48" Washwater Main

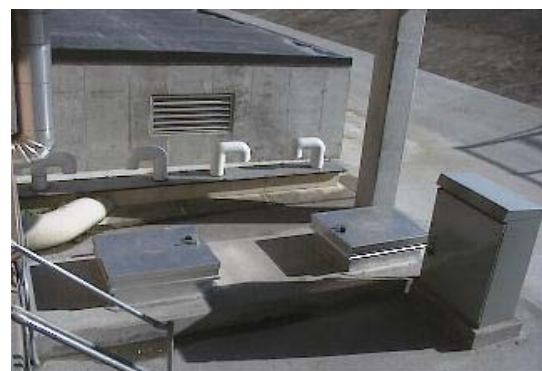
Construction is complete to rehabilitate the interior of the clearwell. Work consisted of rehabilitating eroded concrete surfaces and cracks, and leaking construction joints inside the interior of the structure. Also included in the scope of work was the structural rehabilitation of two cast-in place concrete 72" x 42" effluent venturi meters. The instrumentation has been fully restored with a new pressure sensing diaphragm type system replacing the annular rings. New process piping and signal wiring has been installed to carry the signal flow to the SCADA system.

New access hatches and instrumentation panel installed over the opening of the venturi meters

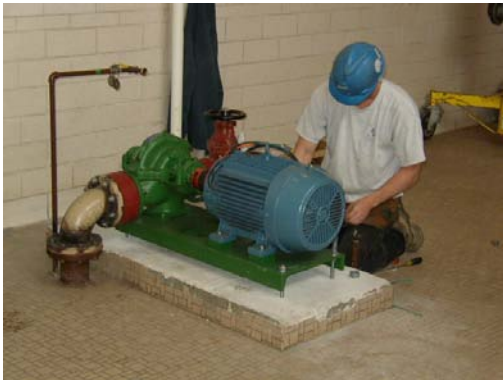
The two (2) 5600 GPM pumps which supply the backwash water for the treatment plant's filters were almost forty years old and had outlived their useful life. Construction to replace the pumps is complete.

Wiring new service water pump

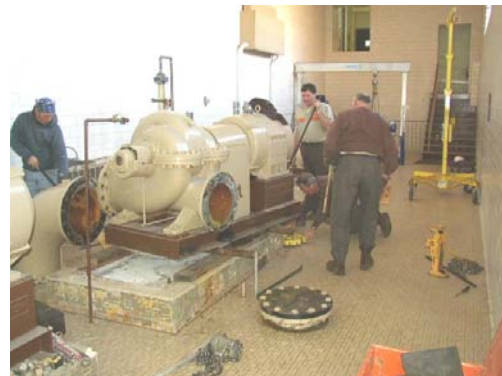
Removal of existing Wash Water pump

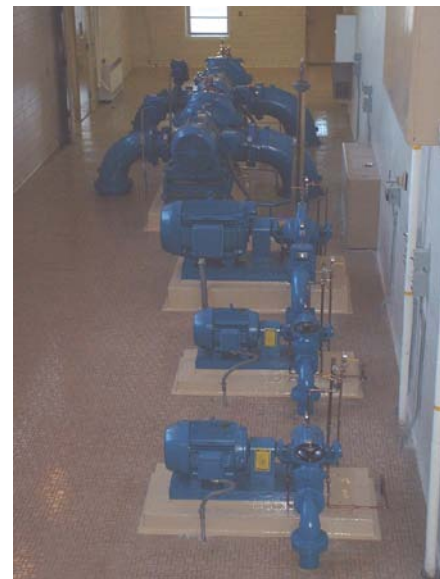
The two (2) 1750 GPM pumps for the service water system which provides process water at the treatment plant and the 1200 GPM hydrant pump which provides water to the hydrants surrounding the sedimentation basins were almost forty years old and had outlived their useful life. Construction for the replacement of the two service water pumps and the hydrant pump is complete.

New Pumps following replacement

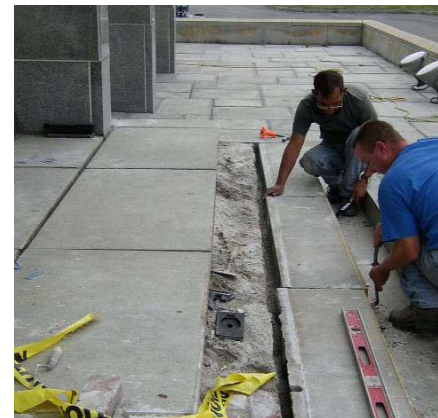
Construction is complete for the rehabilitation of the limestone and granite facade at the Treatment Plant. The Treatment Plant's limestone and granite facade was constructed during the 1960's and had deteriorated over time as a result of weathering and exposure from freeze-thaw cycles. The scope of work also included repair of mortar joints and spalled areas, cleaning of the limestone panels, parapet wall, and the brick chimney. The granite terrace and stairs were rehabilitated by removing and resetting sections of stone.

Resetting sections of stone on the stairs

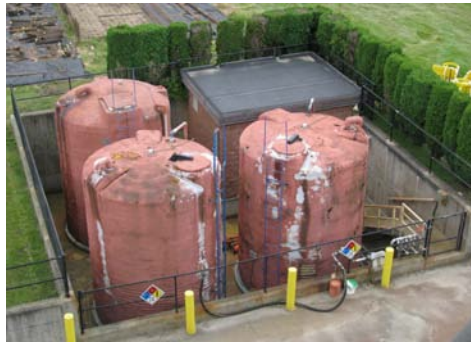
During internal inspection of the three 12,000 gallon liquid ferric storage tanks, a crack was found in one of the tanks. Based on the age and condition of the tanks, all three tanks were replaced with new 16,000 gallon fiberglass tanks. Work included replacement of all exterior piping, strainers, and insulation. The tank containment area and the floor in the bulk storage transfer building were also recoated.

Old 12,000 Gal Liquid Ferric Storage Tanks

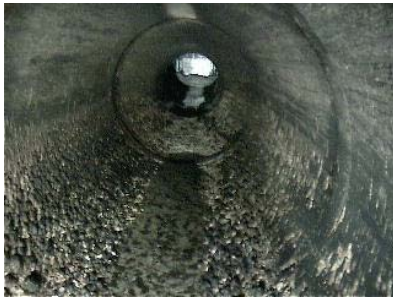
Concrete corrosion damage to the lower half of the effluent conduit

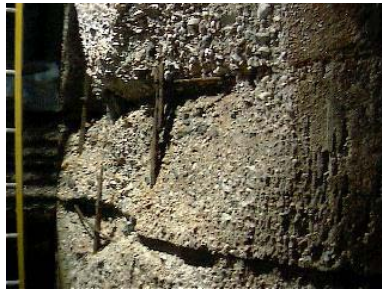
Extensive concrete corrosion damage in vicinity of south venturi meter

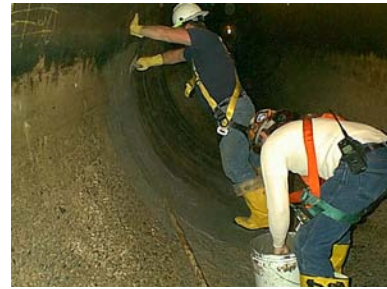
Concrete repairs to the interior of the 90" pipeline
