Re: Commission's Proceeding Relating to Stray and
Contact Voltage Pursuant to Enacted Legislation
Docket No. 4237

Test Report No. TR-PR019987-12E, Rev 1 Contact Voltage Benchmarking - Rochester
NY

Power Survey Company operates contact voltage detection equipment for the purpose of locating energized structures and surfaces in the public landscape. Over the period of 12/5/2012 through 12/24/2012, Power Survey Company performed a survey of the electrical distribution system in Rochester NY. The test consisted of driving a vehicle equipped with an SVD2000 detection system along the streets in search of energized objects and surfaces. When the SVD2000 signaled the presence of a potentially energized object, the truck was stopped and technicians made voltage measurements on the energized object. Over the course of the test, 258 objects were measured with varied voltage levels present. This sweep covered approximately 495 road miles.

A total of 258 energized objects were measured in Rochester NY. The highest voltage recorded was 112 volts.

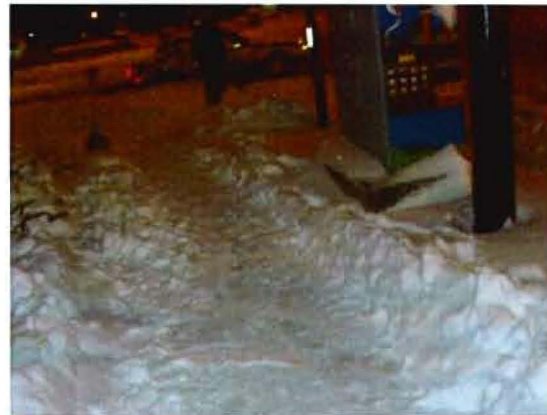
Photo 1

Date/Time	Event ID	Structure	Structure ID	Voltage	V Shunt	Voltage	V Shunt	Address	Cross Street	Photo #
27-Dec										
6:30	99	Traffic Control Box	140	10.1	9	5.8	1.3	Genesee St -NEC	Brooks Ave	1

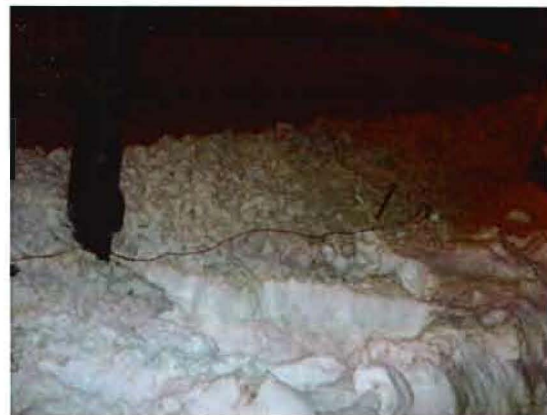
Photo 3

6:35	100	Traffic Light	140	10.1	8.8	5.6	1.2	Genesee St -NEC	Brooks Ave	2
6:37	56	Traffic Light	142A	10.9	10.4	9.4	4.2	Genesee St -SEC	Brooks Ave	3
6:39	54	Street Light	143	10.1	9.3	9.5	7.9	Genesee St	Brooks Ave	4

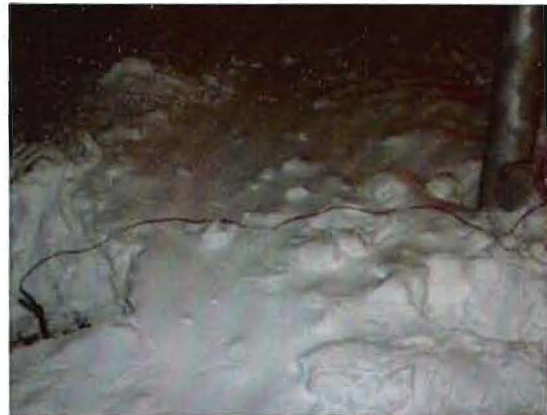
Photo 19

7:45	93	Street Light	12R	4.6	2.5	4.1	2	Plymouth Ave	Elmwood Ave	18
7:55	10	Traffic Light	170R	3.5	1.7	3.2	2	Plymouth Ave	Elmwood Ave	19
8:09	1	Street Light	23	0.8	0.6	0.7	0.4	OPP 296 Flint St	Costello Park	20

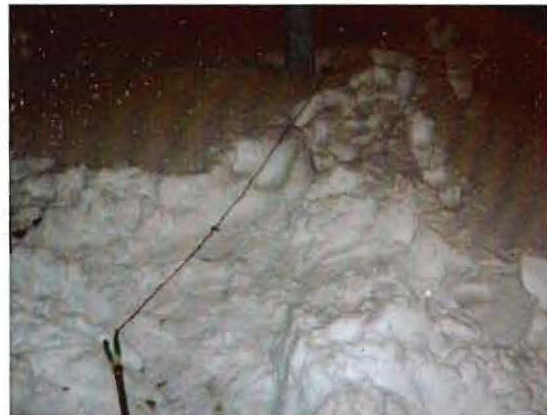
Photo 21

8:15	1	Street Light	24	0.9	0.41	0.9	0.4	304 Flint St	Costello Park	21
8:30	8	Street light	12	4.7	3.3	3.7	2	Moran St	Ardmore St	22
8:35	4	Street Light	10	4.5	3.5	3.7	2	Ardmore St	Moran St	23

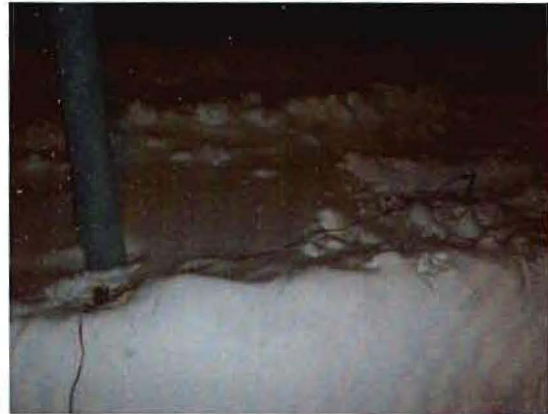
Photo 23

8:39	3	Street Light	9	4.9	4.7	4.2	2.7	81 Ardmore St	Moran St	24
8:42	57	Street Light	8	3.9	2.4	3.3	2.2	OPP 69 Ardmore ST	Moran St	25
8:55	6	Street Light	101	3.8	2.6	3.5	1.7	Genesee ST	W High Terrace St	26

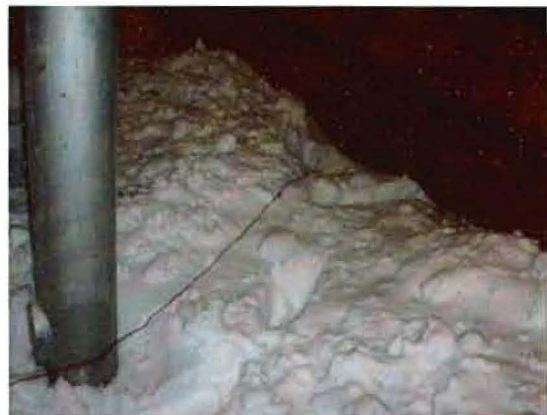
Photo 31

10:20	53	Street Light	53	2.3	1.8	2.3	1.9	OPP 700 Brooks Ave	Genesee park BLVD	30
10:30	58	Street Light	n/a	3.8	3.7	3.2	2.1	291 Arnett BLVD	Wellington AVE	31

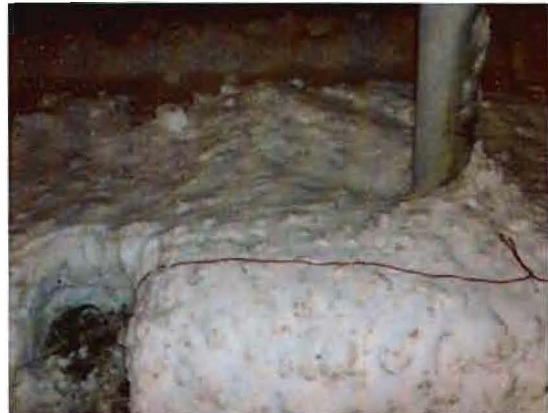
Photo 37

11:12	66	Street Sign	X	2.1	1.3	Hot Ground	Hot Ground	1046 Arnett BLVD	Westfield St	37
11:30	67	Street Light	8R	17	16.5	15.3	13.5	Buffalo RD	Glide St	38
11:57	20	Street Light	89	3.3	2.9	2.9	2.5	737 E Main St	Alexander St	39

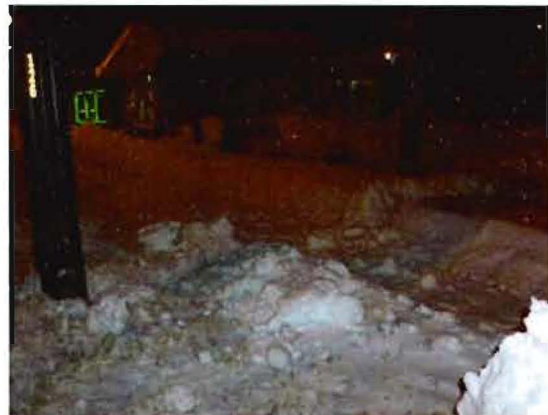
Photo 43

12:14	23	Street Light	97	5.2	4.9	5.1	3.3	835 E Main St	Prince St	42
12:33	26	Street Light	128	0.9	0.5	No Grass	No Grass	570 West Main St	Jefferson Ave	43

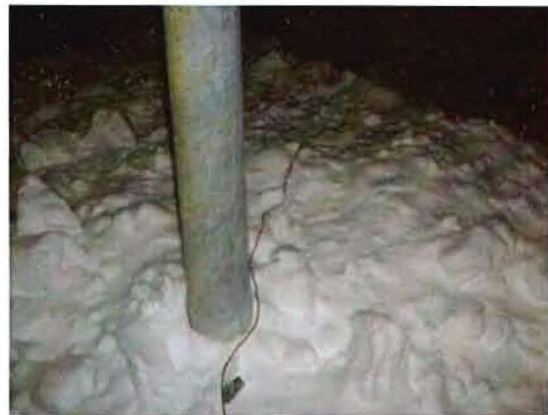
Photo 45

12:33	25	Street Light	138	0.8	0.4	0.8	0.4	570 West Main St	Madison St	44
12:44	32	Street Light	1	0.9	0.3	0.9	0.3	5 Madison St	Yack Ally	45
12:59	107	Street Light	4	51	46	45.5	31	66 Champlain St	Olean St	46

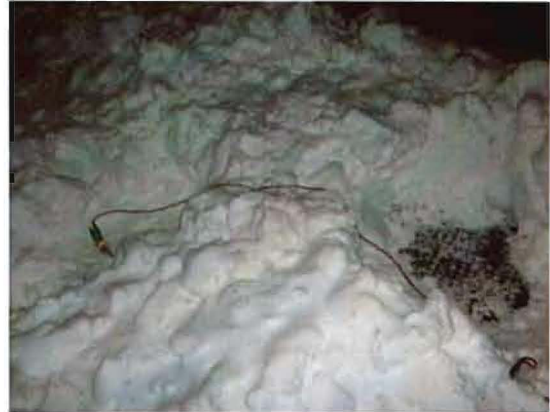
Photo 47

1:03	28	Street Light	5	3.7	2.9	1.3	0.9	79 Champlain St	Olean St	47
1:05	29	Access Hatch	X	5.2	2.3	1.5	0.6	79 Champlain St	Olean St	48
1:11	30	Street Light	6	52.2	51.3	44	26	94 Champlain St	Seward St	49

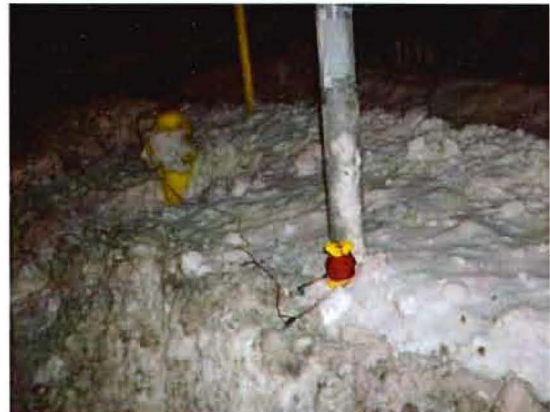
Photo 51

1:36	31	Street Light	4	17.3	8.6	11.6	5.6	Tracy St	Alexander St	50
1:50	34	Street Light	n/a	1.2	1	1.2	0.8	603 Park Ave	Vassar St	51
1:54	33	Ped X-Ing	n/a	3.7	3.3	1.8	1.1	OPP 603 Park Ave	Vassar St	52
