OUR VISION

**To create a  
world powered  
by renewable  
energy**

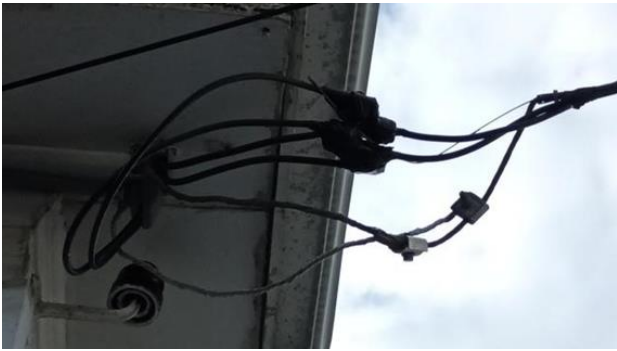
<p>The service drop support is broken away from point of attachment. Conductors not supported and creating tension on terminations.</p>

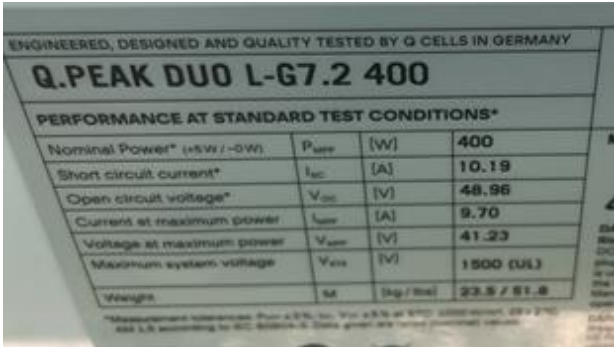
Undersized string fuses for module short-circuit current (Isc).  Module Isc is 10.19A 10.19 x 156% = 15.9A (NEC 690.9) 20A fuses required. 15A observed.

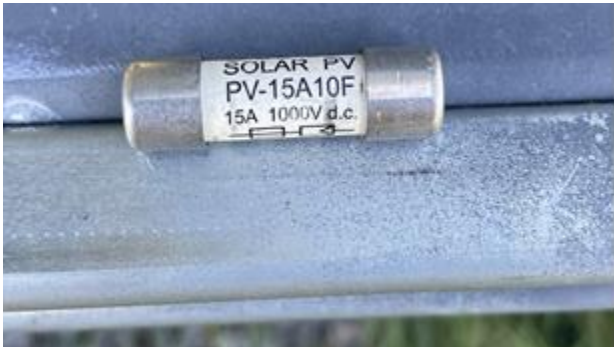
### 5.3. Large Solar PV System Findings

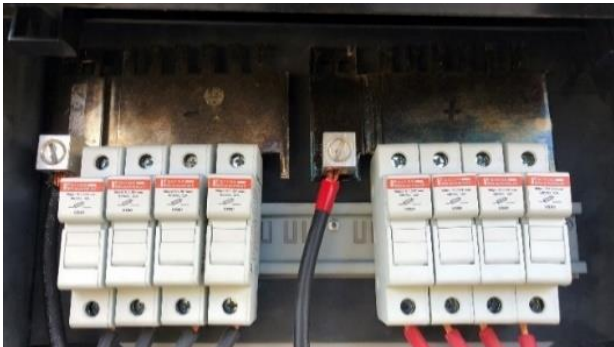
<p>Example of thermal damage to busbar inside DC combiner.</p>

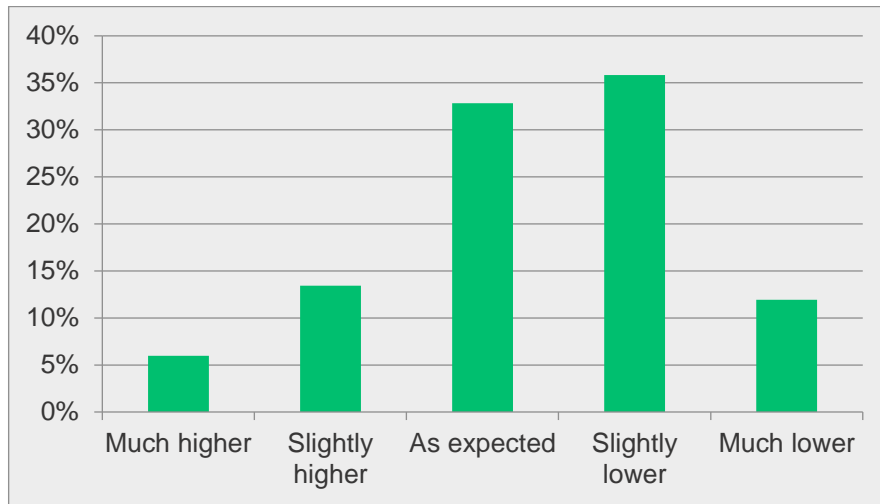
**Figure 5.7: REG Payment Perception**
