Attachment DIV 2-1 (Electric) Asset Condition FY 2013 Electric Infrastructure, Safety, and Reliability Plan Responses to Division's Data Requests – Set 2 Page 1 of 1

### Narragansett Electric Company

Subject: Equipment Condition Eldred No.45

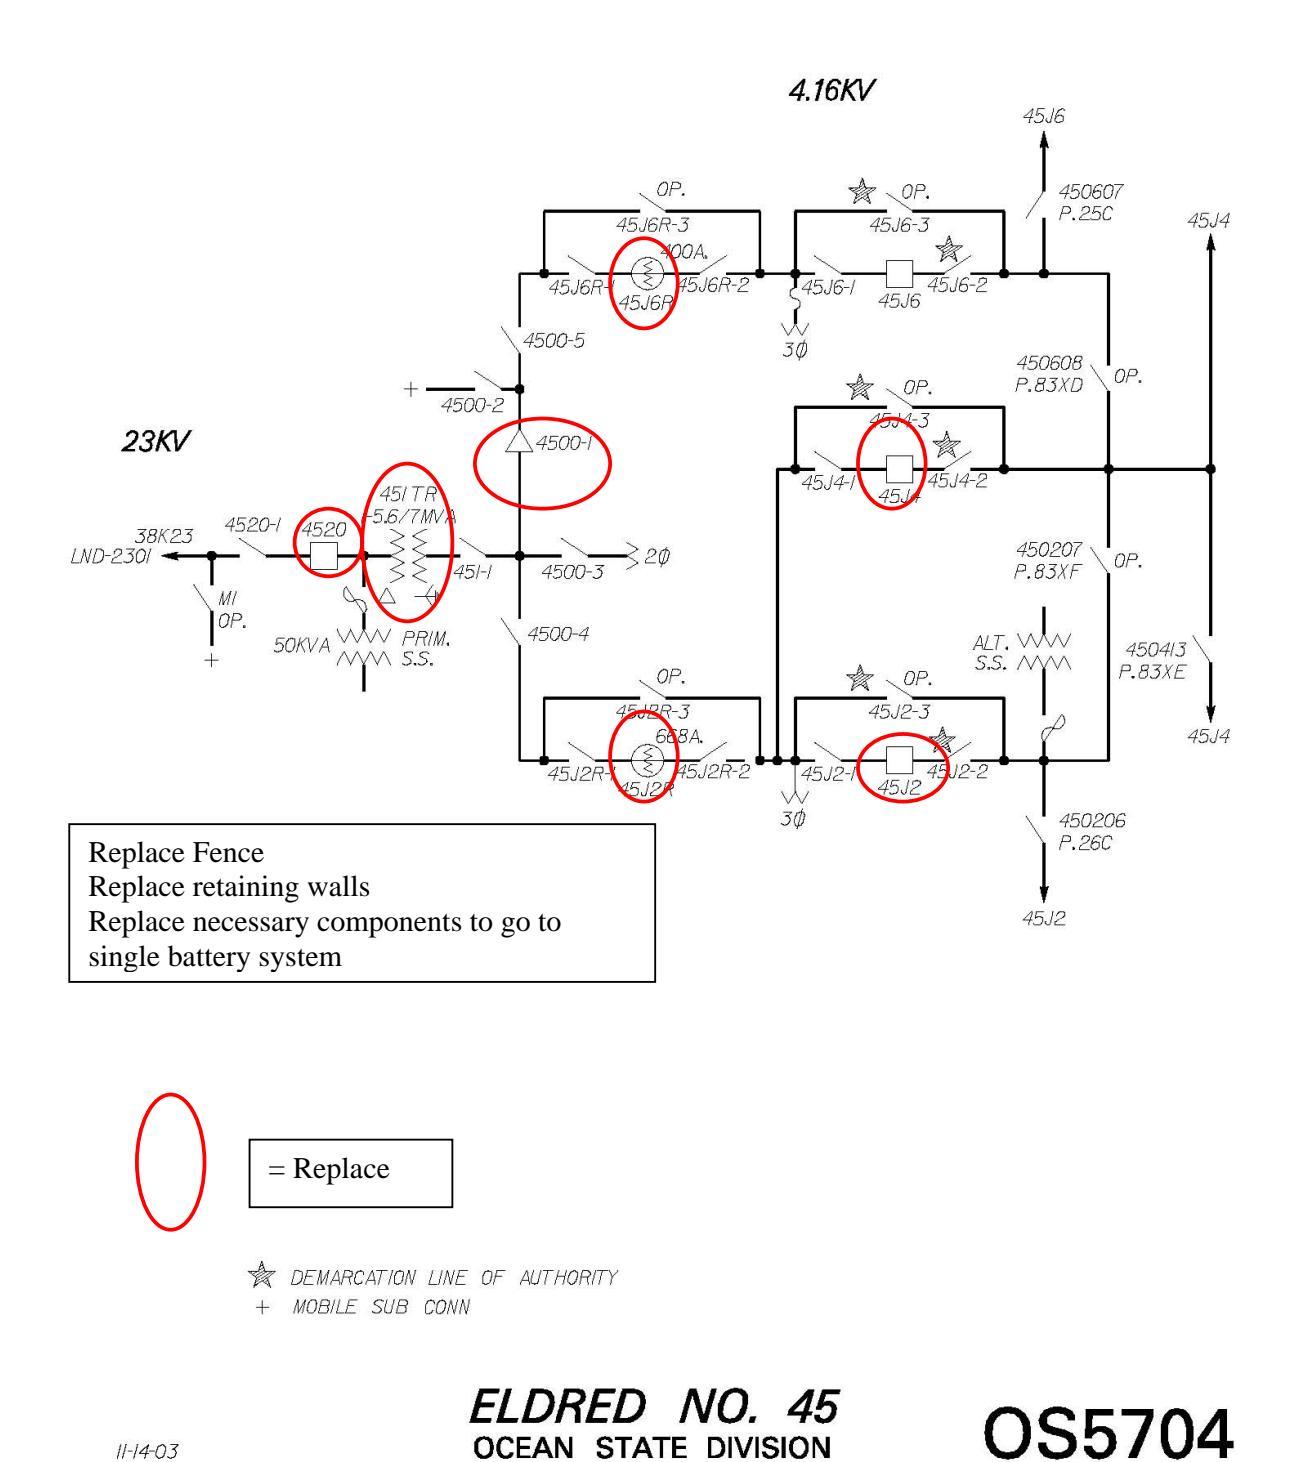
Equipment Condition Report Eldred No. 45

Diagnostic testing indicates there are insulation issues with the transformer windings. It is recommended that it be replaced.

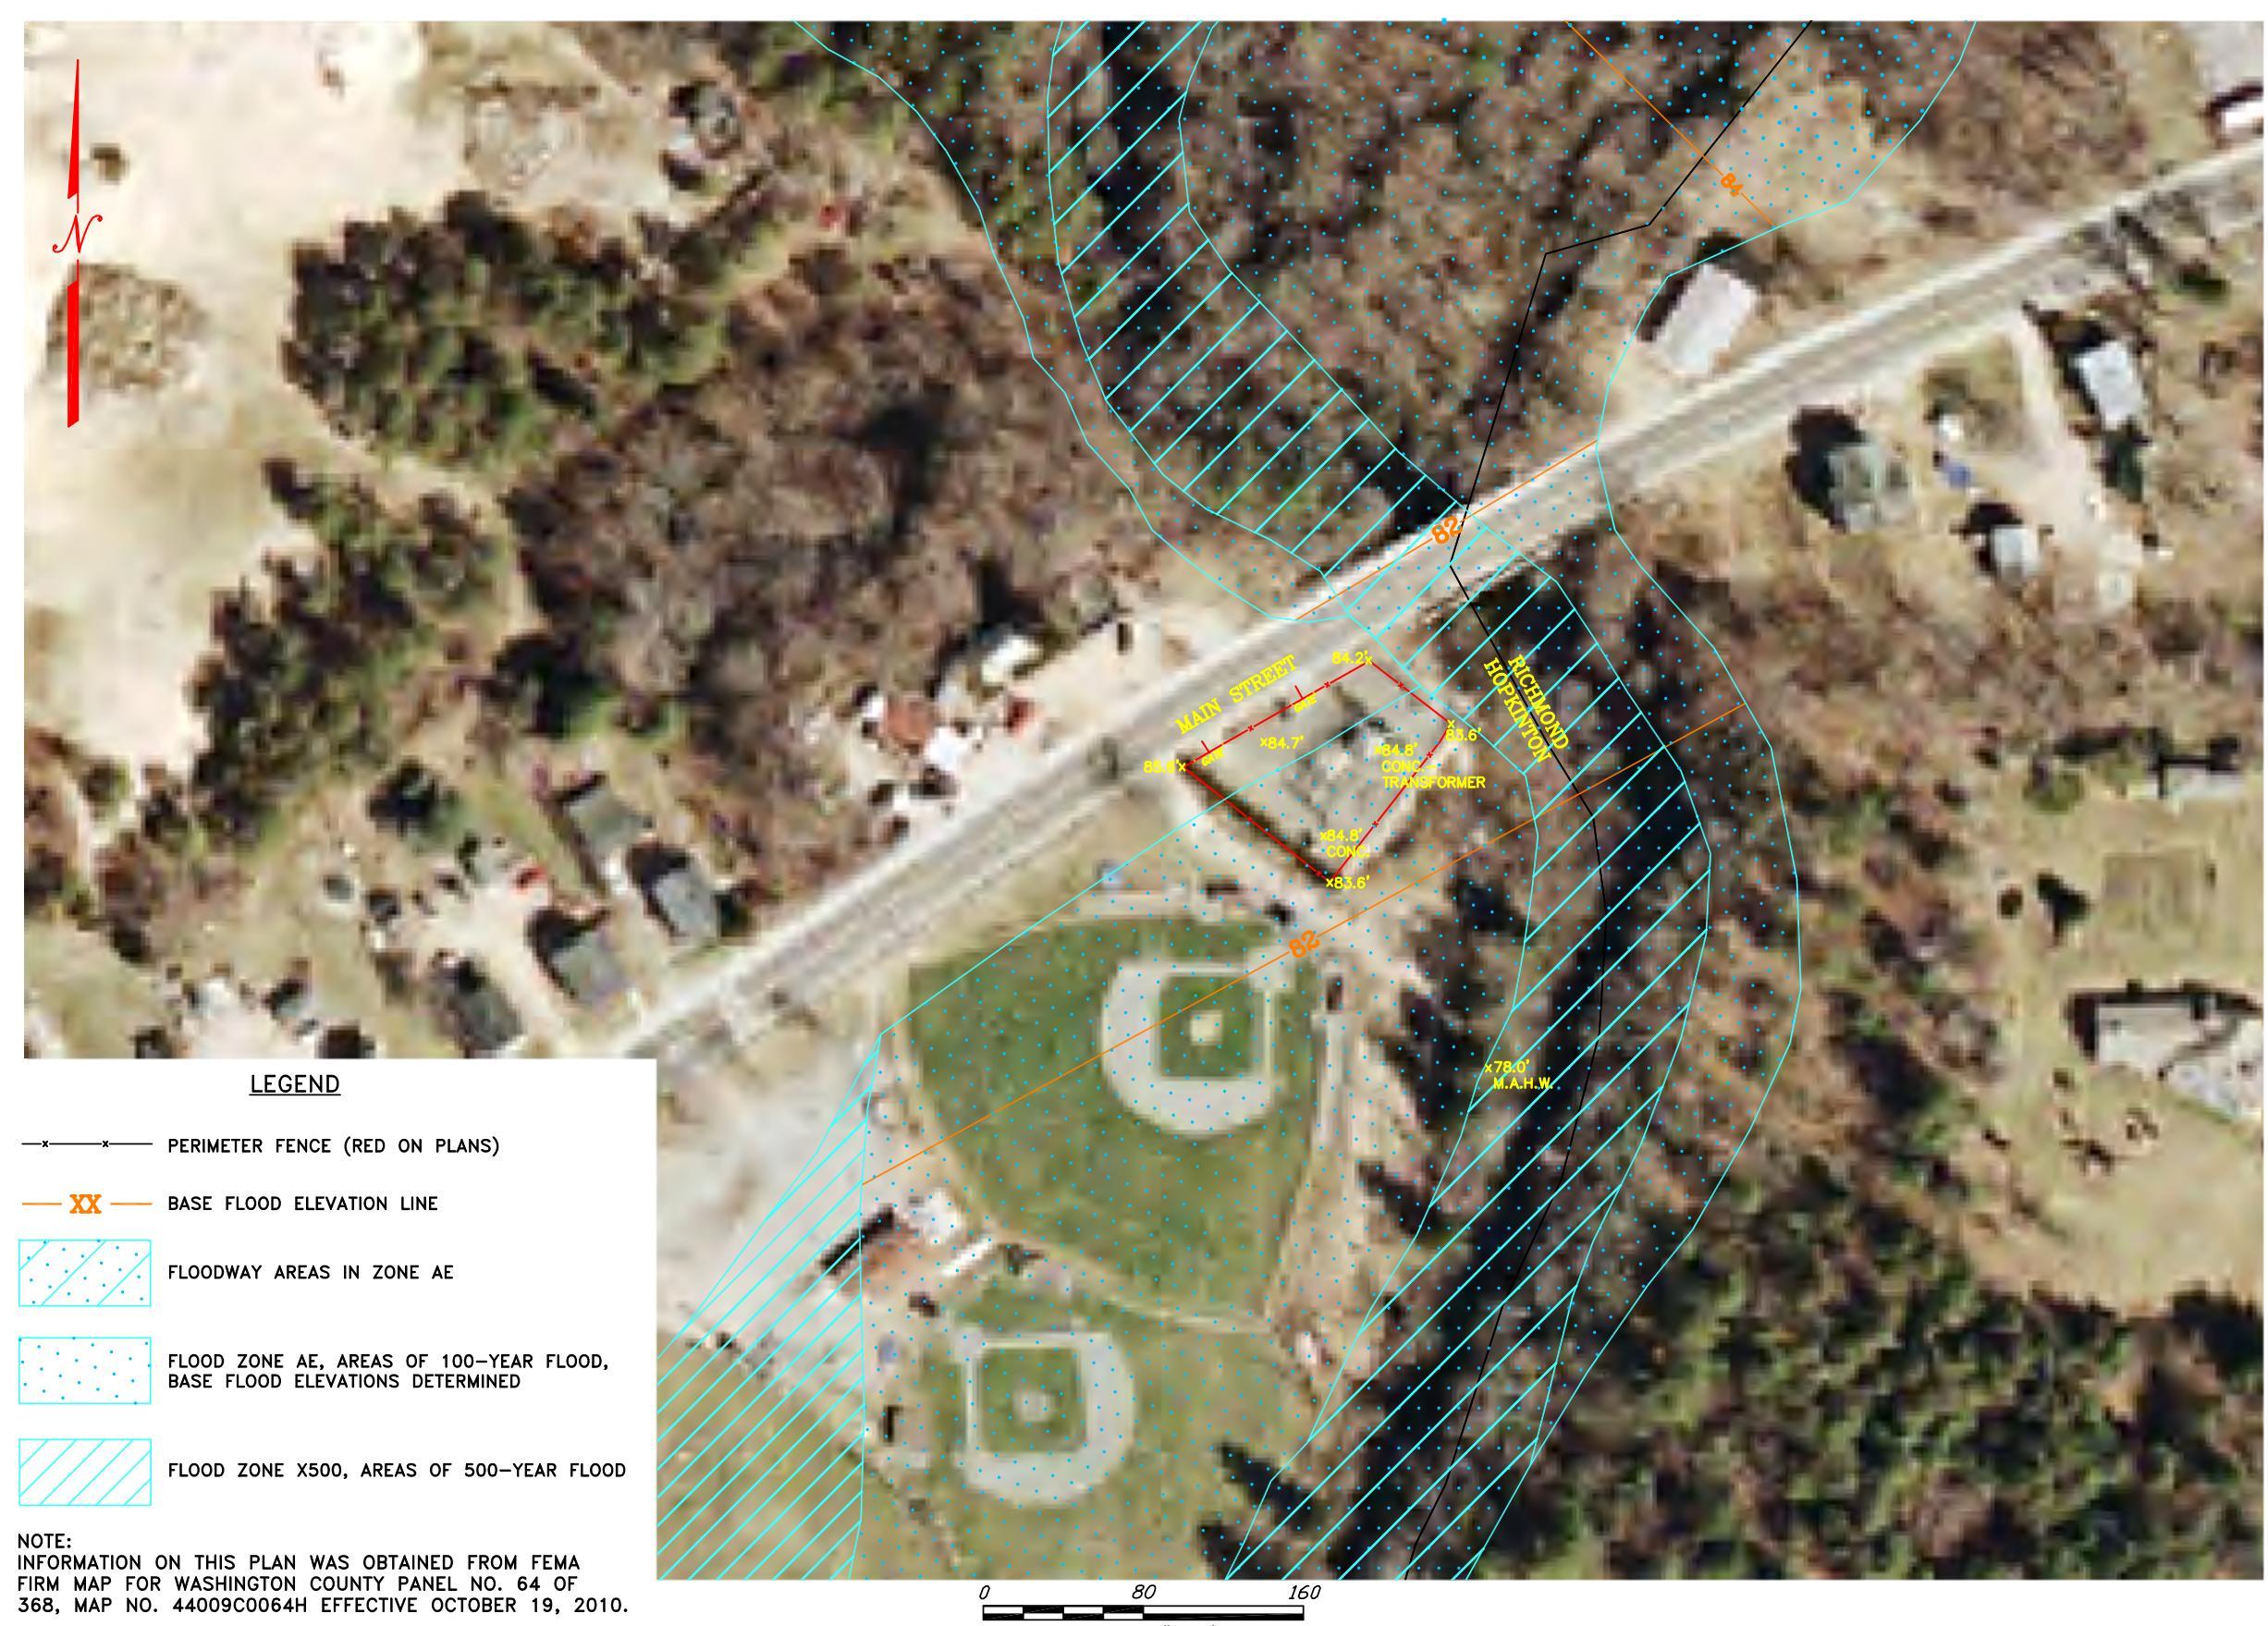
Division	Substation	State	Comments
Ocean State	Hope Valley 41	RI	Water in station during heavy rains
Ocean State	Jepson 37	RI	Water in station during heavy rains
Ocean State	Johnston 18	RI	Water in station during heavy rains
Ocean State	Staples 112	RI	Water in station during heavy rains
Ocean State South Aquidneck 122		RI	Water in station during heavy rains
NYCD Newton Falls 774		NY	Station flooded and site access affected caused by beaver dams
NYCD	South Oswego 292	NY	Station flooded and site access affected caused by beaver dams
NYCD	Taylorville 770	NY	Station gets flooded due to water run off and access affected
NYCD	Union Falls 844	NY	When river is at high level, yard gets wet and access affected
NYCD	Whitesboro 632	NY	Water has risen to fenceline, however, did not impact metaclad
NYWD	Motimer	NY	Water in control house 2-3 years back
NYWD	Ashville	NY	Site access was affected a few years back

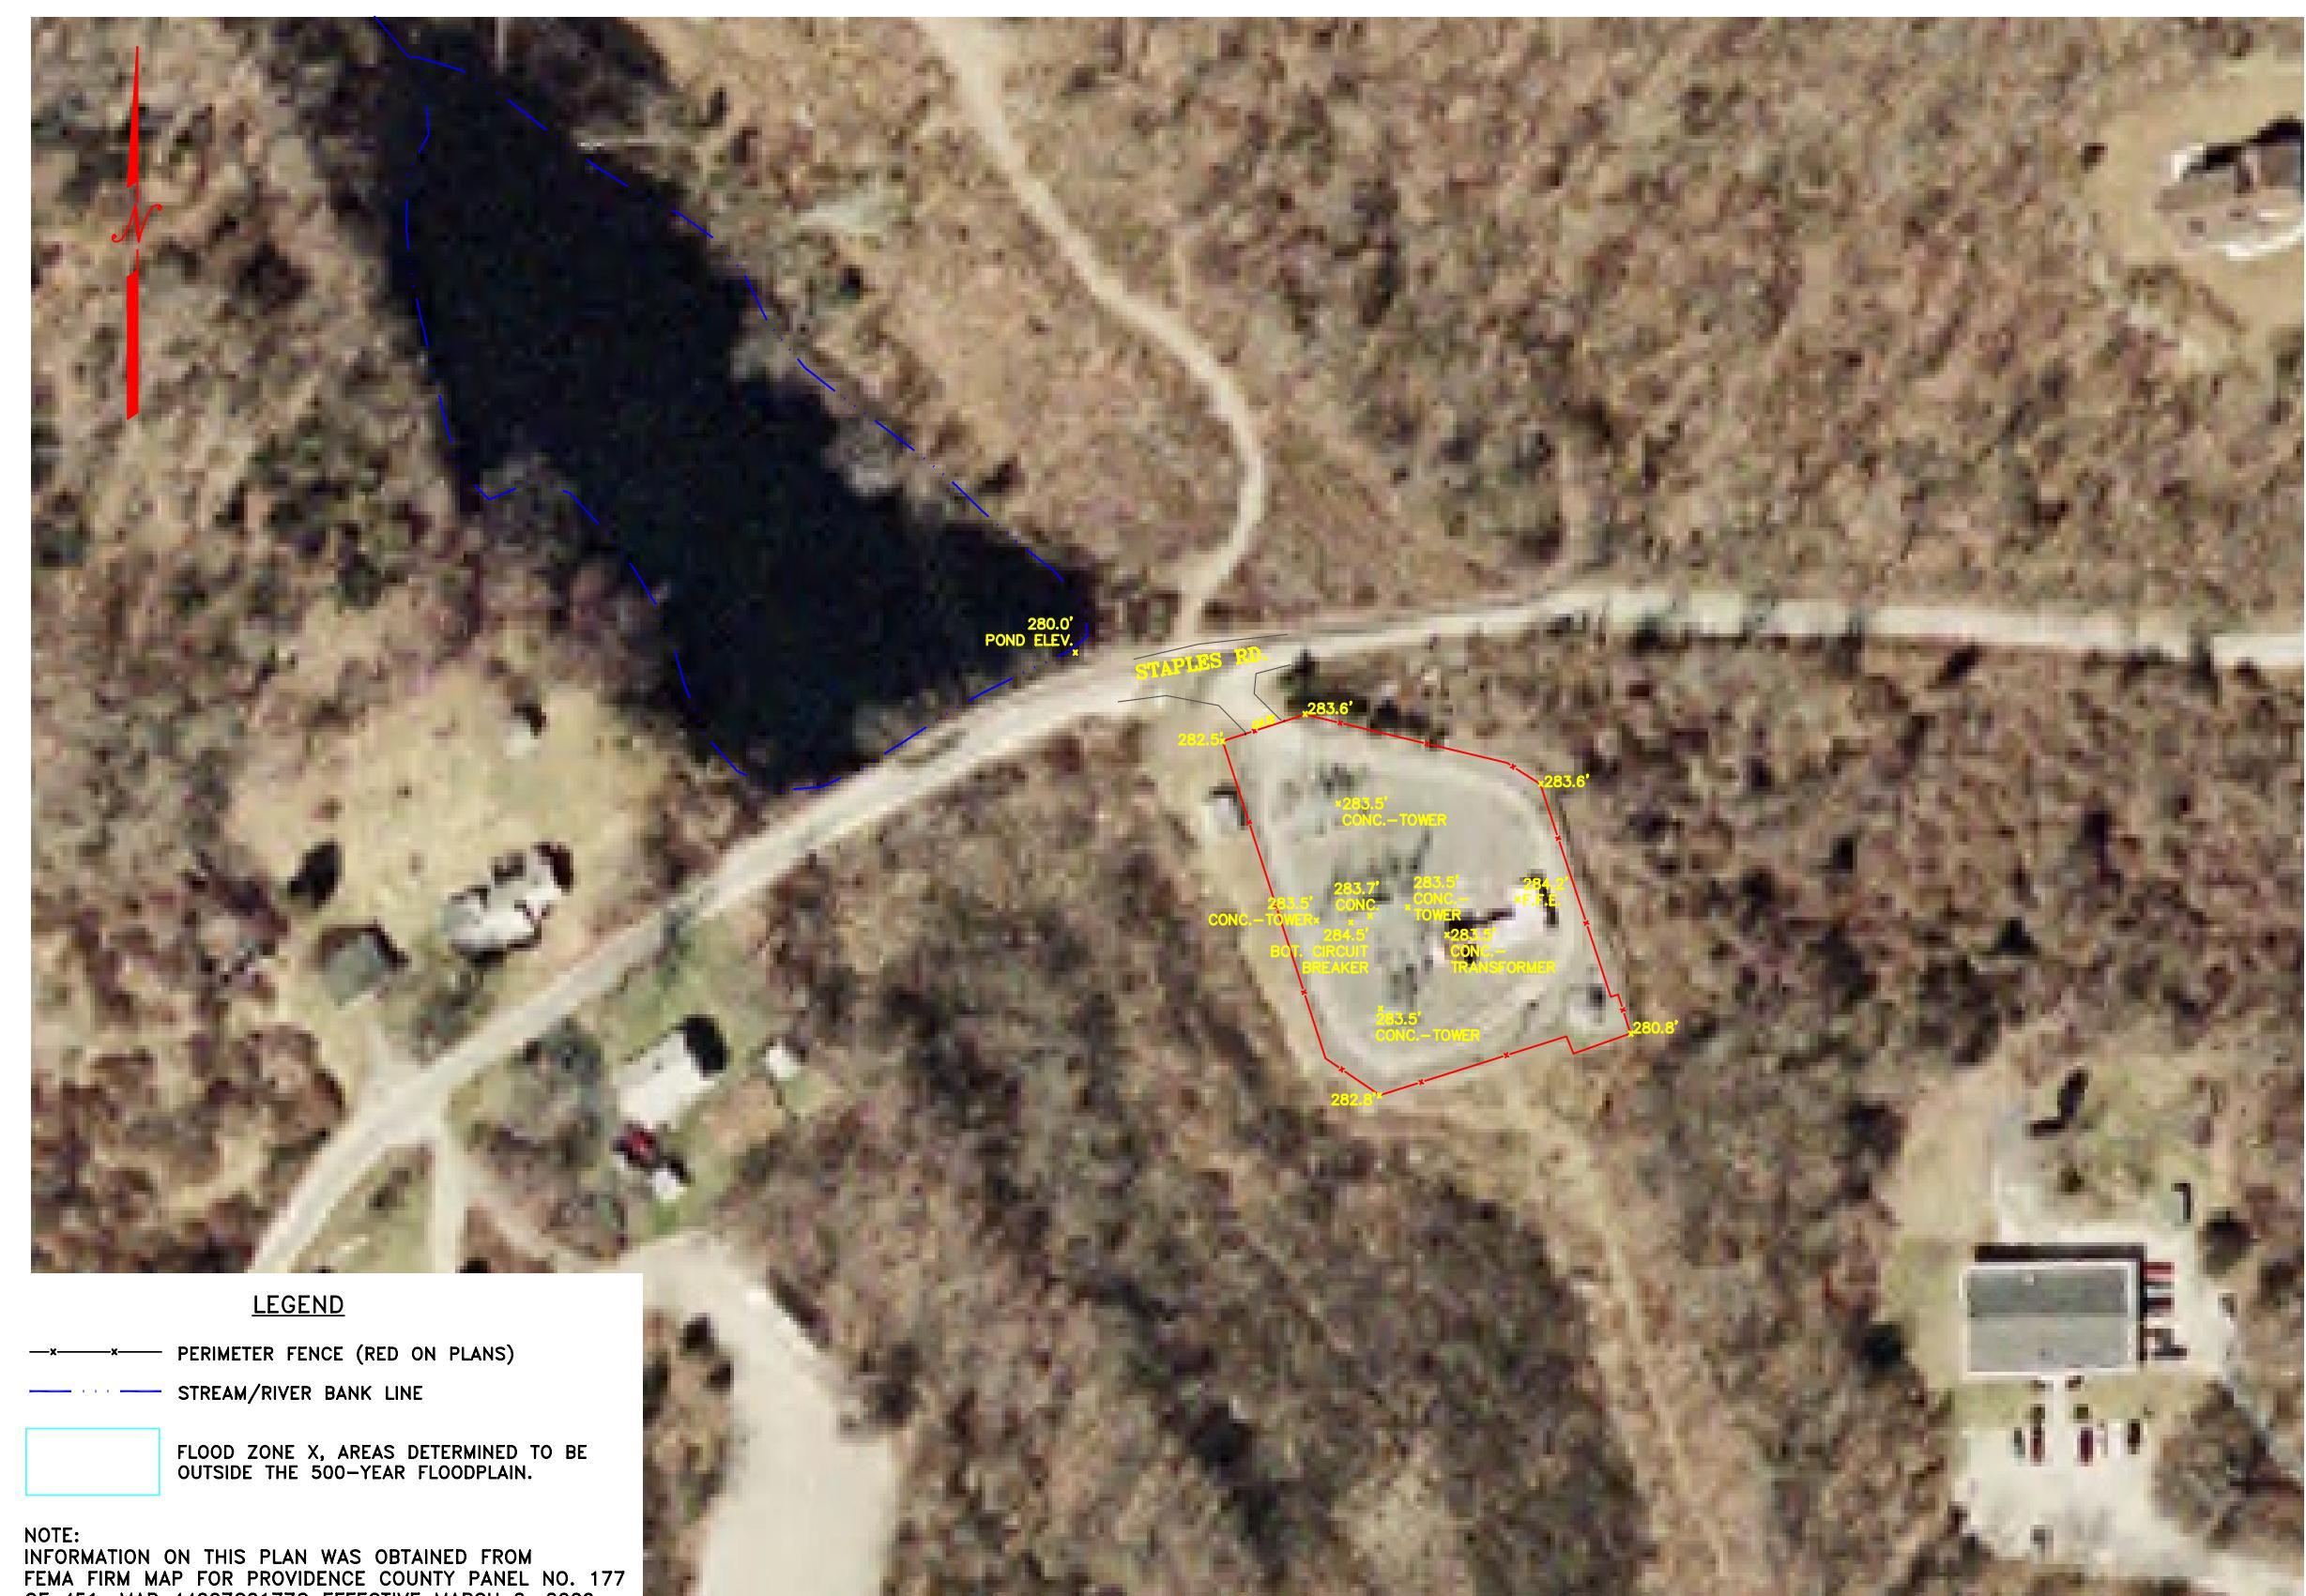
NOTE: INFORMATION ON THIS PLAN WAS OBTAINED FROM FEMA FIRM MAP FOR PROVIDENCE COUNTY PANEL NO. 177 OF 451, MAP 44007C0177G EFFECTIVE MARCH 2, 2009. THE SITE IS APPROXIMATELY 0.6 MILES AWAY FROM THE CLOSEST 100-YEAR FLOODPLAIN BOUNDARY.
