20-YEAR INFRASTRUCTURE REPLACEMENT PLAN 2011-2030

PROVIDENCE WATER SUPPLY BOARD

INFRASTRUCTURE REPLACEMENT PLAN For Fiscal Years 2011 Through 2030

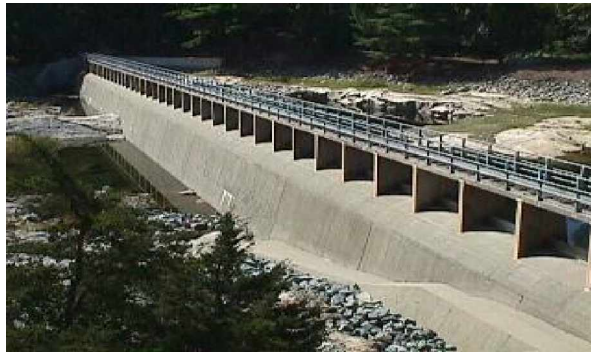
Rehabilitate Large Dams (Gainer Dam/Regulating Dam)

Construction has been completed to rehabilitate the 400 foot long Gainer Dam concrete spillway, the blowoff structure, and the meter chamber. Also completed was work to correct undermining of the Regulating Dam spillway structure footing.

400 foot Gainer Dam spillway showing new concrete facing

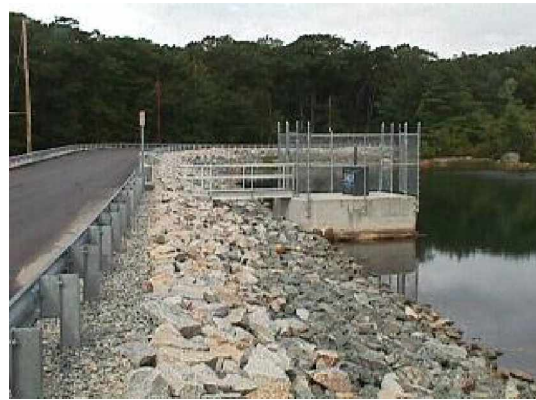
Ponaganset Reservoir after rehabilitation

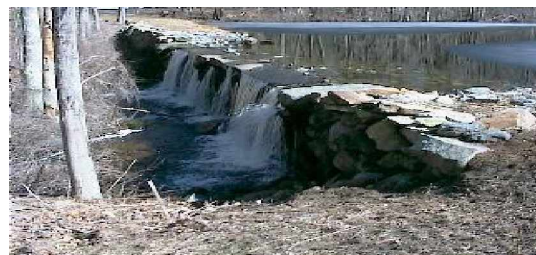
Burton Pond Dam

The project has been completed. The breached area of the earth/masonry dam has been reconditioned. Riprap was installed along the top upstream face of the dam to provide continued slope protection.

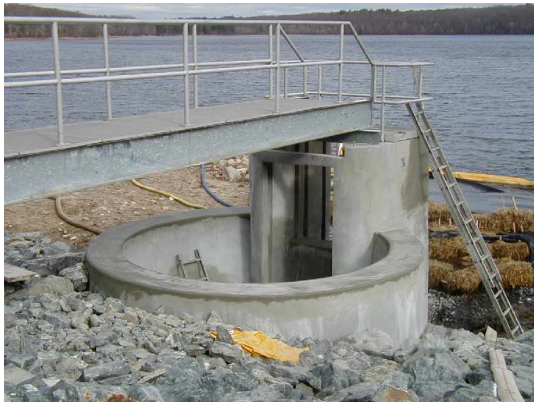
Construction is complete that improved the slope stability of the dam and corrected localized seepage including the start of a sand boil in the vicinity of the Dam's left abutment. Work included installation of a toe drain system and flattening the downstream slope of the dam with the addition of a gravel buttress.

Concrete remediation at the outlet structure

Construction is complete consisting of regrading and armoring the upstream slope of the dam, miscellaneous concrete repairs to the outlet structure, regrading the crest of the dam, clearing and grubbing both the outlet and emergency spillway discharge channels, and regrading the access road to the dam.

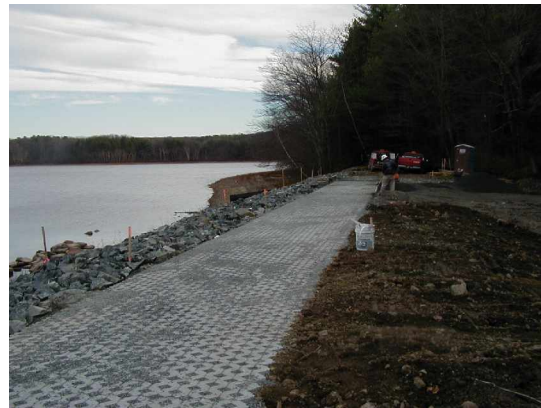
Regrading the access road on the crest of the dam

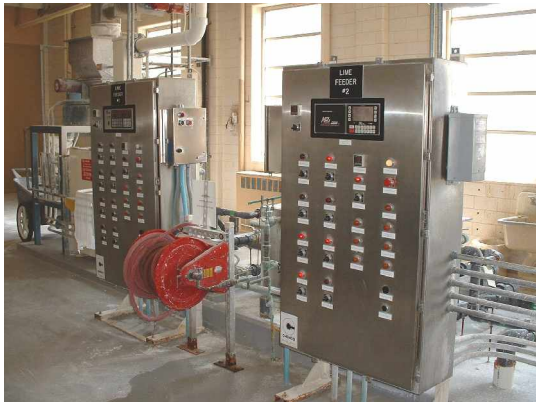
The old lime feeders at the plant have been replaced with 4 new feeders. New injection piping has been installed to provide for an additional lime injection point prior to raw water aeration for corrosion control optimization purposes. The corrosion control optimization measures are necessary as a result of the lead and copper rule.

Two of four new lime feeders installed at treatment plant

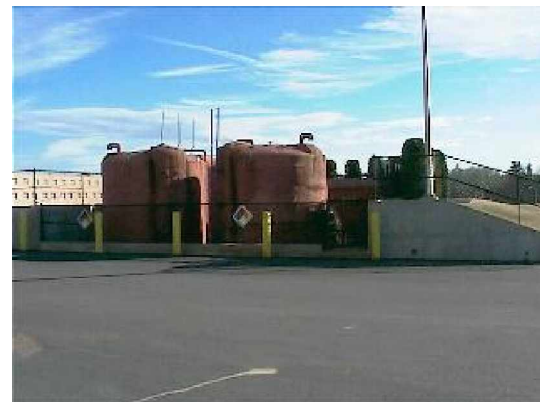
Replace Ferric Feed Equipment

Installation of a new liquid feed system consisting of new chemical storage tanks, new feeder pumps, controls and piping has been completed. The system replaces the old problem-ridden dry feed system.

New liquid ferric sulfate bulk storage tanks

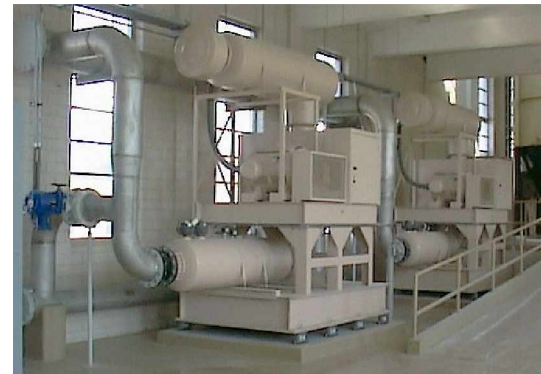
Auxiliary Wash and Blower System for Filters

Installation of the new air blowers and piping for providing the capacity to air backwash the filters has been completed.

New air blowers

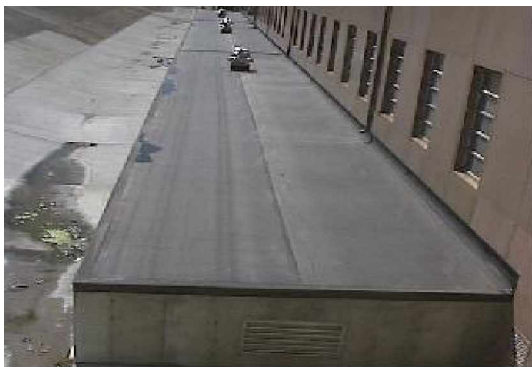
Effluent Clearwell Yard - Concrete Repairs

Construction is complete for the rehabilitation of the area of the effluent yard located directly over the clearwell. The scope of work for the project consisted of installation of a new protective structure directly above the clearwell to eliminate the possibility of rainwater or contaminants from entering. Also included were rehabilitation of the existing drainage system and replacement of deteriorated concrete slabs.

Completed clearwell protective structure

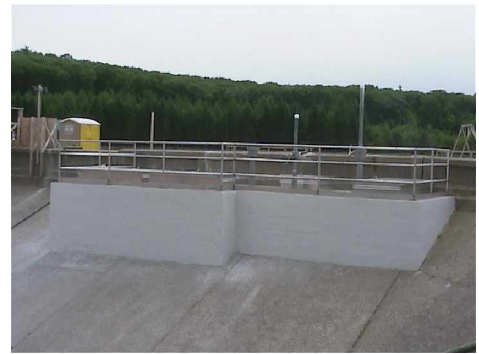
Emergency Bypass Structure

The rehabilitation of the emergency bypass structure located at the treatment plant has been completed. The project consisted of replacement of the sluice gates and access ladders and restoration of the concrete surfaces of the structure. In addition, a new crack-bridging cementitious coating was applied to the exterior of the emergency bypass structure.

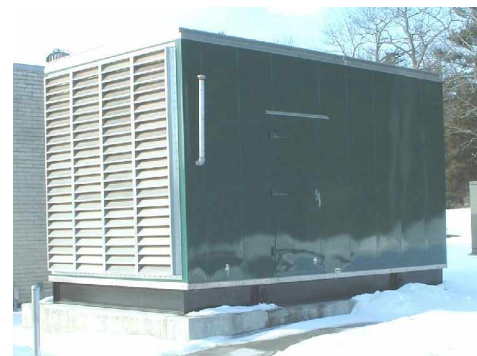
A project to phase-over the treatment plant from the current antiquated 550 volt service to a standard 480 volt service has been completed. The scope of work included construction of a new electrical room dedicated solely to electrical panelboards and switchgear, the replacement of the existing 175KW emergency power generator with a new 600 KW generator, and the installation of new power and control wiring to each filter influent and drain actuator. The scope of work

New treatment plant emergency generator

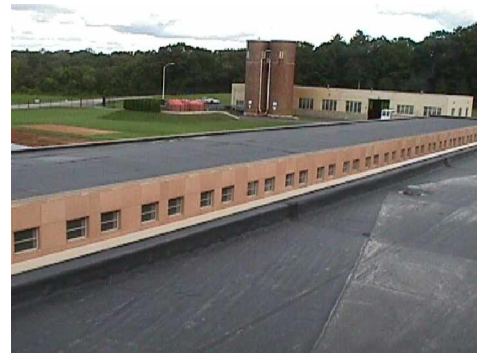
Treatment Plant - Roof/Insulation

The replacement of the entire roof at the treatment plant has been completed. Construction consisted of the removal of the existing roof to the concrete deck and installation of new roof insulation and a new rubber membrane roof.

New treatment plant replacement roof

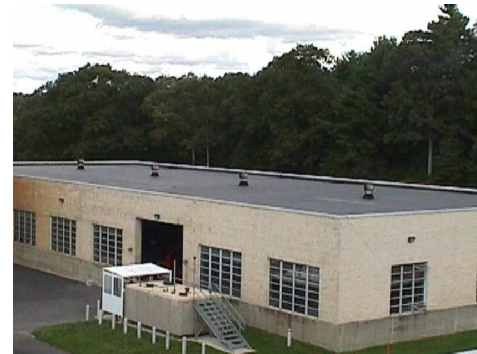
Forestry Garage - Roof / Insulation

Included as part of the roof replacement for the treatment plant, the roof at the forestry garage building was replaced and completed during May 1997. The decision was made to move the project up in schedule because the roof was leaking in a number of locations. The construction consisted of removal of the existing roof to the concrete deck and replacement with rubber membrane roofing.

Forestry Garage replacement roof

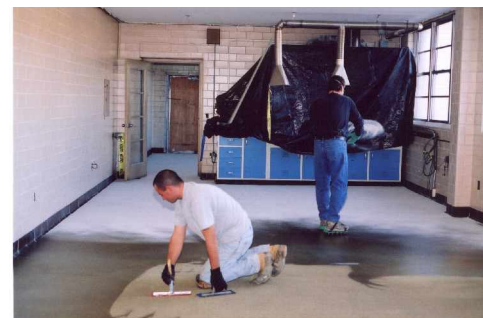
Treatment Plant - Lab Improvements

Construction has been completed to upgrade the testing laboratory at the treatment plant. A new epoxy floor, electrical feeder lines, lighting and laboratory benches have been installed. Also installed were three rooftop HVAC units and a new chemical fume hood.

Installation of a new epoxy floor in the lab

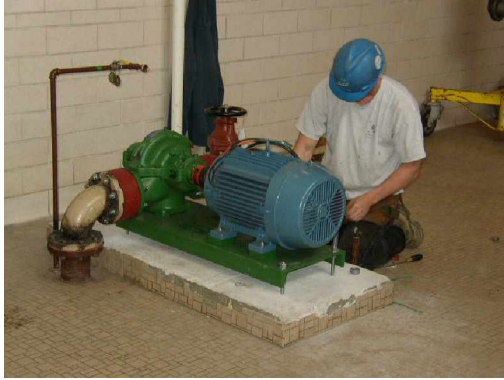
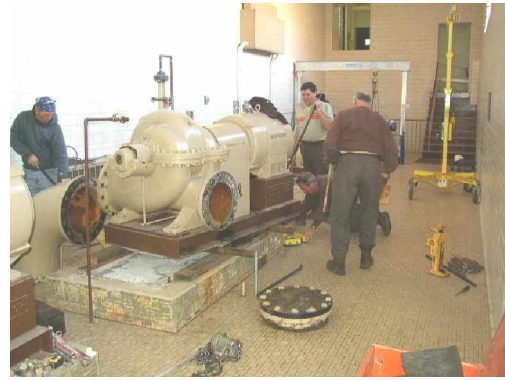
Replace Wash Water Pumps

The two (2) 5600 GPM pumps which supply the backwash water for the treatment plant's filters were almost forty years old and had outlived their useful life.

Wiring new service water pump

Removal of existing Wash Water pump

Construction to replace the pumps is complete.

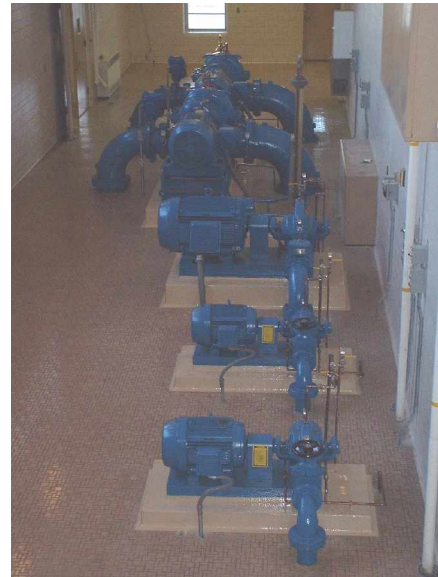
Replace Service Water and Hydrant Pumps

The two (2) 1750 GPM pumps for the service water system which provides process water at the treatment plant and the 1200 GPM hydrant pump which provides water to the hydrants surrounding the sedimentation basins were almost forty years old and had outlived their useful life. Construction for the replacement of the two service water pumps and the hydrant pump is complete.

New Pumps following replacement

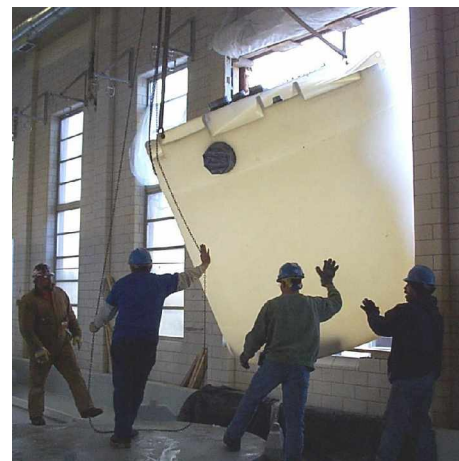
The existing pneumatic fluoride transfer system dated back to its original installation in the 1960's and needed to be upgraded. Needed improvements to the ventilation system in the fluoride room combined with an increase in chemical costs associated with the former delivery mode of fluoride in 400 pound cylinders necessitated moving this project up in priority and schedule. Providence Water investigated modifications to the fluoride handling process as part of the overall project and it was determined that the best long-term solution was to convert to a liquid based, fluorosilic acid system. The new liquid fluoride system is in service and construction is complete.

Bringing new Fluoride Storage Tank into the Treatment Plant

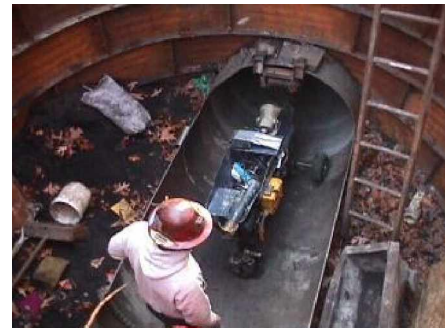
Interior cement mortar lining machine in 48" steel transmission main

In addition to cathodic protection, approximately 1400 feet of the 48" steel water main was cleaned and relined with cement mortar to eliminate the leaks that were found on the main.

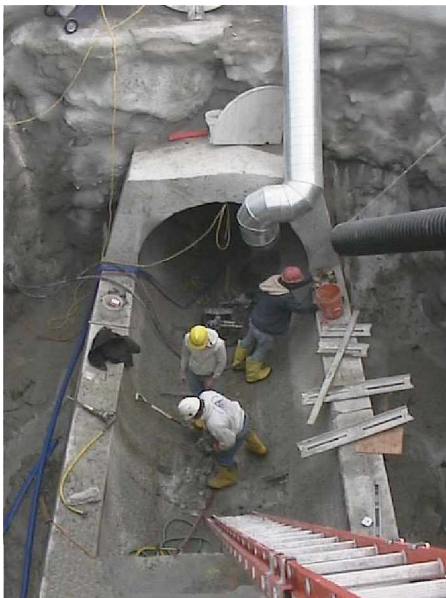
Access into 90" aqueduct at new valve location

Multiple methodologies and approaches for the rehabilitation of the 90" aqueduct were investigated and a work plan was developed that included the installation of a 90" butterfly valve in the aqueduct just downstream of the 78" aqueduct connection in order to enable the 78"/102" aqueduct to continue to function during an event in which the 90" is out of service. The installation of this valve made it possible to conduct the rehabilitative work on the 90". The interior of the 90" aqueduct was rehabilitated for a distance of 1000 feet from the Effluent Chamber to the West Portal using fast curing, potable water-safe, cementitious products.

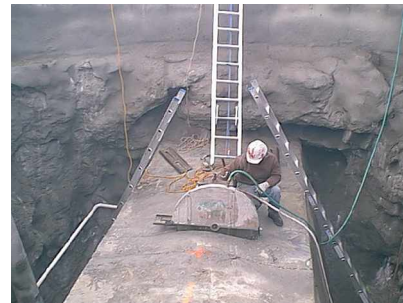
Sawcutting top of 90" pipeline to gain access for repairs and valve installation

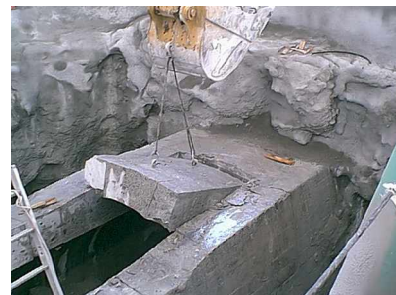
Removal of top of 90" pipeline

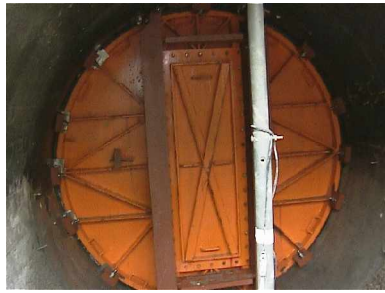
90” disc plug in place prior to rehabilitation and valve installation

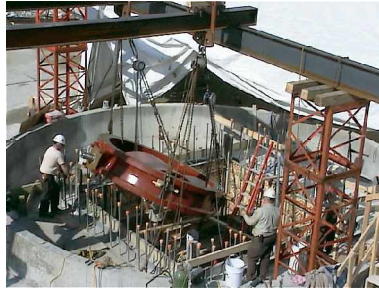
Lowering the 90” valve into place

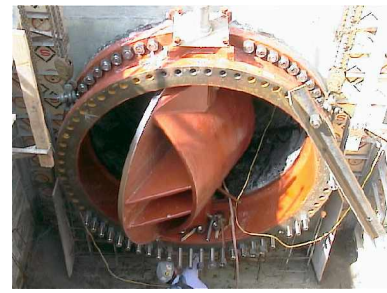
90” valve in place

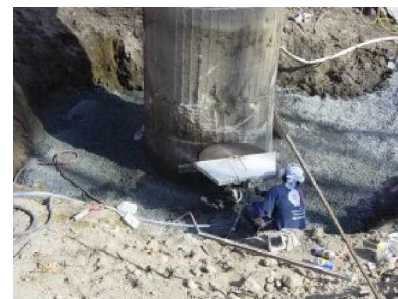
Removal of old East Portal Structure

A new access point was constructed adjacent to the old East Portal. The old east portal was placed out of service because it had become antiquated and was in need of repairs. A new concrete block building was constructed with a new venting mechanism, a security system, and a hoisting system.

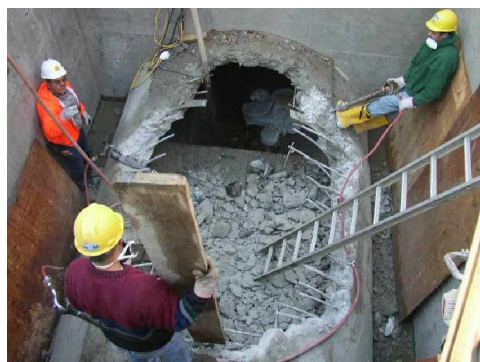
Opening into Aqueduct at New Access Structure

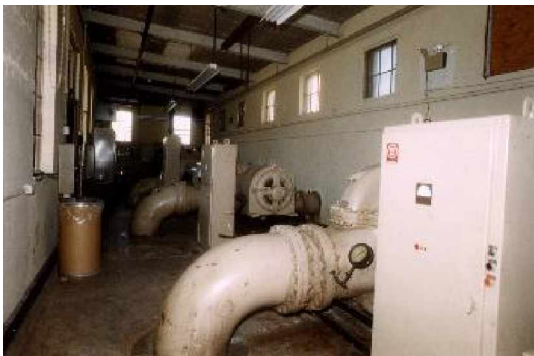
Interior of Neutaconkanut Pump Station before rehabilitation

Construction is complete. Rehabilitation of the facility included replacing pumps, replacing suction and discharge piping, instrumentation and electrical system upgrades, and architectural and structural improvements. Final pump control programming has been completed.

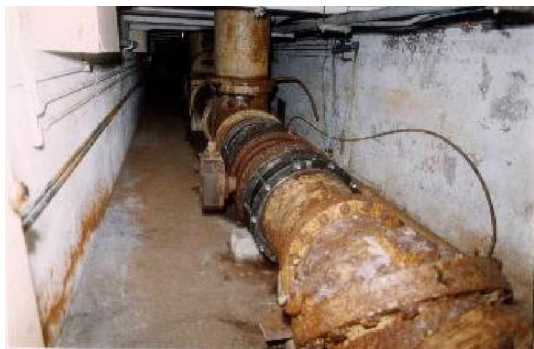
Neutaconkanut Pump Station piping before rehabilitation

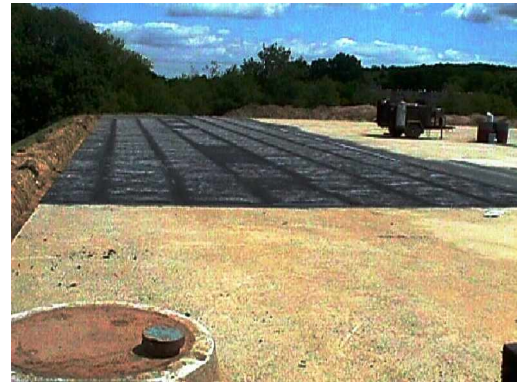
Aqueduct Reservoir Waterproofing

Construction is complete to rehabilitate Aqueduct Reservoir. The work consisted of the application of a hot-applied reinforced rubber membrane sealant over the entire roof surface and the sealing of cracks and construction joints on the interior walls and floor of the reservoir.

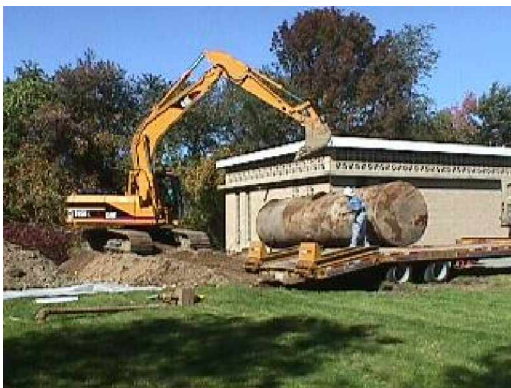
Removal of old underground fuel storage tank at the Aqueduct Pumping Station

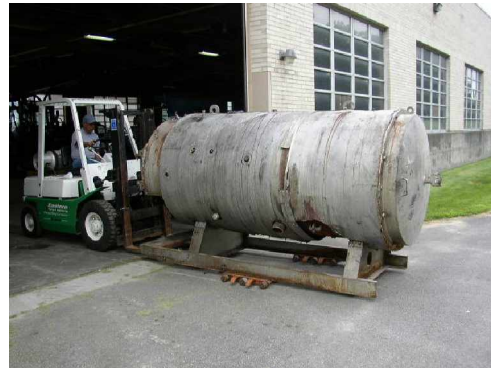
The original boiler for the forestry garage dated back to the 1960's and was in need of replacement. The boiler had pneumatic controls and drew power off of the 600V electrical service for the building.

Removal of Original Forestry Boiler

Replacement parts were difficult and expensive to maintain. The construction contract for the replacement of the heating system and a complete electrical upgrade of the service to a new 480V supply at the forestry building is complete.

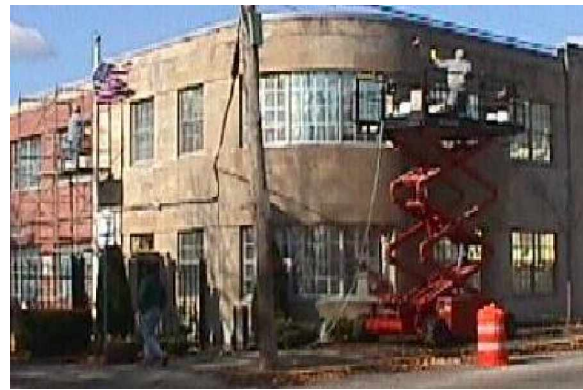
Restoration of the masonry and brickwork at Academy Avenue in progress

Construction has been completed for the restoration of the masonry and brickwork for the administration building at Academy Ave. Areas of the building surface had cracked and deteriorated because of age and exposure to the external elements.
