Providence Water Supply Board Facility Assessment - Phase I

December 2008

Final Report

CDM

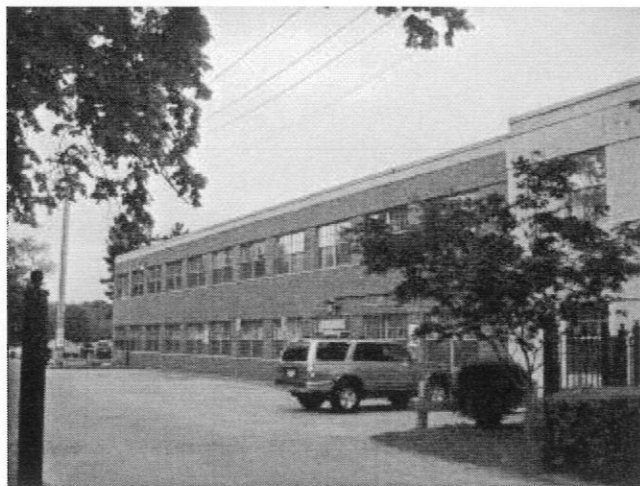
Providence Visitor Entrance

- The single site entrance and access road is a safety hazard for visitors and employees, with PWSB vehicles and deliveries entering and leaving the site. Delays sometimes extend into Academy Avenue.

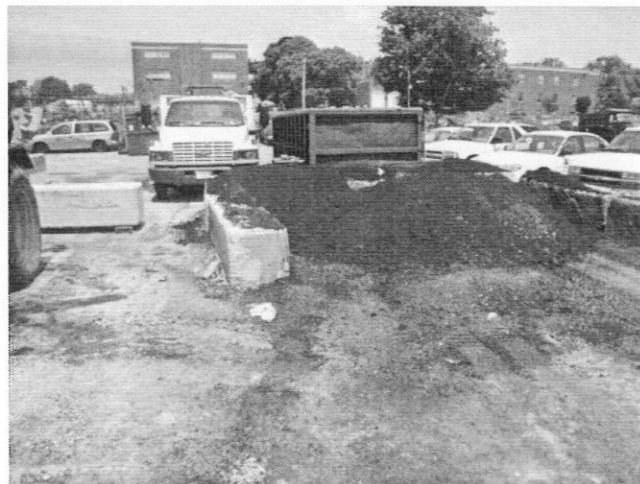
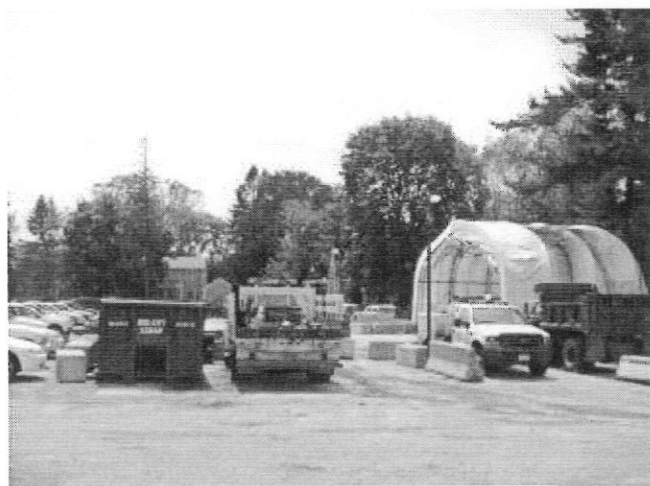
Providence Materials Storage

- Parking for employees and PWSB vehicles in the yard is inadequate, and restricted aisle space has caused accidents and damage to vehicles.
- Storage and handling of bulk materials is limited, and maneuvering space for trucks and loaders is severely restricted.

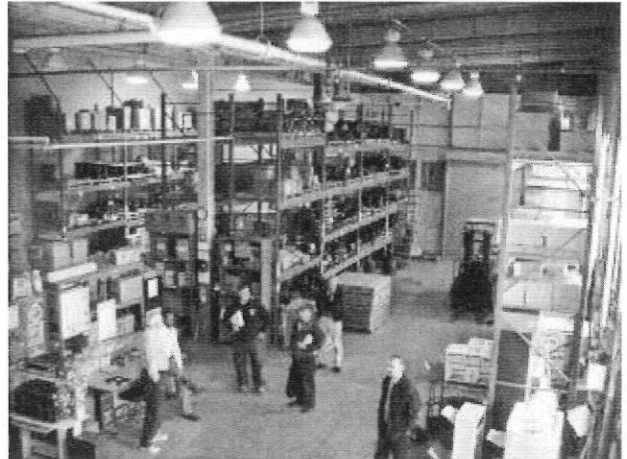
Providence T&D Stock Room

- Large trucks making deliveries to the central stock room or yard storage areas are not able to maneuver safely into the yard due to restricted aisles and turning space, and frequently must be unloaded by forklifts while parked on Academy Ave, resulting in a serious hazard to traffic and pedestrians.

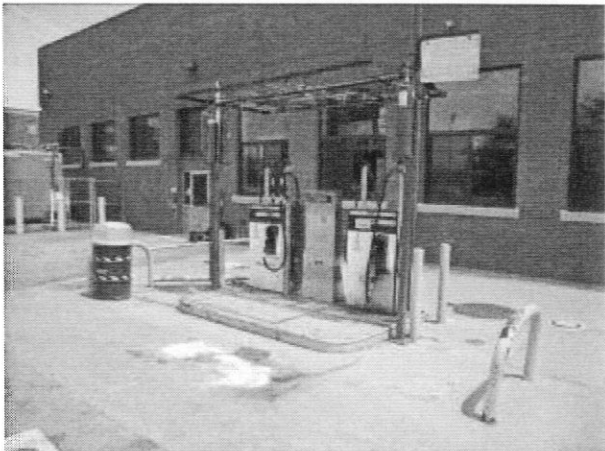
Providence Gas Pumps

- Storage and handling of bulk materials (i.e., stone, fill, waste) is limited, and maneuvering space for trucks and loaders is severely restricted.
- Vehicle fueling adds to the yard congestion and risk of damage.
