Property Condition Assessment

125 Dupont Drive
Providence, RI

June 2015

RE: Property Condition Assessment Report
Proposed Central Operations Facility
125 Dupont Drive, Providence RI

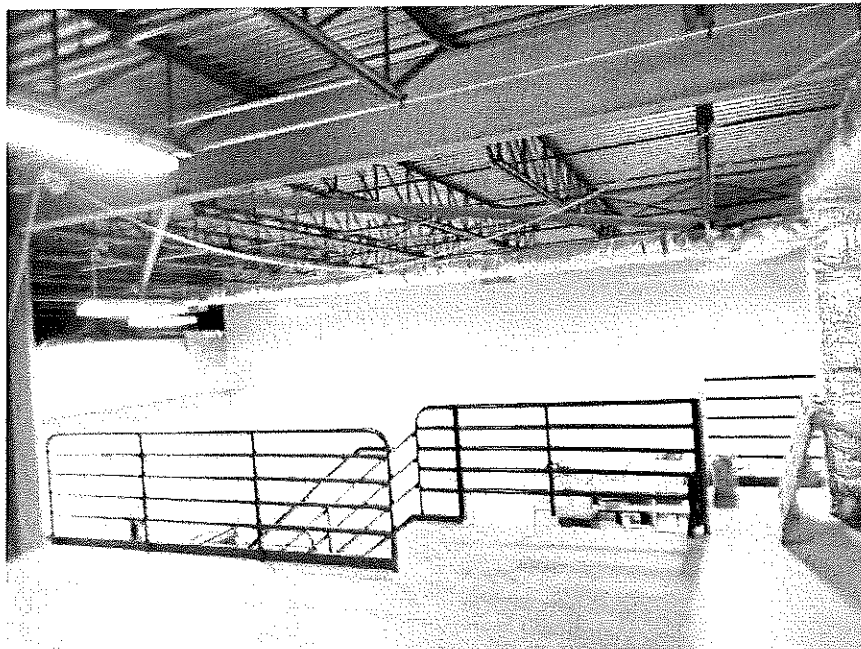
Photo A-2: Storage area located within main building exhibiting typical roof framing

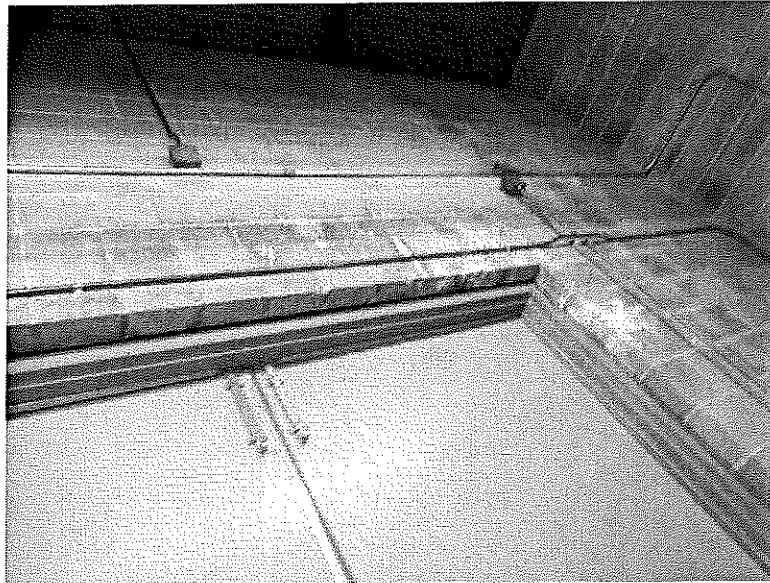
Photo A-3: Generator house concrete masonry bearing/shear wall with efflorescence visible

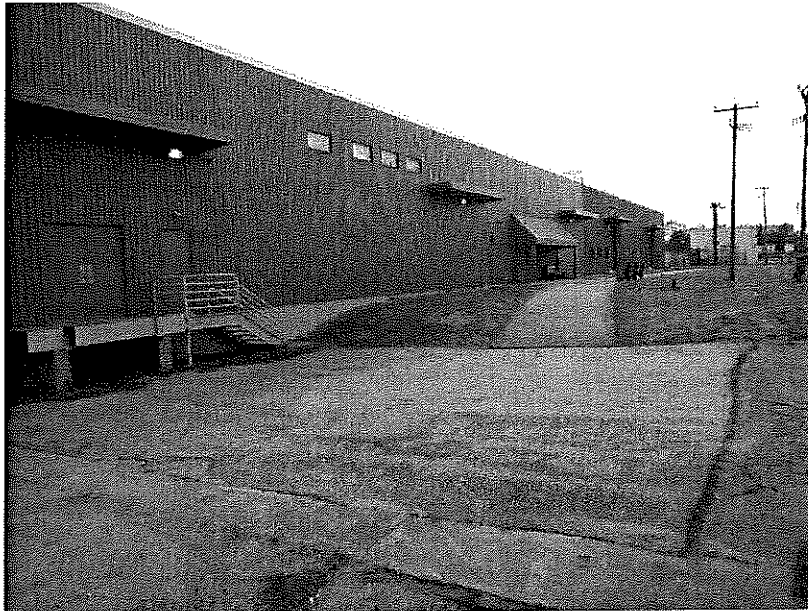
Photo A-4: Typical metal building façade (north wall)

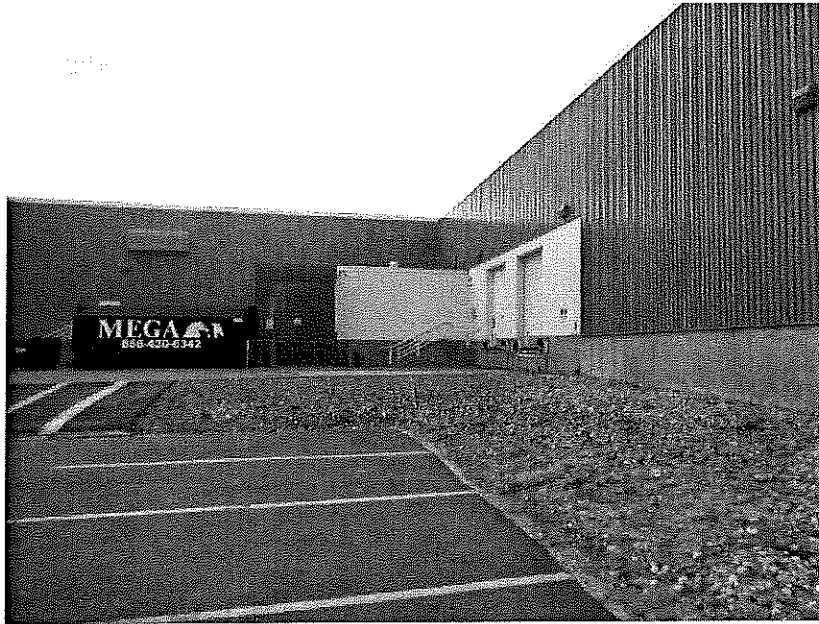
Photo A-8: Concrete masonry façade at southeastern loading dock

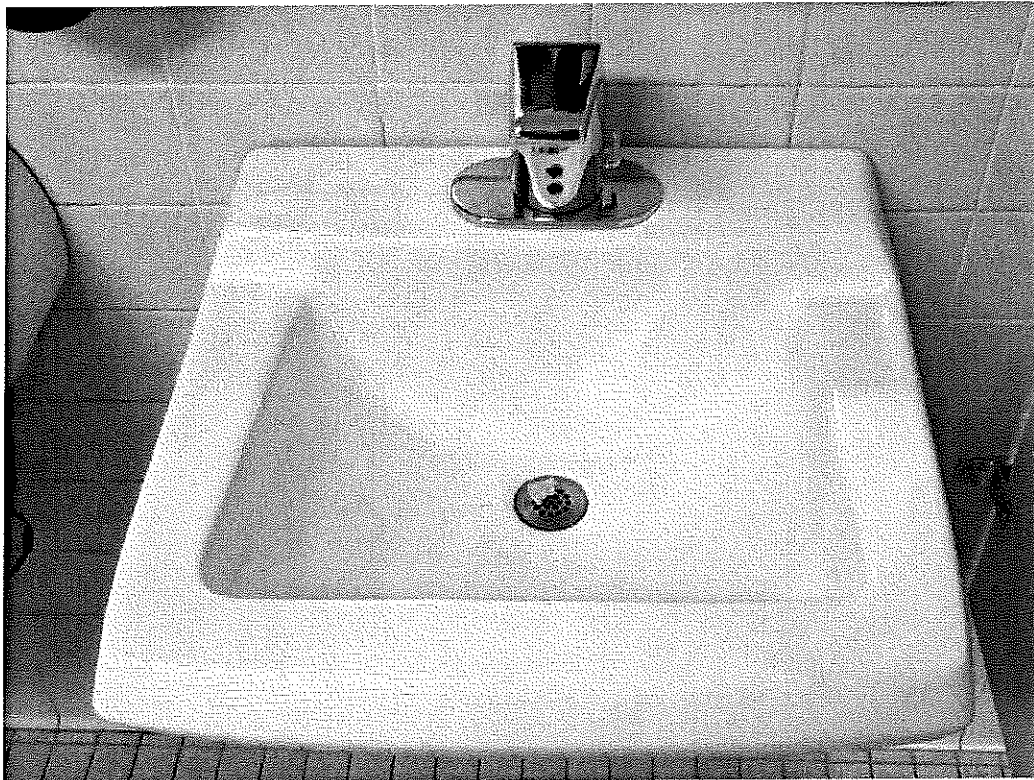
Photo B-2: Sink (Typical)

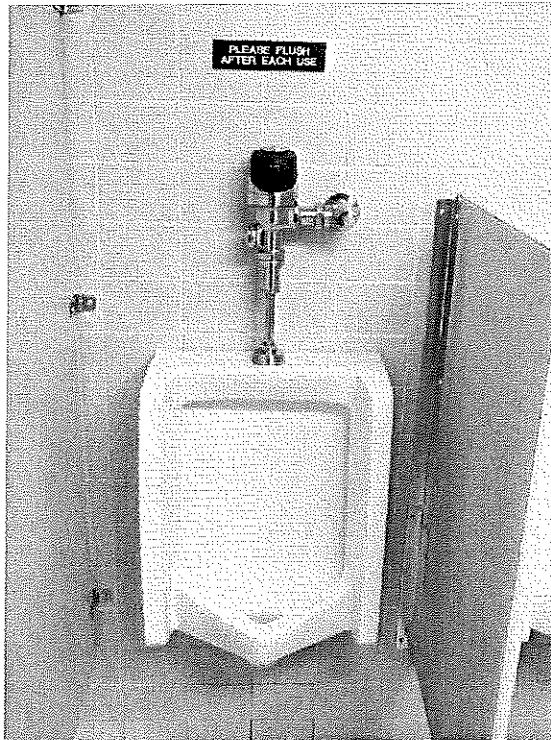
Photo B-5: Urinal (Typical)

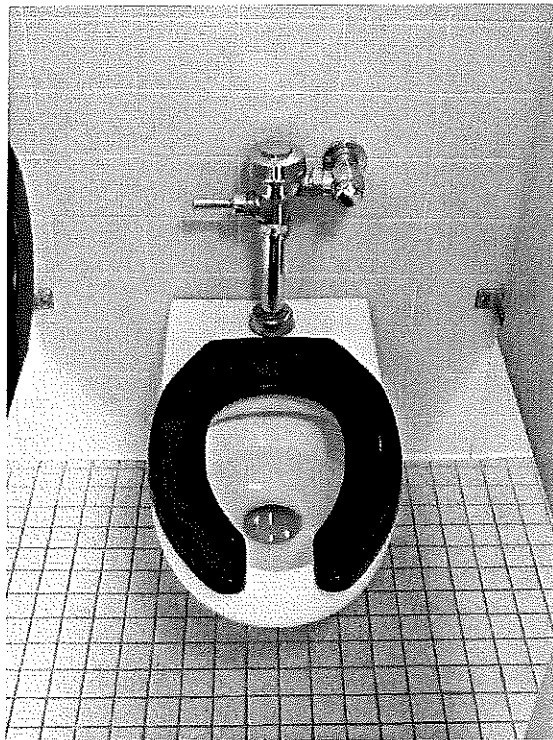
Photo B-6: Tankless Toilet (Typical)

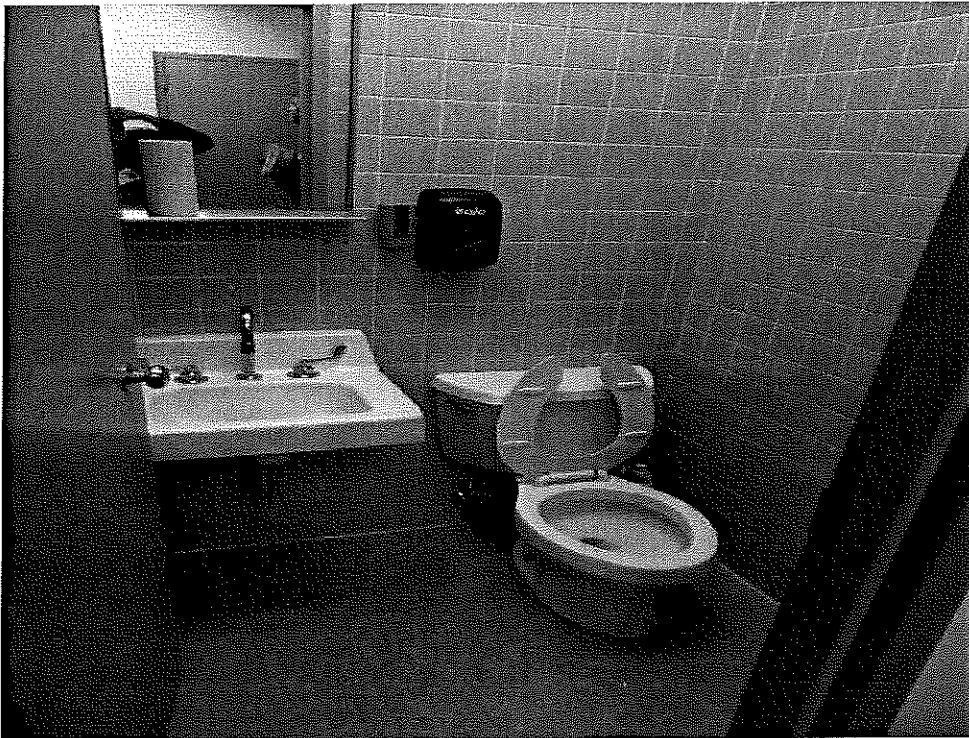
Photo B-8: Single Toilet Room

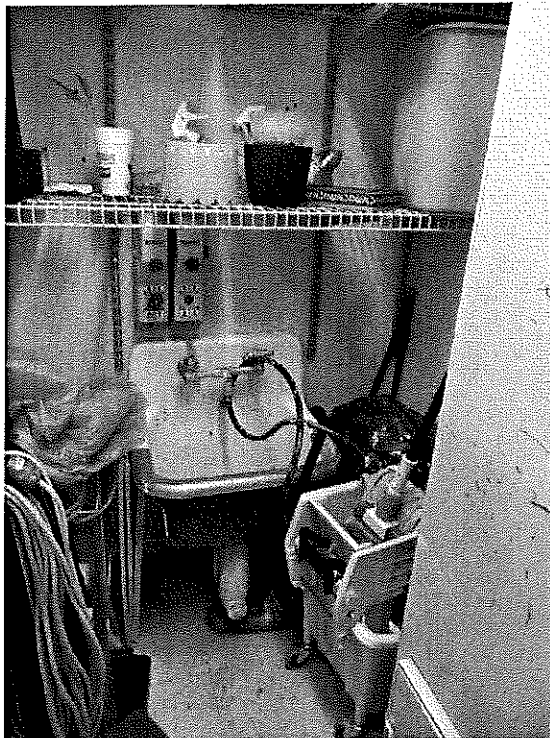
Photo B-10: Janitor Closet Mop sink

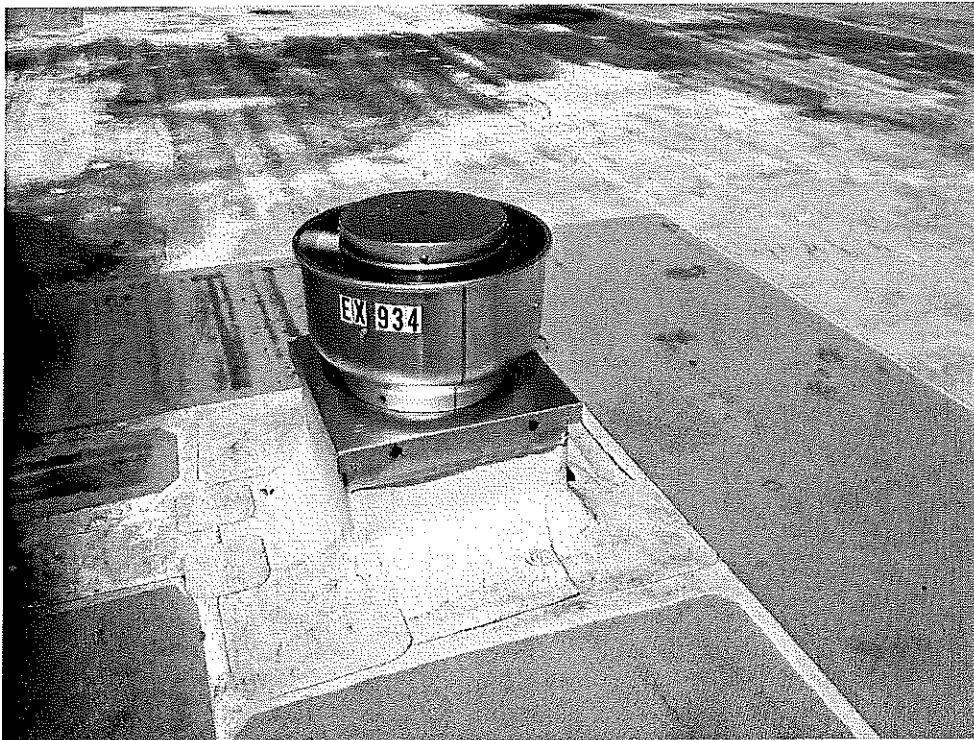
Photo B-16: Kitchen Ventilation Hood Exhaust

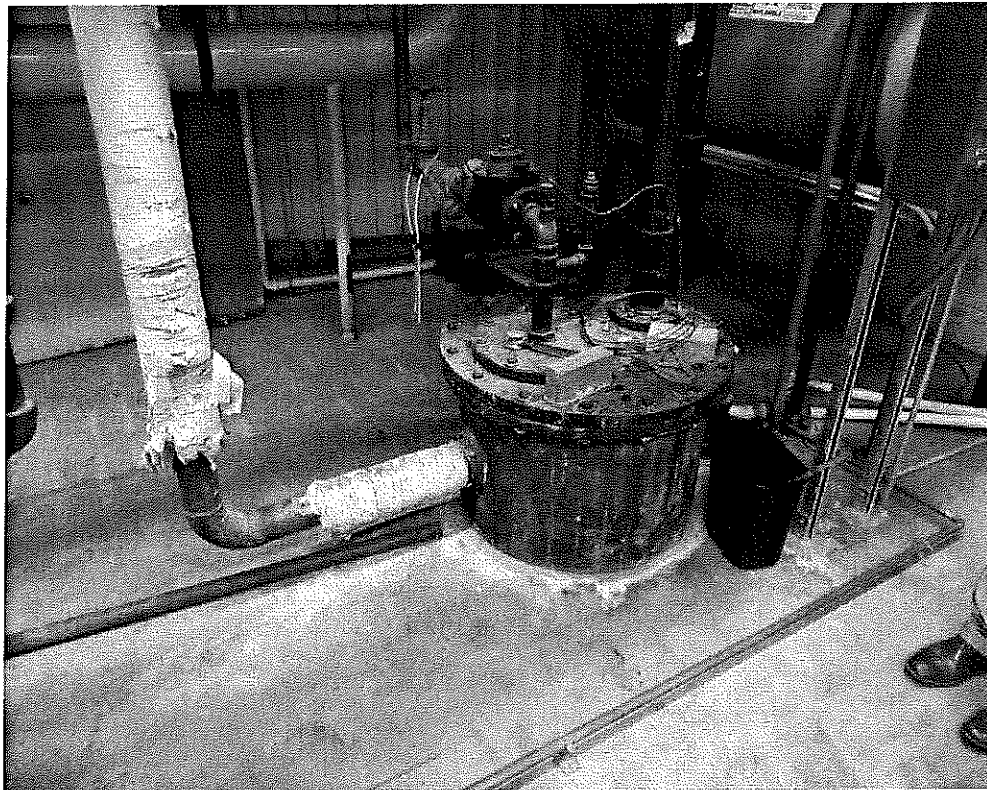
Photo B-24: Boiler Blowdown

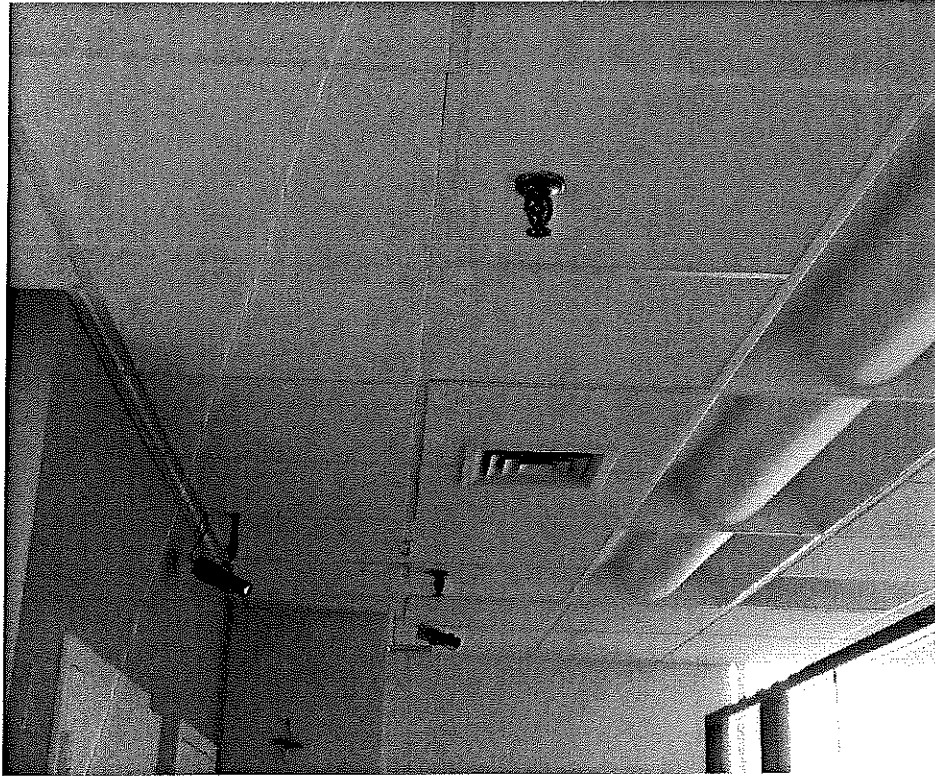
Photo B-50: Sprinkler and Diffuser (Typical)

3. The building is sprinklered throughout. (See Photo B-50).
4. Siamese connections were not observed outside of the building.
5. Fire dampers were witnessed within the ductwork. (See Photo B-52).
6. The data centers have a dedicated Kidde brand fire suppression system. The system appears to have recent inspection tags and is in good condition. (See Photo B-48)
