Providence Water Docket 4994

Bristol County Water Authority Data Request – Set 1 January 28, 2020

20-YEAR INFRASTRUCTURE REPLACEMENT PLAN 2016-2035

Infrastructure/Capital Program Report 1996 - 2015

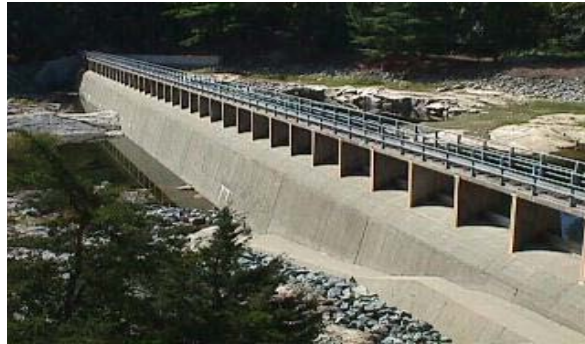
Construction has been completed to rehabilitate the 400 feet long Gainer Dam concrete spillway, the blowoff structure, and the meter chamber. Also completed was work to correct undermining of the Regulating Dam spillway structure footing.

400 foot Gainer Dam spillway showing new concrete facing

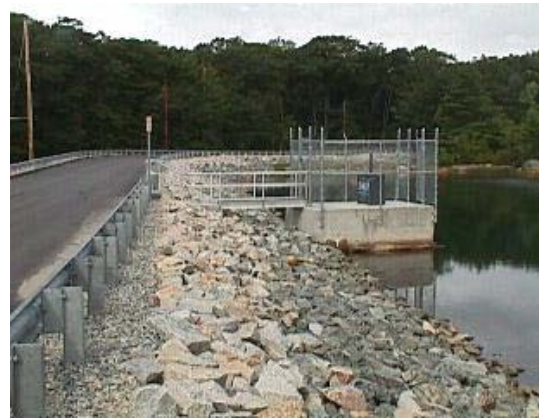
Ponaganset Reservoir after rehabilitation

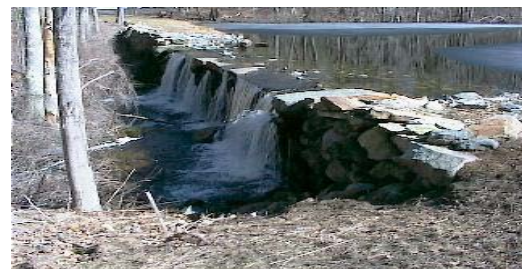
Burton Pond Dam

The project has been completed. The breached area of the earth/masonry dam has been reconditioned. Riprap was installed along the top upstream face of the dam to provide continued slope protection.

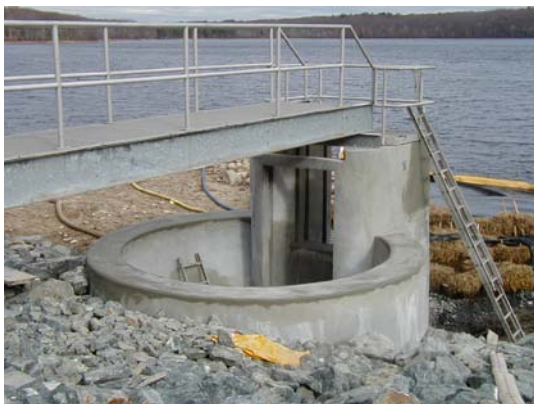
Construction is complete that improved the slope stability of the dam and corrected localized seepage including the start of a sand boil in the vicinity of the Dam's left abutment. Work included installation of a toe drain system and flattening the downstream slope of the dam with the addition of a gravel buttress.

Concrete remediation at the outlet structure

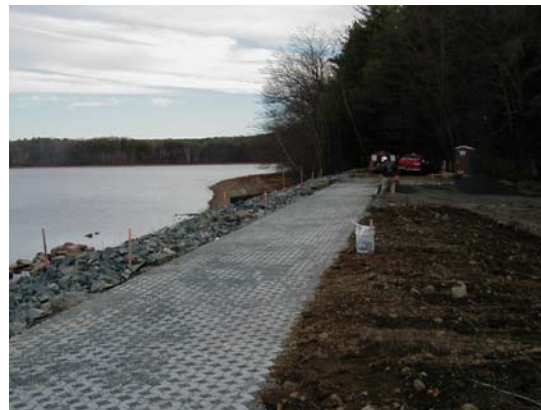
Regrading the access road on the crest of the dam

Construction is complete consisting of regrading and armoring the upstream slope of the dam, miscellaneous concrete repairs to the outlet structure, regrading the crest of the dam, clearing and grubbing both the outlet and emergency spillway discharge channels, and regrading the access road to the dam.

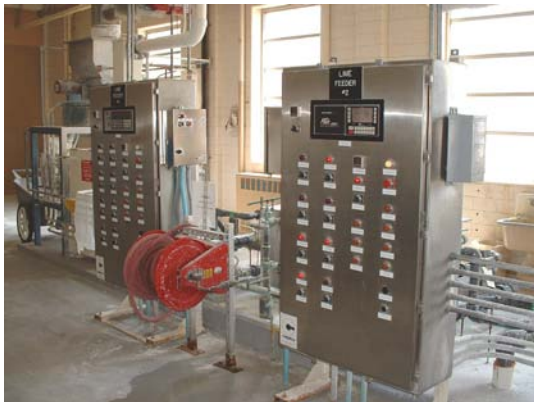
The old lime feeders at the plant have been replaced with 4 new feeders. New injection piping has been installed to provide for an additional lime injection point prior to raw water aeration for corrosion control optimization purposes. The corrosion control optimization measures are necessary as a result of the lead and copper rule.

Two of four new lime feeders installed at treatment plant

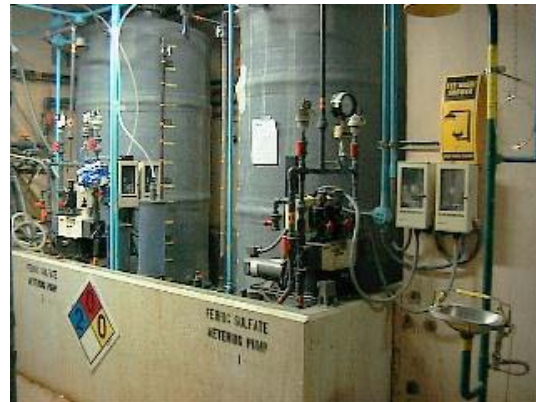
New sulfate feeder equipment and day tanks for liquid ferric sulfate coagulant injection

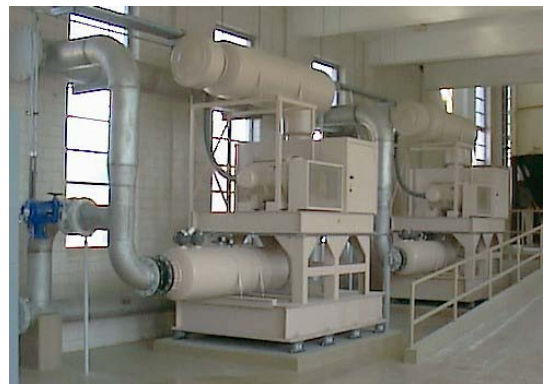
Installation of the new air blowers and piping for providing the capacity to air backwash the filters has been completed.

New air blowers

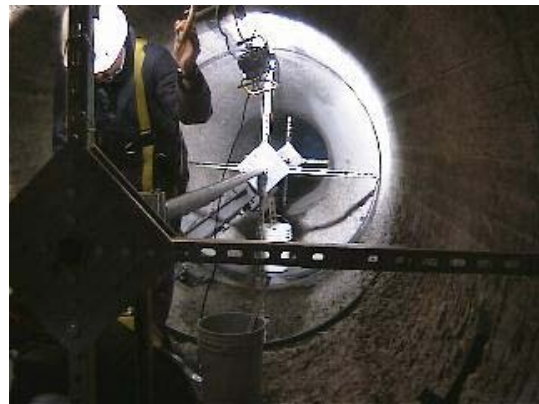
Concrete reconstruction and installation of new instrumentation in treatment plant's 72" x 42" effluent venturi meter

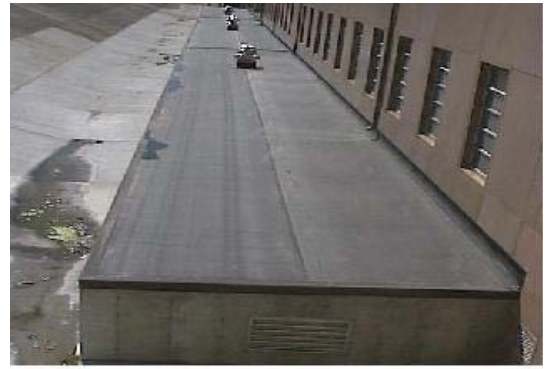
Construction is complete for the rehabilitation of the area of the effluent yard located directly over the clearwell. The scope of work for the project consisted of installation of a new protective structure directly above the clearwell to eliminate the possibility of rainwater or contaminants from entering. Also included were rehabilitation of the existing drainage system and replacement of deteriorated concrete slabs.

Completed clearwell protective structure

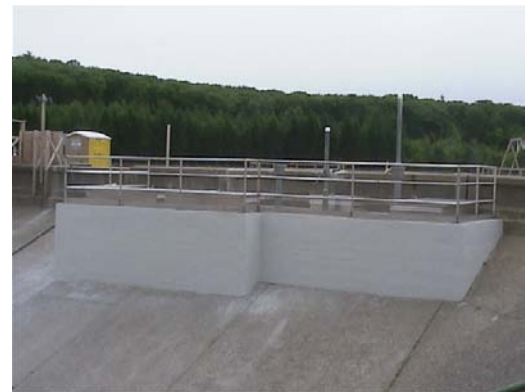
Emergency Bypass Structure

The rehabilitation of the emergency bypass structure located at the treatment plant has been completed. The project consisted of replacement of the sluice gates and access ladders and restoration of the concrete surfaces of the structure. In addition, a new crack-bridging cementitious coating was applied to the exterior of the emergency bypass structure.

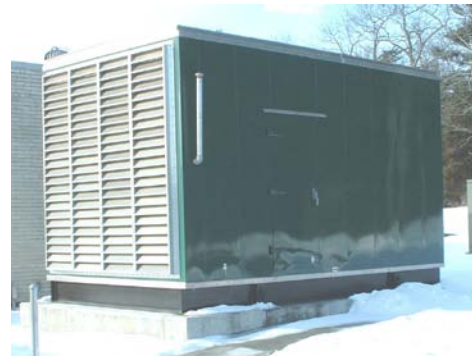
The scope of work included construction of a new electrical room dedicated solely to electrical panelboards and switchgear, the replacement of the existing 175KW emergency power generator

New treatment plant emergency generator

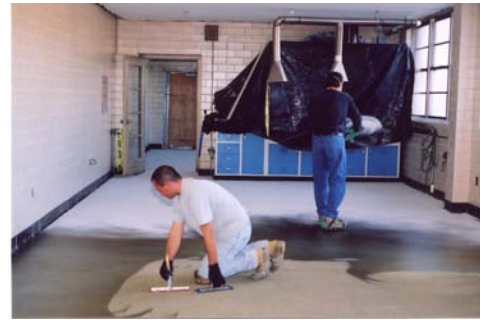
Construction has been completed to upgrade the testing laboratory at the treatment plant. A new epoxy floor, electrical feeder lines, lighting and laboratory benches have been installed. Also installed were three rooftop HVAC units and a new chemical fume hood.

Installation of a new epoxy floor in the lab

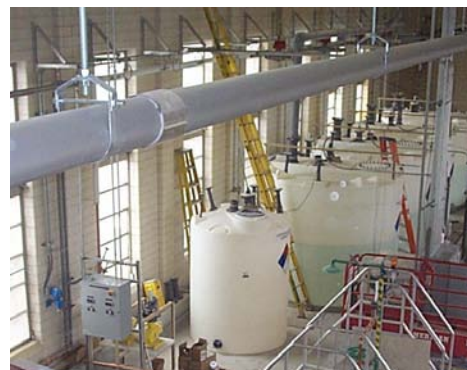
New fluoride tanks in place

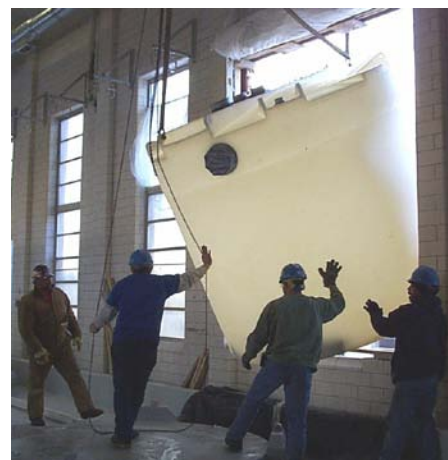
The existing pneumatic fluoride transfer system dated back to its original installation in the 1960's and needed to be upgraded. Needed improvements to the ventilation system in the fluoride room combined with an increase in chemical costs associated with the former delivery mode of fluoride in 400 pound cylinders necessitated moving this project up in priority and schedule. Providence Water investigated modifications to the fluoride handling process as part of the overall project and it was determined that the best long-term solution was to convert to a liquid based, fluorosilic acid system. The new liquid fluoride system is in service and construction is complete.

Bringing new Fluoride Storage Tank into the Treatment Plant

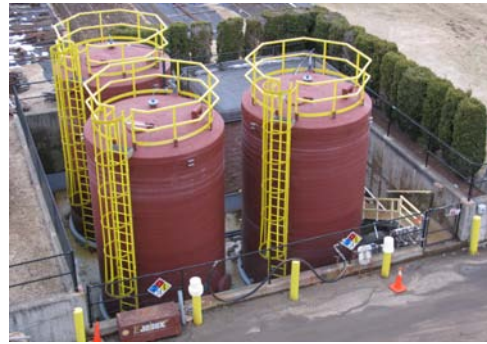
New 16,000 Gal Liquid Ferric Storage Tanks

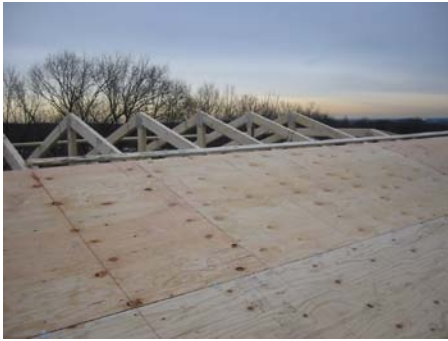
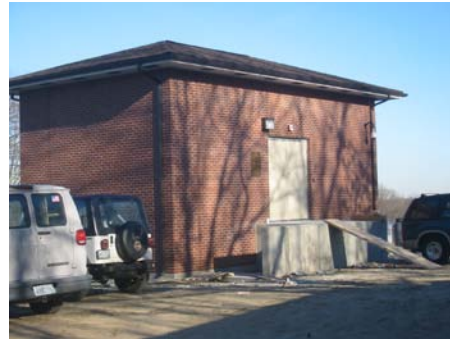
The project has been completed.

Roof Construction – Aqueduct Siphon Chamber

Completed Aqueduct Siphon Chamber

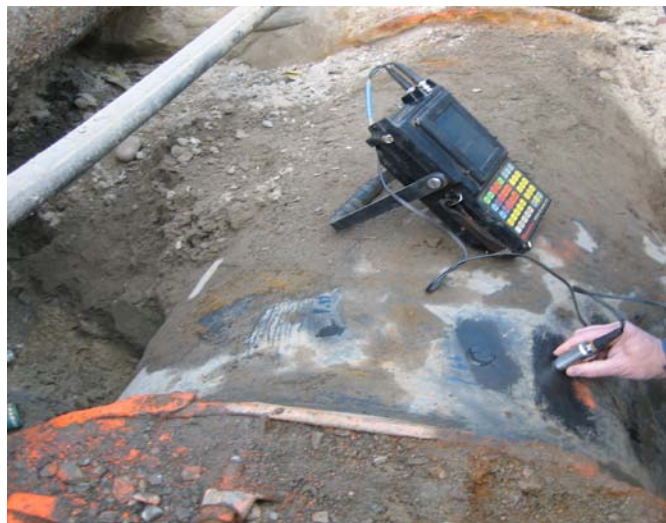
Construction has been completed for the installation of four isolation couplings and the installation of an impressed current cathodic protection system. A final inspection

Cathodic Testing 30" Tee, Eddy St.

was conducted and a report was prepared which indicated that the system is operating to protect the main. In addition to cathodic protection, approximately 1400 feet of the 48" steel water main was cleaned and relined with cement mortar to eliminate the leaks that were found on the main.

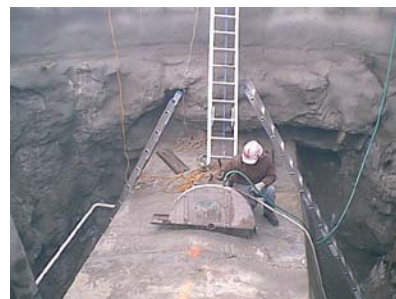
Sawcutting top of 90" pipeline to gain access for repairs and valve installation

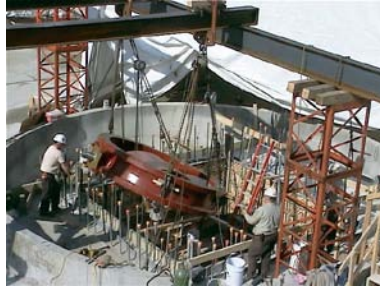
Lowering the 90” valve into place

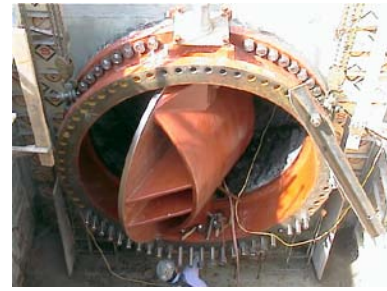
90” valve in place

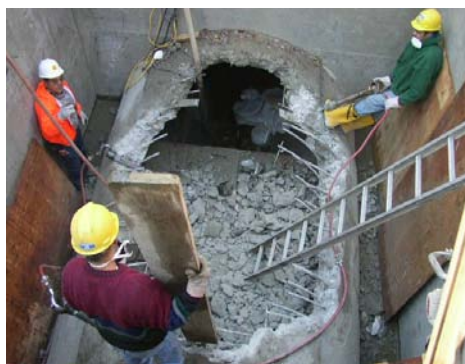
A new access point was constructed adjacent to the old East Portal. The old east portal was placed out of service because it had become antiquated and was in need of repairs. A new concrete block building was constructed with a new venting mechanism, a security system, and a hoisting system.

Opening into Aqueduct at New Access Structure

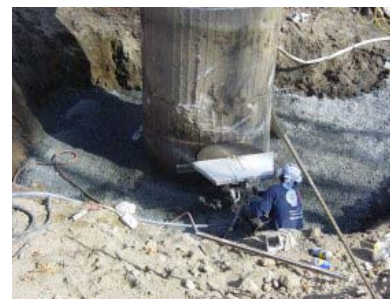
Removal of old East Portal Structure

The existing Siphon Chamber needed replacement due to size constraints and deterioration of the building. The replacement of the structure moved up in priority and was added to the scope of work for this project when it became apparent that it would be more cost effective to replace the building than it would be to expend funds on the existing obsolete structure. Work on the construction of a new Siphon Chamber has been completed.

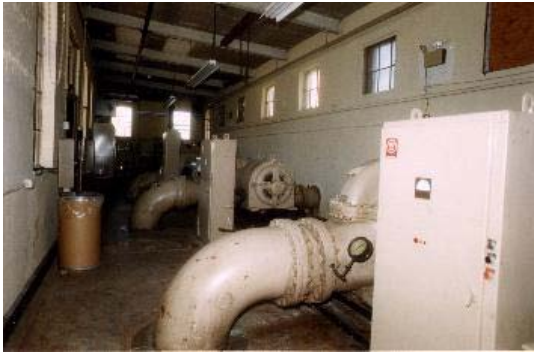
Interior of Neutaconkanut Pump Station before rehabilitation

Construction is complete. Rehabilitation of the facility included replacing pumps, replacing suction and discharge piping, instrumentation and electrical system upgrades, and architectural and structural improvements. Final pump control programming has been completed.

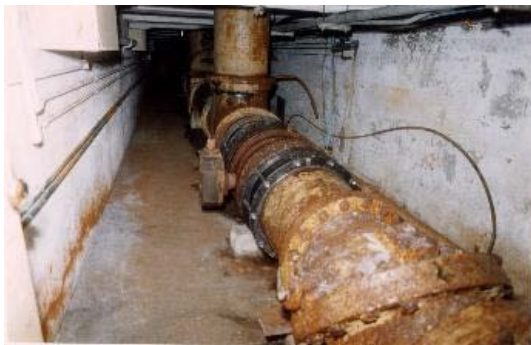
Neutaconkanut Pump Station piping before rehabilitation

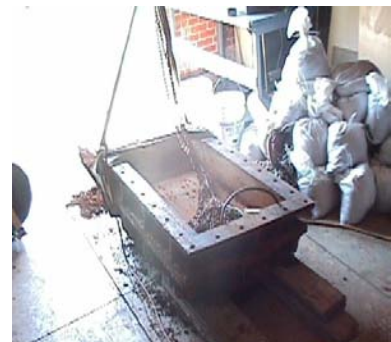
Old Longview Reservoir sluice gate being removed

Construction is complete for the rehabilitation of the original section of Longview Reservoir. The rehabilitation work consisted of the application of a hot-applied reinforced rubber membrane sealant over the entire roof surface of the reservoir, sealing of all cracks and construction joints on the walls and floor of the interior of the reservoir, replacement of the sluice gate, and replacement of the stop shutters.

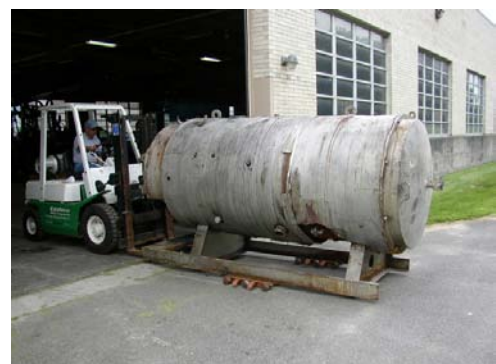
The original boiler for the forestry garage dated back to the 1960's and was in need of replacement. The boiler had pneumatic controls and drew power off of the 600V electrical service

Removal of Original Forestry Boiler

for the building. Replacement parts were difficult and expensive to maintain. The construction contract for the replacement of the heating system and a complete electrical upgrade of the service to a new 480V supply at the forestry building is complete.

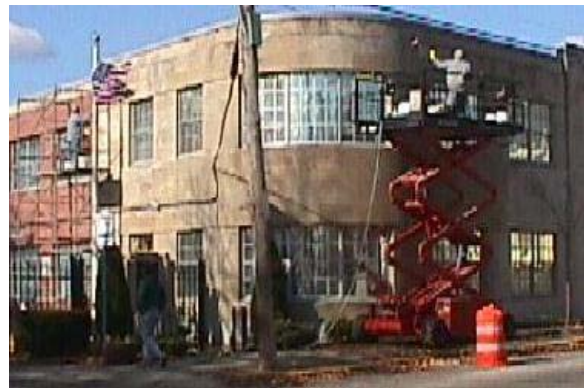
Restoration of the masonry and brickwork at Academy Avenue in progress

Construction has been completed for the restoration of the masonry and brickwork for the administration building at Academy Ave. Areas of the building surface had cracked and deteriorated because of age and exposure to the external elements.

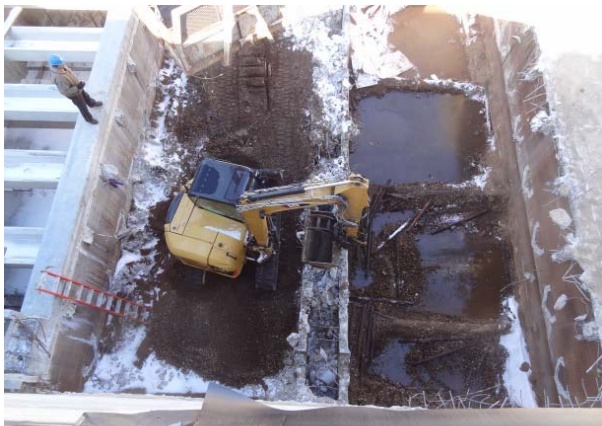
Demolition of Existing Filter Bed #7

Construction is in progress for filters 13 through 18 is in progress. The scope of work includes reconstructing all 18 filters by providing new filter drains, raising the filter backwash troughs to provide greater filter media depth, and completely removing the existing underground concrete roof slab structures covering the filters with a new concrete above-ground protective structure

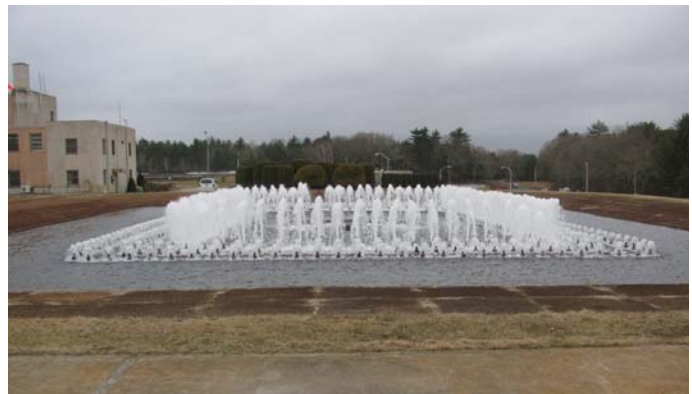
Existing Aeration Basin to be Reconstructed

Rehabilitation of the concrete structure and appurtenances are currently underway.

The overflow weir in the influent structure has been raised to increase hydraulic capacity for water influent through the structure. A masonry structure will be constructed on top of the existing footprint of the structure to protect the new actuators and electrical equipment from the elements.

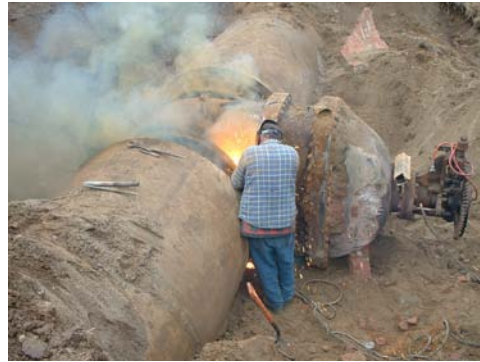
Since 1996, 208 old and outmoded gate style transmission valves in the system were replaced with new butterfly valves. The valves were comprised of the following sizes: one hundred thirty-one (131) 16" valves, nine (9) 20" valves, forty-one (41) 24" valves, twenty-two (22) 30" valves, four (4) 42" valves, and one (1) 48" valve.

Removal of old 48 inch transmission gate valve
