**RE: Division Docket No. D-11-94
National Grid Hurricane Irene Response Assessment
Responses to Division Data Requests (Set 2)
Section I. Engineering & Design**

SUBJECT L14 Failure Analysis

Analysis of L14 Pole 54 Failure

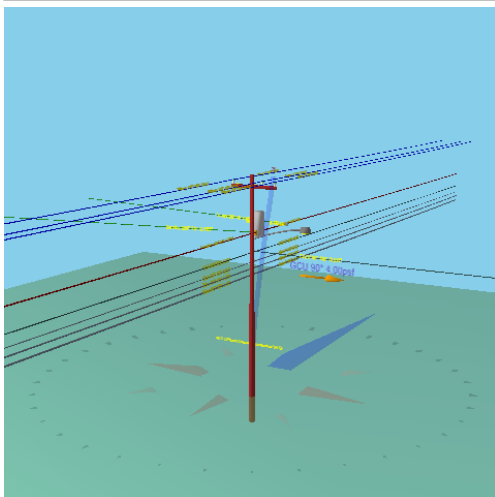
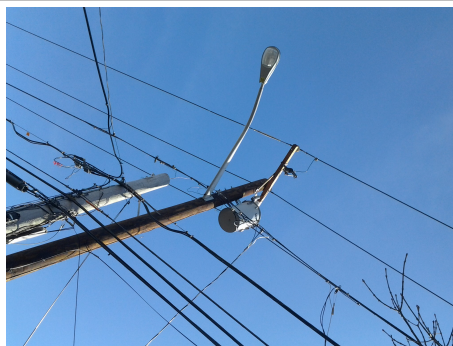
O-Calc® Pro Analysis Report

Pole Capacity Utilization		Height	Wind Angle
Maximum:	66.7%	0.0 ft	90.0°
Groundline:	66.7%	0.0 ft	90.0°
Vertical:	20.2%	22.4 ft	90.0°

Pole Moments		Load Angle	Wind Angle
Max Capac. Util:	42,158 ft-lb	87.8°	90.0°
Groundline:	42,158 ft-lb	87.8°	90.0°
