INFRASTRUCTURE REPLACEMENT PLAN

2001-2020

**Providence
Water**

INFRASTRUCTURE REPLACEMENT PLAN For Fiscal Years 2001 Through 2020

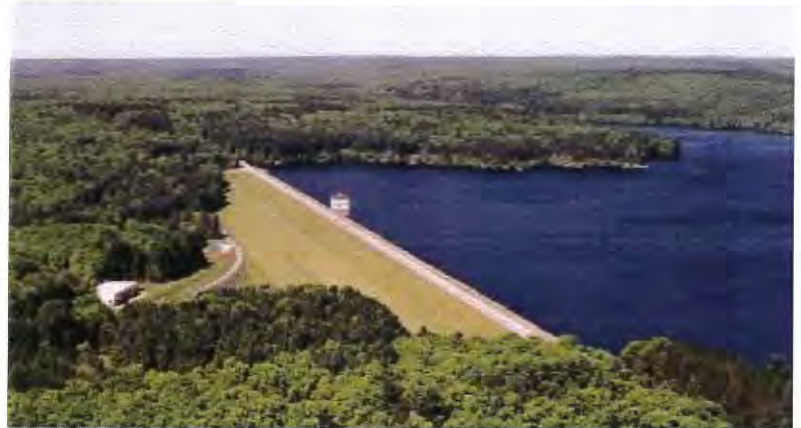
Gainer Dam

Water in the Scituate Reservoir is impounded behind the Gainer Dam, a large zoned earth structure at the southeast end of the Reservoir which is traversed along its 3,200 foot length by Rhode Island Route 12. Elevation of the crest of the dam is 299.0 Mean High Water Datum (MHW).

The spillway is located to the right of the right abutment of the main embankment and is an uncontrolled, reinforced concrete structure 440.0 feet long. The weir is an ogee section with provisions for stop-log (removable timber) flashboards. Crest elevation is 284.01 (MHW). The flow discharges through a natural rock channel to the Pawtuxet River below the dam.

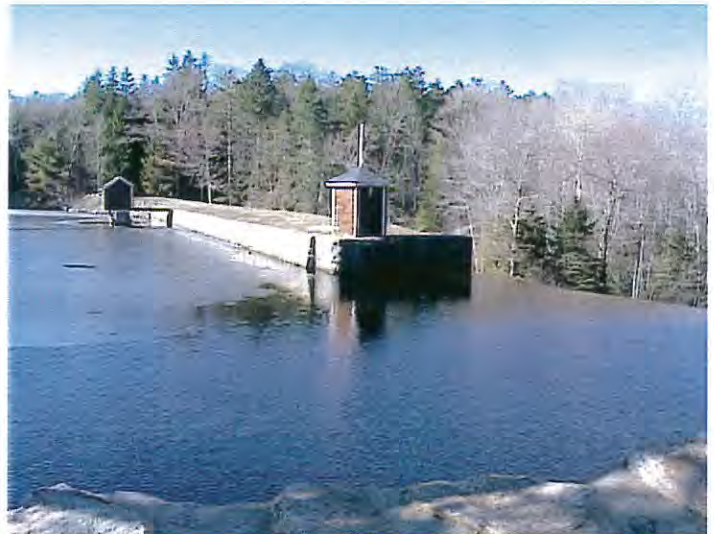
The Barden Reservoir Dam is located on the northeast end of the Barden Reservoir. It is an earth embankment structure with a concrete corewall. The length, including the spillway, is approximately 612 feet. The crest of the dam is at elevation 352.2 (MHW).

Discharges from the dam are over the spillway and through two outlet works. The 81.5 feet long uncontrolled spillway is a stone masonry arched overflow weir located at the right abutment of the dam. Elevation of the crest of the spillway is 345.1 (MHW).

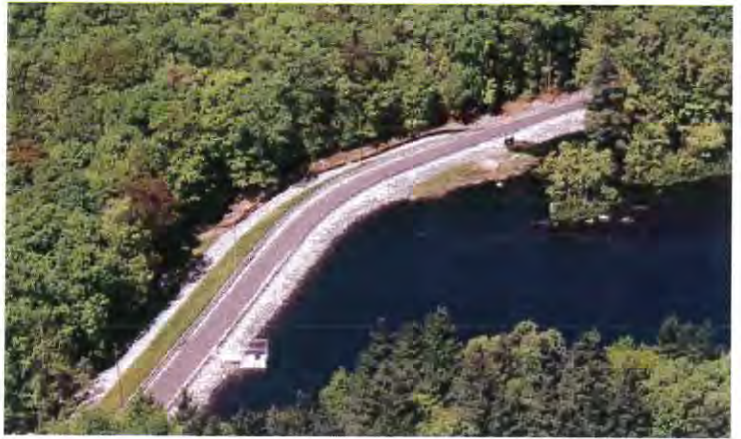
The dam impounding the Ponaganset Reservoir is an approximately 635 feet long earth embankment structure which is traversed by George Allen Road. Crest of the dam is elevation 641.4 (MHW).

The spillway consists of an uncontrolled double-barreled reinforced concrete culvert under George Allen Road. Spillway crest elevation is 633.05 (MHW).

The regulating outlet consists of a 24-inch diameter cast iron pipe through the dam, located near the left side of the embankment; control is by a manually operated sluice gate

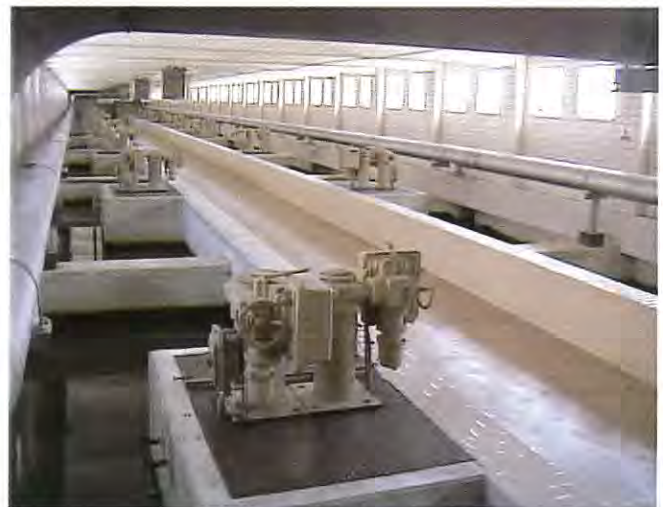
Filter Gallery

Settled water travels from the open basins through a 10 foot wide, 11 foot high conduit to the sand filters. There are eighteen (18) single media rapid sand filters which remove non-settleable floc and impurities remaining following the coagulation, flocculation, and sedimentation stages. Each filter is operated over a flow range of 5 to 8 million gallons per day. The number of filters on-line concurrently is dependent upon water demand. Each filter has two 16-inch effluent lines with 12"

butterfly valves that discharge into the clearwell. The average filter run is approximately 72 hours and is initiated when head loss through the filter reaches approximately 6.5 feet of water. The backwash water is supplied by gravity via a 400,000 gallon wash water tank and is discharged to waste lagoons.

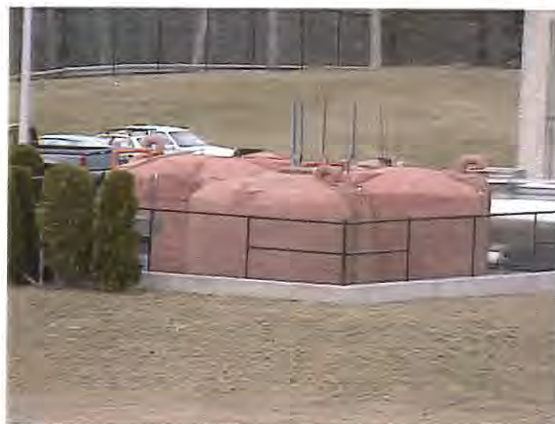
Ferric Storage Tanks

The plant uses ferric sulfate as a coagulant. Ferric sulfate arrives at the plant in liquid form and is stored in three (3) 12,000 gallon storage tanks (36,000 gallon total capacity). The liquid is then transferred by pumps as needed into two (2) day tanks with a capacity of 700 gallons each located in the treatment plant. Metering pumps are then used to provide a measured feed rate to the raw water.

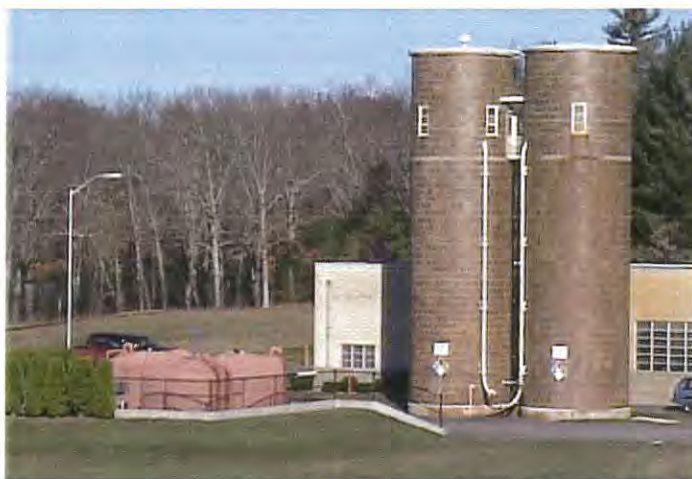
Quicklime Silo

Quicklime is added to aerated water for pH adjustment and is stored in a 180 ton silo located adjacent to the ferric sulfate silo. A pneumatic transfer system is utilized to convey lime from the silo to secondary storage hoppers located in the treatment facility. Secondary storage hoppers, gravimetric feeders, slakers, float tank, and pumps are utilized to add lime to the aerated water.

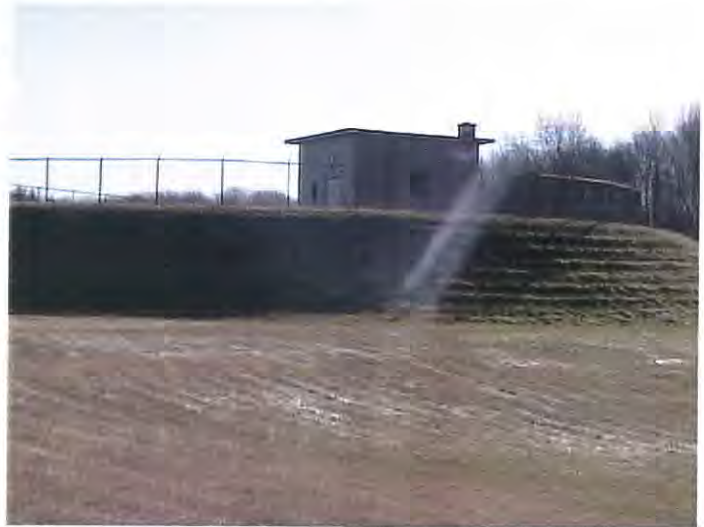
The Aqueduct Reservoir has a storage capacity of 43.4 MG and is located on Scituate Avenue in the Town of Cranston. The reservoir is a 390 x 590 foot enclosed concrete structure with a water depth of approximately 25 feet and an overflow elevation of 231 feet mean high water (MHW). The facility provides operational storage for the low service area and operates by gravity feed. Water is supplied to the reservoir through a 60-inch diameter prestressed

reinforced concrete cylinder pipe conduit which connects the reservoir with the 60-inch diameter Neutaconkanut Conduit.

Aqueduct Reservoir and Gatehouse	1962	38	50	The reservoir has been fully rehabilitated. Exterior waterproofing was applied and cracks and construction joints on the interior of the structure were sealed.
Neutaconkanut Reservoir and Gatehouse	1928	72	35	Dates back to the 1920s. The interior of the reservoir needs to be inspected. The need for some concrete rehabilitative work is anticipated. The roof of the gatehouse was replaced but the structure is in need of structural rehabilitation.
Longview Reservoir and Gatehouse	1928, 1990	41	50	The reservoir has been fully rehabilitated. Exterior waterproofing was applied and cracks and construction joints on the interior of the structure were sealed. The gatehouse is in good condition.
Ridge Road Reservoir	1989	11	40	The storage tank is relatively new and in good condition.
Lawton Hills Reservoir	1972	28	40	The interior of the reservoir needs to be inspected. The need for some concrete rehabilitative work is anticipated. The roof of the gatehouse was replaced but the structure is in need of structural rehabilitation.

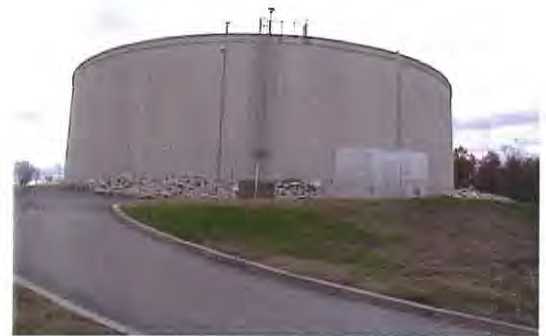
The Ridge Road Reservoir has a capacity of 3.5 MG and is located off Ridge Road in Smithfield. The facility provides operational and fire storage for the extra-high service area. Water is pumped to the reservoir by the Fruit Hill Pumping Station. The structure is an above ground prestressed concrete tank with a water depth of 40 feet and an overflow elevation of 398 MHW.

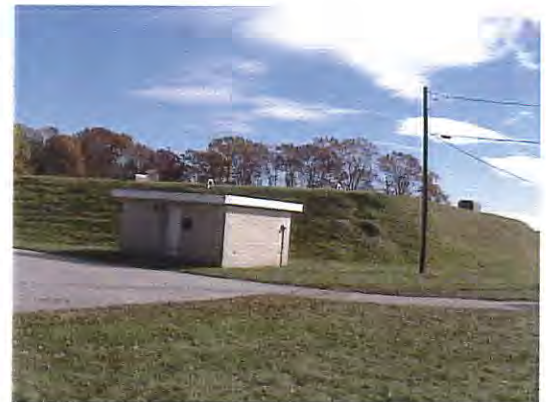
The Lawton Hill Reservoir has a storage capacity of 5.0 MG and is located on Plainfield Pike in the City of Cranston. The reservoir is a 187-foot by 187-foot underground enclosed concrete structure with a water depth of 20 feet and an overflow elevation of 485.00 mean high water (MHW). The facility provides operational storage for the high service area in Western Cranston. Water is supplied to the reservoir through a 24-inch DI pipe from the Aqueduct Pump Station.

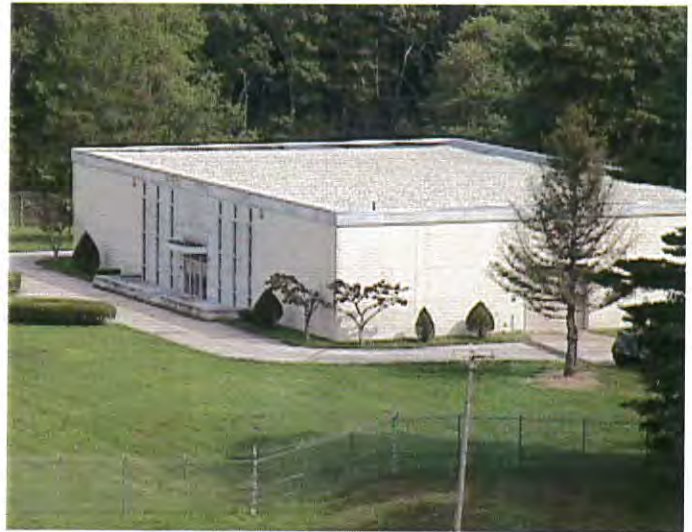
Raw Water Pumping Station

The Raw Water Booster Pumping Station (RWBPS) contains four pumps, two with a pumping capacity of 50 MGD and two with a pumping capacity of 30 MGD and is located near the base of the Gainer Dam. The station is used to supplement head to the plant under low reservoir, high demand periods.

The RWBPS is equipped with emergency power supplied by a 2000 KW diesel generator. This generator also supplies the emergency power to the plant.

90 inch Steel Aqueduct	1926	74	50	Dates back to original plant construction. Structure is in relatively good condition.
Raw Water Booster Pump Station	1966	34	20	A new 2000 kW generator was installed replacing the old diesel generator. The 60" control valves to the station have been adjusted and are in good working condition. The suction and discharge valves for each of the booster pumps need to be replaced.
Electrical Supply System - Treatment Plant	various	various	various	The substation that feeds the treatment plant from Hope substation has been replaced. The feeder lines from Hope substation all the way to the treatment plant have been replaced. A new 480 volt transformer has been installed at the treatment plant with a new feed line into the plant. The secondary voltage for the plant is 550V instead of the standard 480V and the system needs to be replaced. The generator directly feeding the plant needs to be replaced and increased in size.

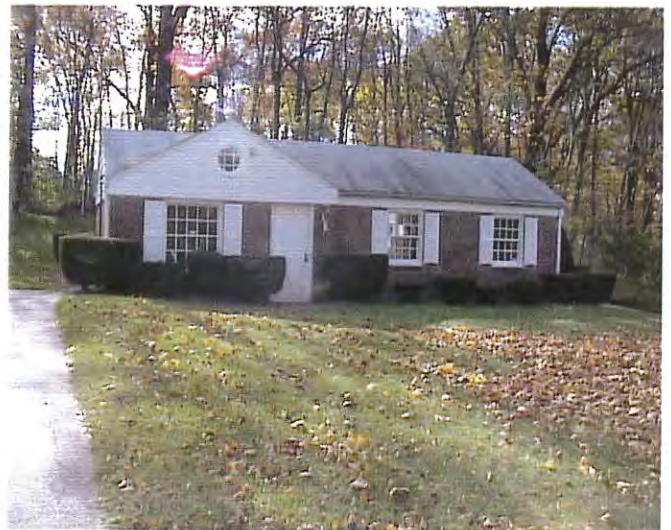
The Garden Hills Pump Station is located on Rockcrest Drive in the City of Cranston. The pump station contains two 400 GPM primary pumps, a 100 GPM jockey pump, and one natural gas driven 400 GPM pump used for emergency response. The station is used to maintain adequate pressures at the higher elevations of the Garden Hills subdivision in Cranston. The station contains an underground 7,200 gallon hydropneumatic storage tank (6' dia. x 30' long).

Garden Hills Pump Station	1959	41	10	The pump station dates back to 1960 but is in relatively good condition. The pumps and hydropneumatic tank are old and will need to be targeted for future replacement.
Dean Estates Pump Station	1982	18	10	The pump station dates back to the 1980s and is in relatively good condition. The roof of the building was replaced. The pumps and hydropneumatic tanks will need to be considered for future replacement.
Fruit Hill Pump Station	1989	11	20	The pump station is relatively new and in good condition.
Bath Street Pump Station	1928	72	25	The pump station has been fully rehabilitated to include replacing pumps, replacing suction and discharge piping, instrumentation and electrical system upgrades, architectural and structural improvements, and installation of an emergency power generator.
Neutaconkanut Pump Station	1935	65	25	The pump station has been fully rehabilitated to include replacing pumps, replacing suction and discharge piping, instrumentation and electrical system upgrades, architectural and structural improvements, and installation of an emergency power generator.

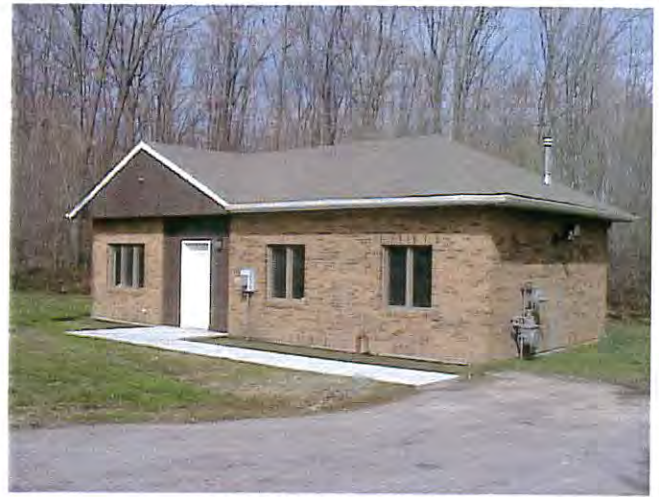
The Dean Estates Pump Station is located on Melody Lane in Cranston and serves the higher elevations in the Dean Estates sub-division. The pump station contains two 1,200 GPM primary pumps and one 1,200 GPM natural gas driven emergency pump. The facility utilizes two 10,000 gallon hydropneumatic storage tanks.

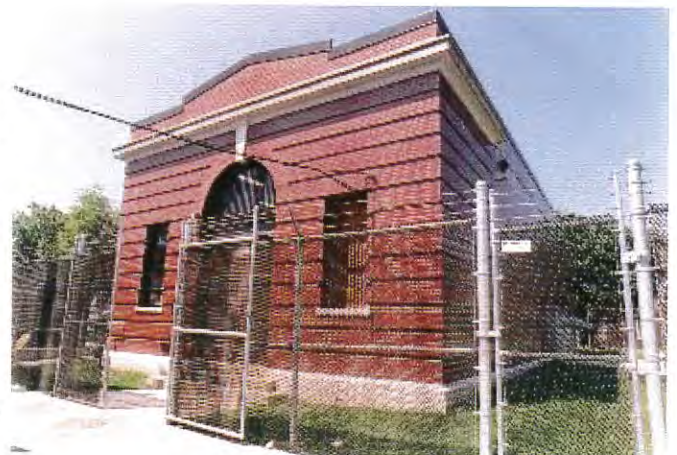
The Bath Street Pump Station is located on Bath Street in the City of Providence. The pump station contains three pumps with a pumping capacity of approximately 6,700 GPM each. A 1000 KW diesel generator supplies emergency power for the station. The station provides water to the high service area as well as the high pressure fire zone in downtown Providence.

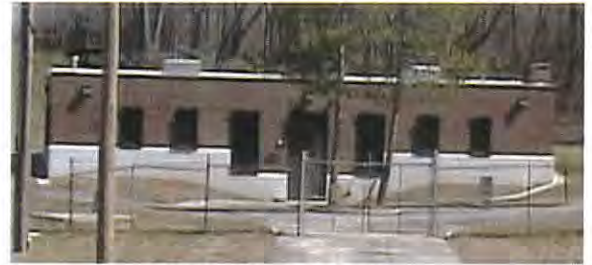
The Neutaconkanut Pump Station is located off Ashby Street in the Town of Johnston. It draws water from the Neutaconkanut Reservoir and supplies water to the high service area. The pump station contains four 6,700 GPM pumps. The station is equipped with a 1,000 KW diesel engine backup power generator.

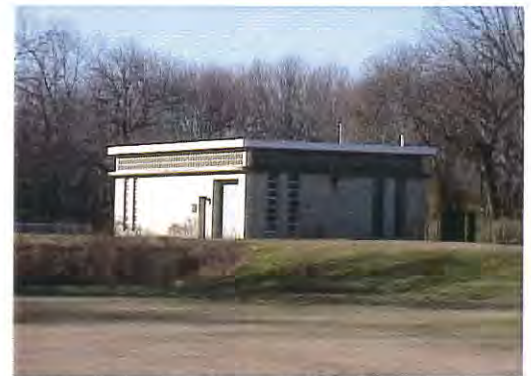
The Aqueduct Reservoir Pump Station is located on Scituate Avenue in the City of Cranston. The station contains four 1050 GPM domestic pumps and a 1600 GPM prefabricated booster pump which provides water throughout the high service area of Western Cranston. Emergency power is supplied by a 450 KW diesel generator.

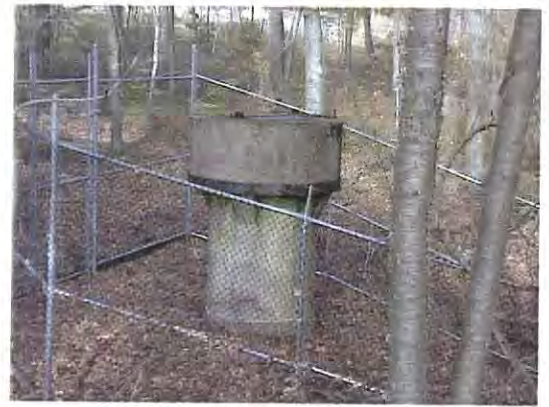
East Portal

The 90-inch diameter concrete lined tunnel portion of the ScTA begins at the West Portal near the plant and finishes at the East Portal, covering a distance of approximately 3.4 miles. At the East Portal, the topography requires the ScTA to become an aboveground aqueduct. This aqueduct is a 90 inch concrete pipe which carries the water approximately 0.95 miles to the Siphon Chamber. From the Siphon Chamber, the transmission line splits into two lines, a 60-inch

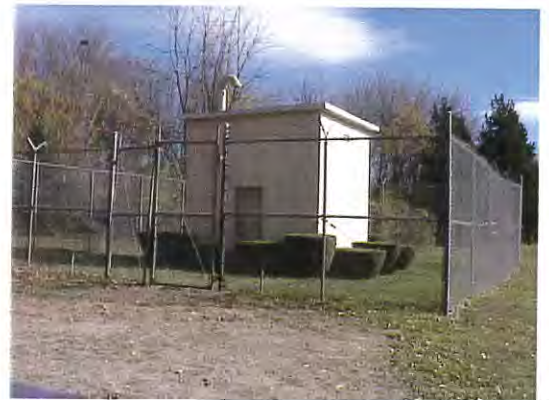
Structure D

Structure "D". Structure "D" is a 36 foot deep 78-inch diameter shaft which accesses a 78 inch concrete lined tunnel. The tunnel continues for approximately 0.5 miles until it reaches Structure "E". Here, the water rises up 65 feet in a 120-inch shaft and enters the 102 inch diameter aqueduct portion of the STA. Structure "E" was constructed with provisions for a point of entry for the once proposed Big River Reservoir supply line. The 102-inch diameter aqueduct carries the water for approximately 4.1 miles to its termination in the general area of Budlong Road in Cranston where further distribution begins.

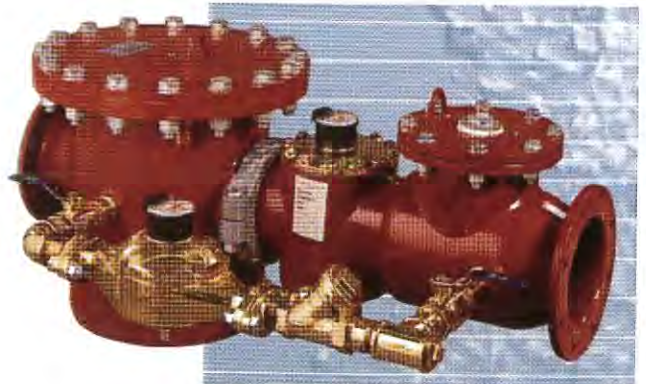
Industrial Meter

In addition to metering water produced by the treatment facility, Providence Water meters its entire distribution system. Distribution system metering includes meters at interconnections to wholesale customers as well as normal metering of all service connections.

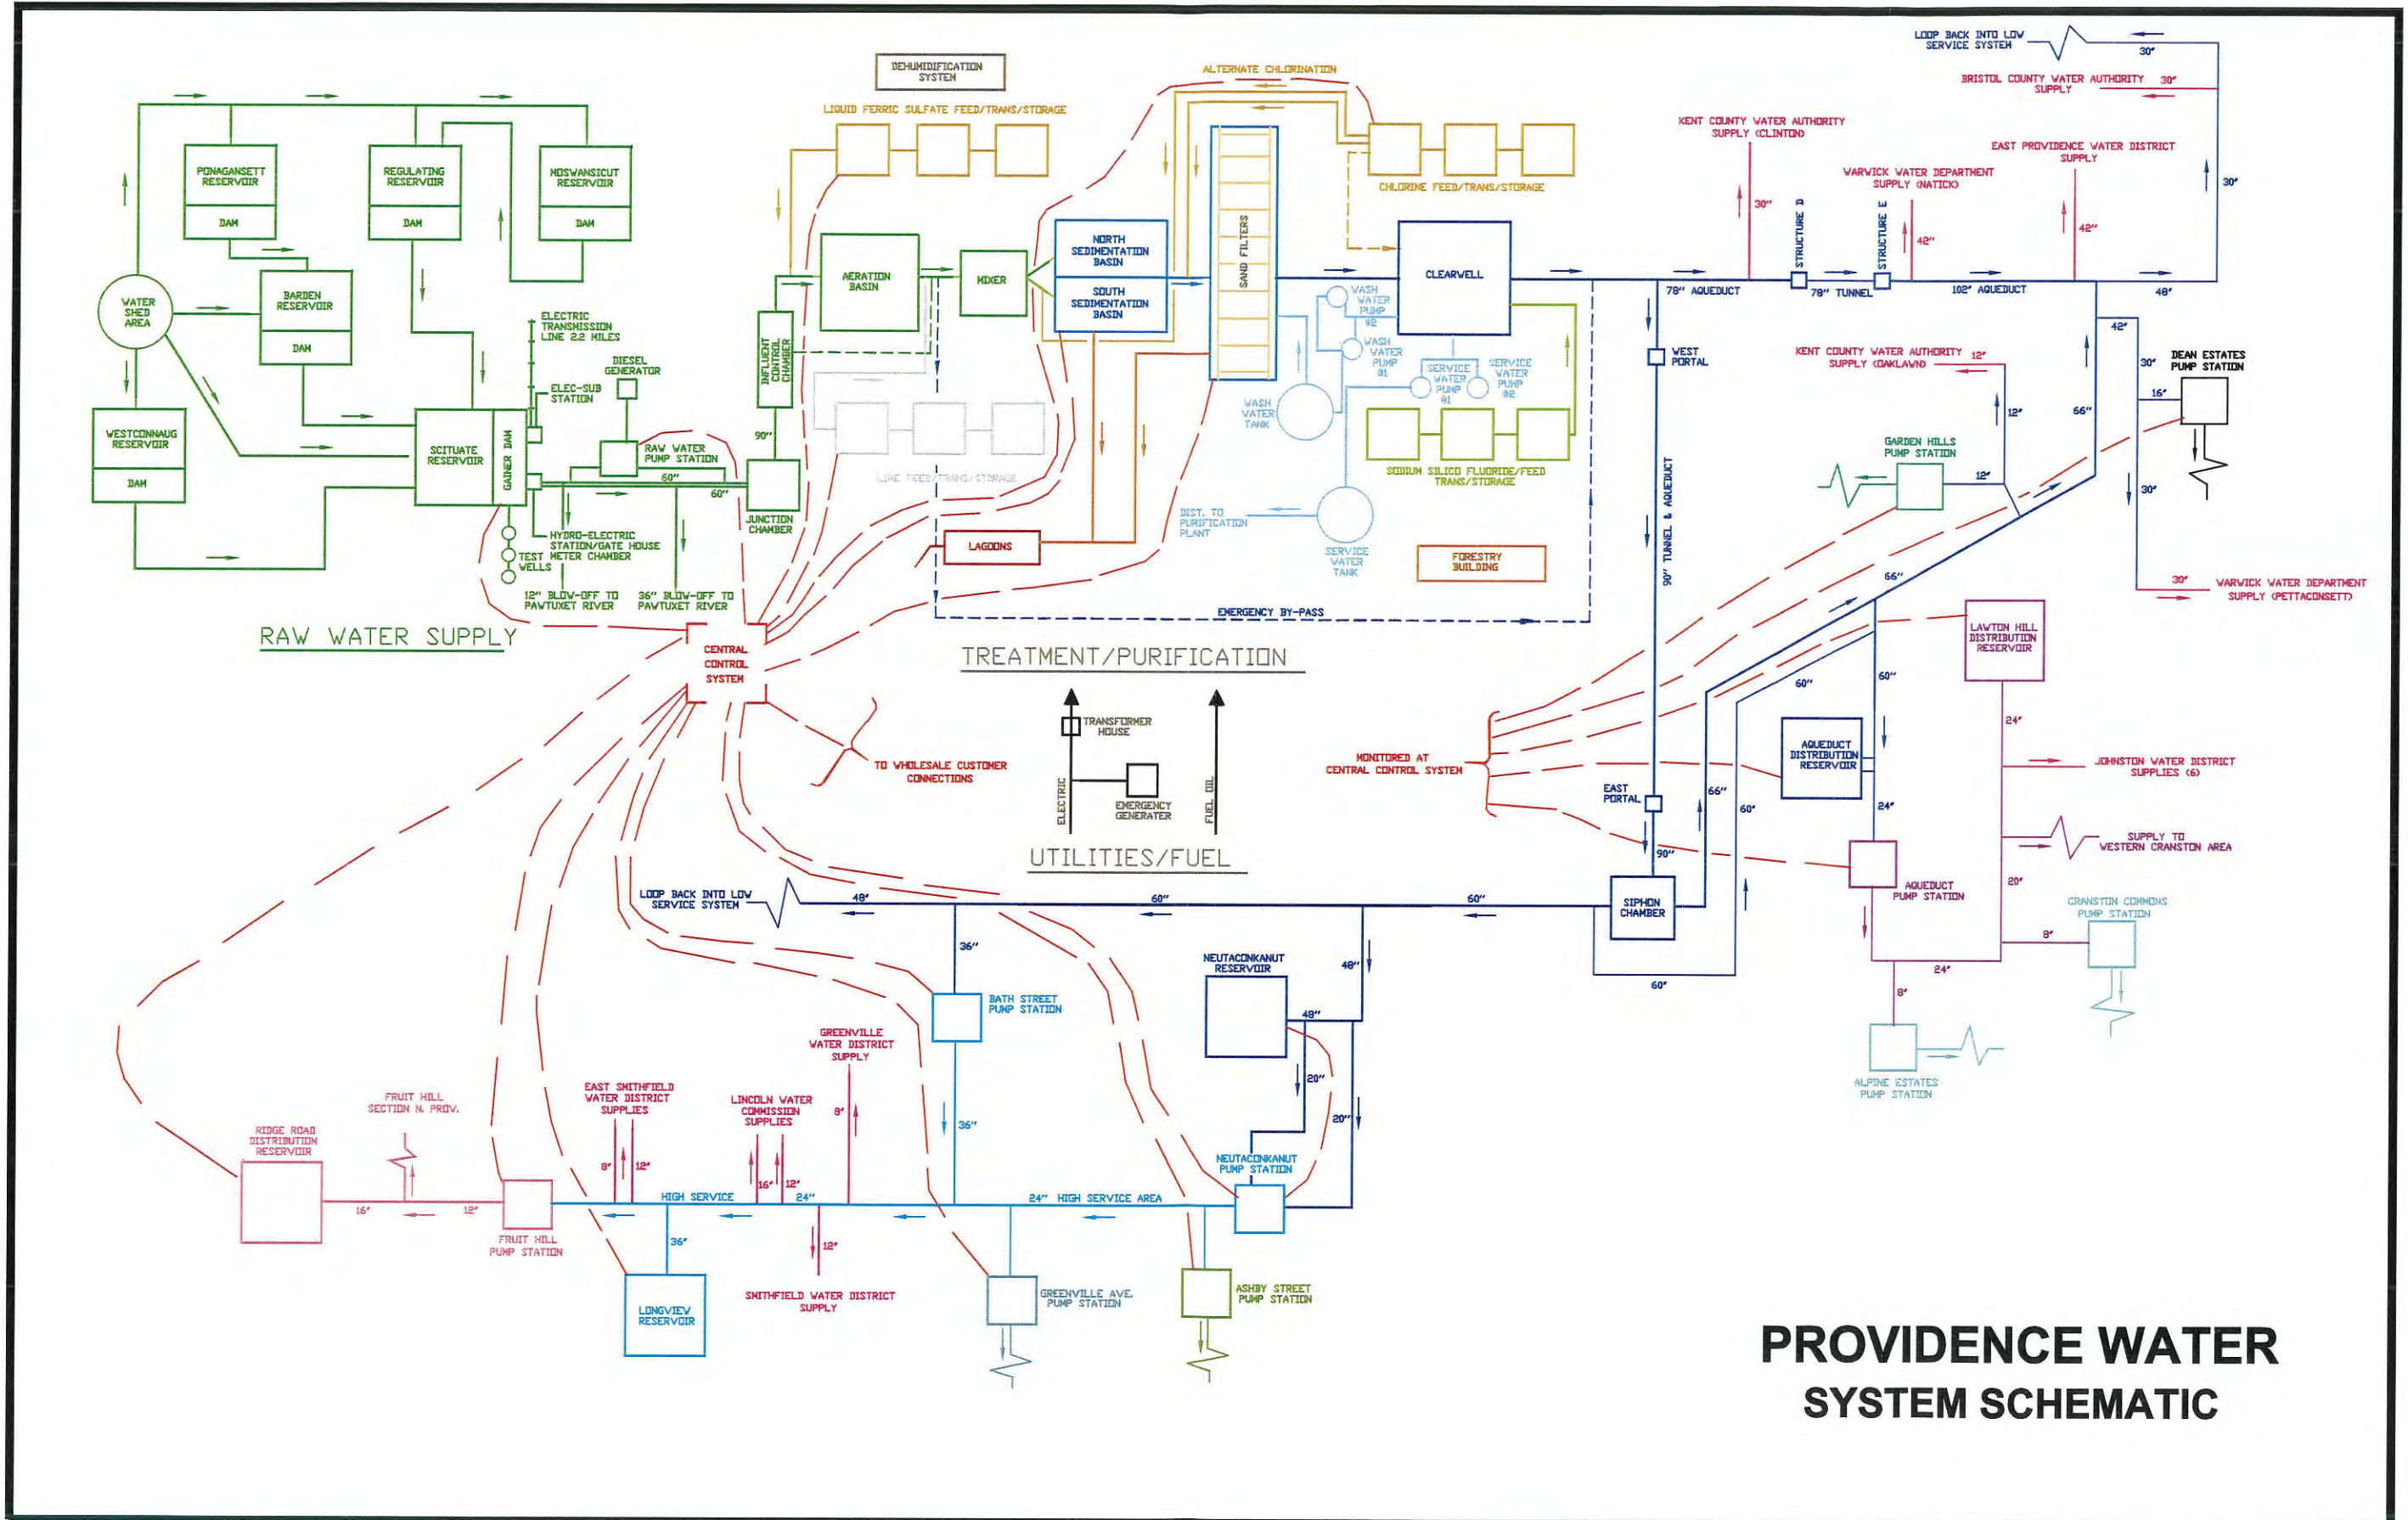
PROVIDENCE WATER SYSTEM SCHEMATIC

Exhibit 2 is a process diagram of the Providence Water Supply Board system. It shows in schematic form the sequence and inter-relation of the various water treatment and delivery processes.

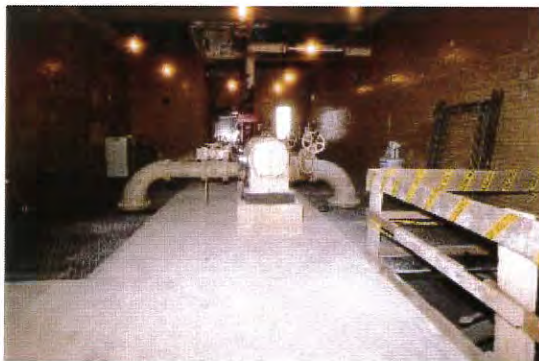
Construction is complete. Rehabilitation of the facility included replacing pumps, replacing suction and discharge piping, instrumentation and electrical system upgrades, architectural and structural improvements, and installation of an emergency power generator. Final pump control programming has been completed.

Bath Street Pump Station before upgrade

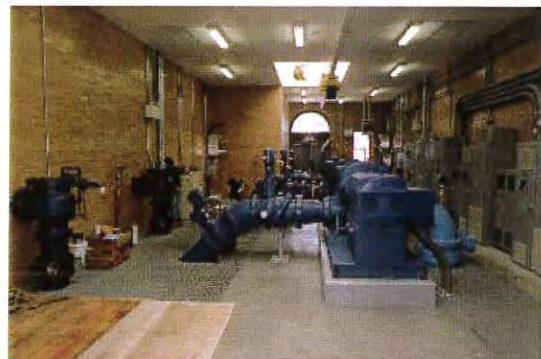
Bath Street Pump Station after upgrade

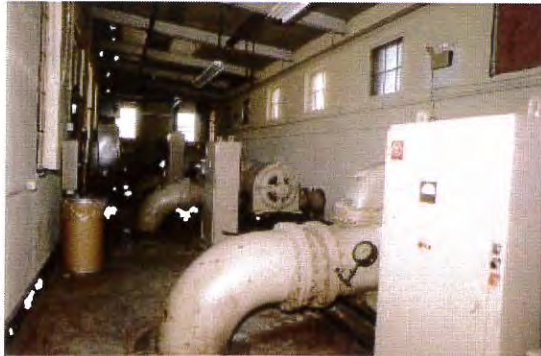
Construction is complete. Rehabilitation of the facility included replacing pumps, replacing suction and discharge piping, instrumentation and electrical system upgrades, and architectural and structural improvements. Final pump control programming has been completed.

Interior of Neutaconkanut Pump Station before rehabilitation

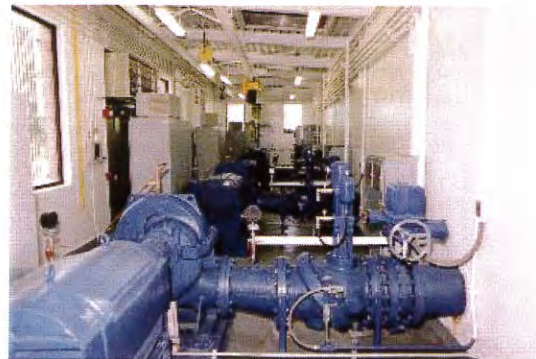
Interior of Neutaconkanut Pump Station after rehabilitation

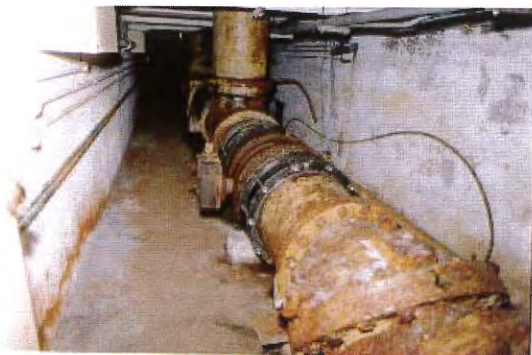
Neutaconkanut Pump Station piping before rehabilitation

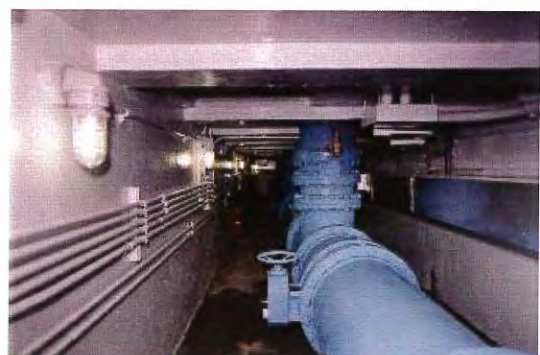
Neutaconkanut Pump Station piping after rehabilitation

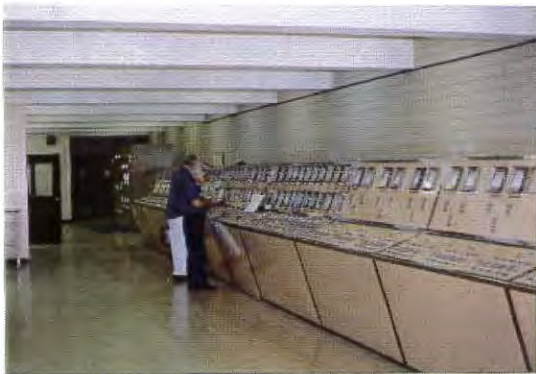
Old analog Central Control Board at treatment plant

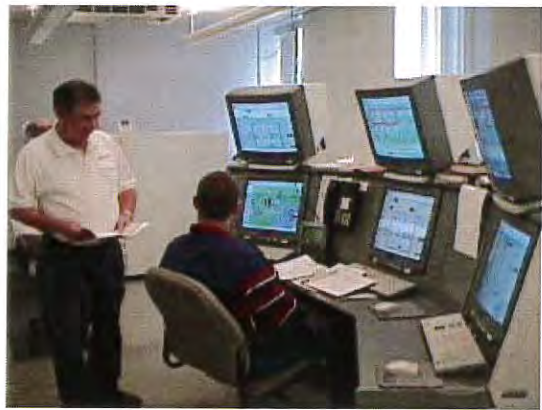
Construction to install a new computerized control, instrumentation, and data acquisition system at the treatment plant is complete. The system to monitor and control the operation of the entire treatment plant is now in operation. Construction of the new control room has been completed, process control equipment has been installed, all remote pump stations and reservoirs are on-line, and all of the in-plant points have been tied into the new control system. Wholesale facilities have been tied into the SCADA (Supervisory Control and Data Acquisition) system.

New state-of-the-art computerized Central Control System

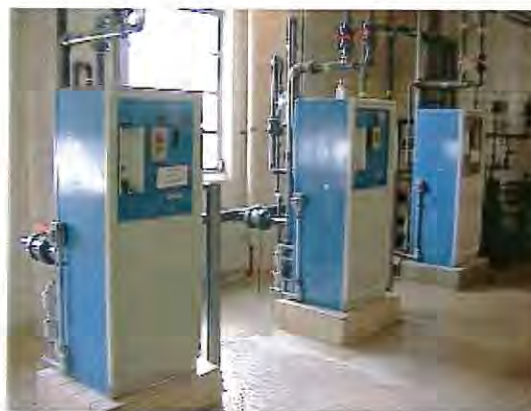
Construction is complete for enlarging the chlorine storage room and providing outside access only to the room. Chlorine feeders and storage equipment were replaced and a new emergency ventilation system has been installed in both the chlorine feed and storage areas.

New automated chlorine feeders at treatment plant

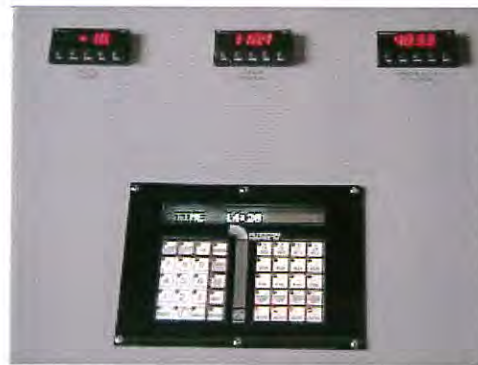
Consists of modernizing and replacing electronic instrumentation equipment at various pump stations and distribution reservoirs in the system. To date, transmitters and other equipment have been replaced at Fruit Hill, Garden Hills, Neutaconkanut, Western Cranston, and Dean Estates pump stations, and the Lawton Hills reservoir.

New electrical control system for Western Cranston Pump Station

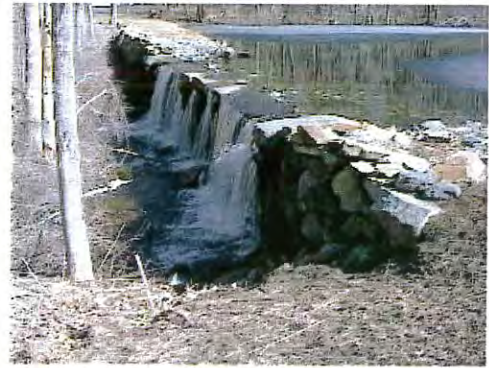
Burton Pond Dam

The project has been completed. The breached area of the earth/masonry dam has been reconditioned. Riprap was installed along the top upstream face of the dam to provide continued slope protection.

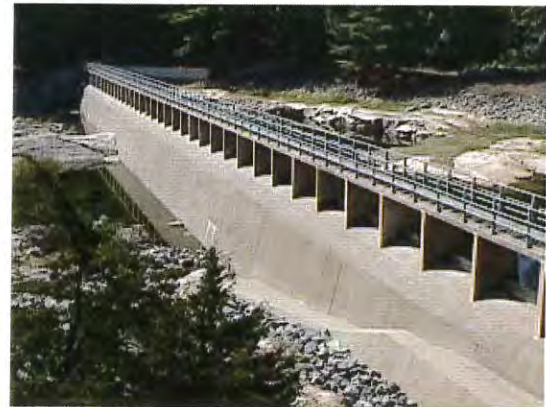
Construction has been completed to rehabilitate the 400 foot long Gainer Dam concrete spillway, the blowoff structure, and the meter chamber. Also completed was work to correct undermining of the Regulating Dam spillway structure footing.

400 foot Gainer Dam spillway showing new concrete facing

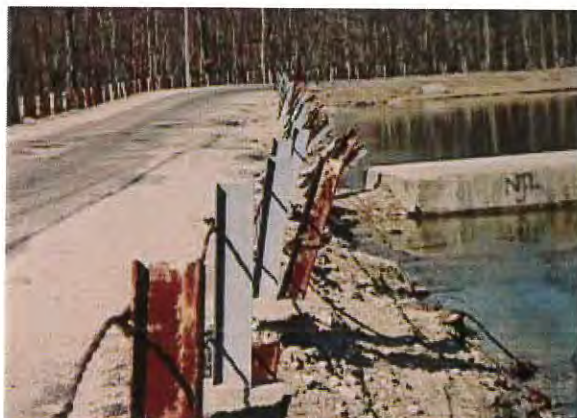
Construction is complete for the rehabilitation of Ponaganset Reservoir. Work included repair of dam erosion and placement of riprap, construction of a downstream buttress, restoration of the gate structure and outlet works, improvements to the discharge channel, and reconstruction of the road and drainage system over the dam

Ponaganset Reservoir before rehabilitation

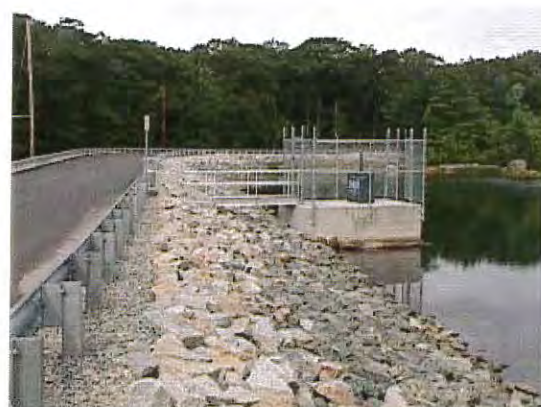
Ponaganset Reservoir after rehabilitation

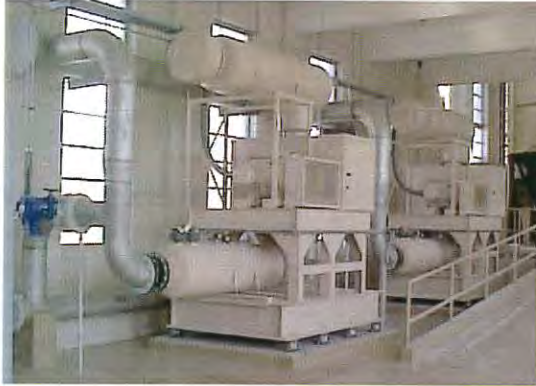
Installation of the new air blowers and piping for providing the capacity to air backwash the filters has been completed.

New air blower system at treatment plant for air scour backwashing of filters

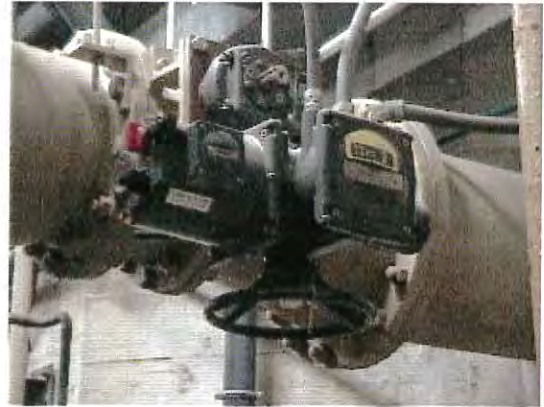
Typical new effluent valve actuator at treatment plant providing precise plant effluent control

Valve actuators for all of the plant's filters have been replaced with new internally programmable actuators that will provide improved effluent flow control and compatibility with the new control board system.

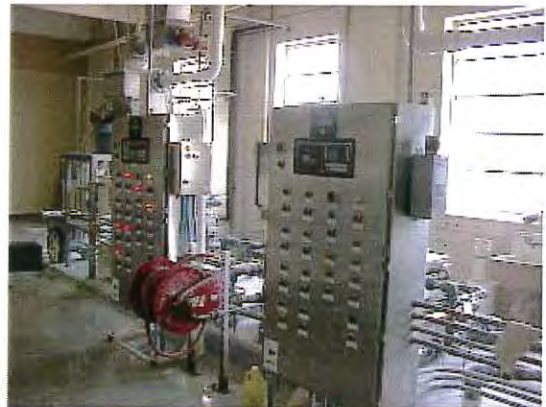
The old lime feeders at the plant have been replaced with 4 new feeders. New injection piping has been installed to provide for an additional lime injection point prior to raw water aeration for corrosion control optimization purposes. The corrosion control optimization measures are necessary as a result of the lead and copper rule.

Two of four new lime feeders installed at treatment plant

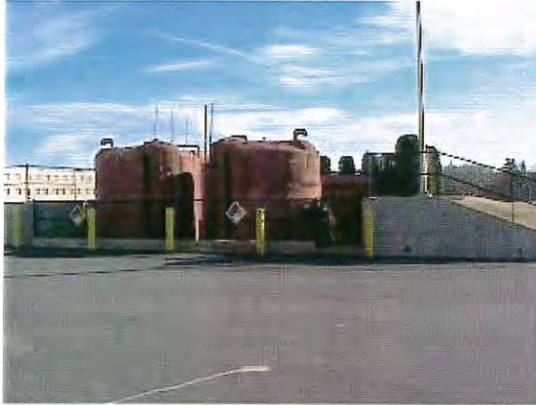
Installation of a new liquid feed system consisting of new chemical storage tanks, new feeder pumps, controls and piping has been completed. The system replaces the old problem-ridden dry feed system.

New liquid ferric sulfate storage tanks for new chemical feed system

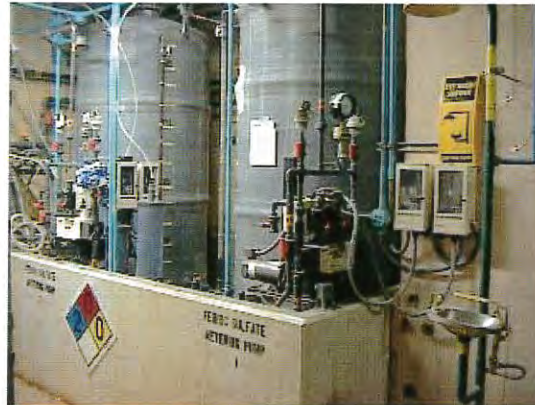
New sulfate feeder equipment and day tanks for liquid ferric sulfate coagulant injection

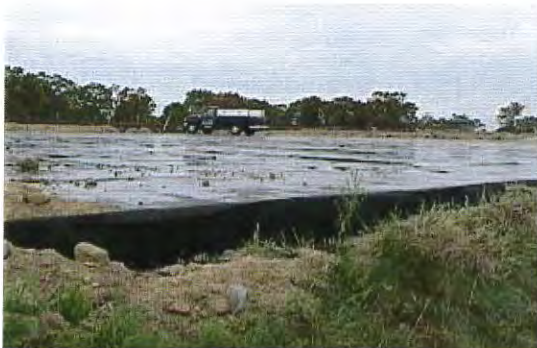
Construction is complete for the rehabilitation of the original section of Longview Reservoir. The rehabilitation work consisted of the application of a hot-applied reinforced rubber membrane sealant over the entire roof surface of the reservoir, sealing of all cracks and construction joints on the walls and floor of the interior of the reservoir, replacement of the sluice gate, and replacement of the stop shutters.

Rehabilitation and waterproofing of Longview Distribution Reservoir roof slab

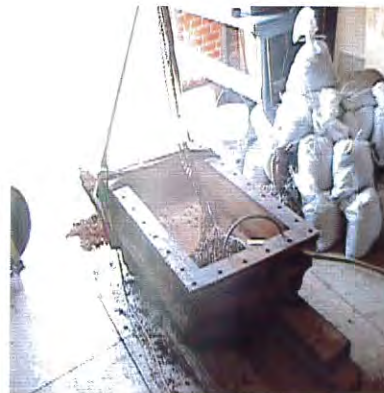
Old Longview Reservoir sluice gate being removed

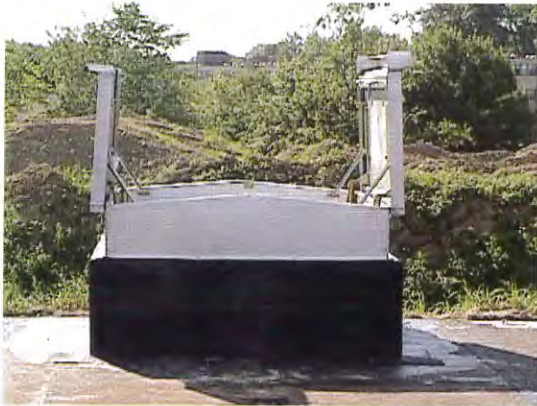
Construction is complete to rehabilitate Aqueduct Reservoir. Exterior waterproofing was conducted and application of a hot-applied reinforced rubber membrane sealant over the entire roof surface of the reservoir was installed. Cracks and construction joints on the interior walls and floor of the reservoir were sealed. Final acceptance of loaming and seeding is scheduled for the Fall of 2000.

Installation of new access hatch into the 43 million gallon Aqueduct Distribution Reservoir

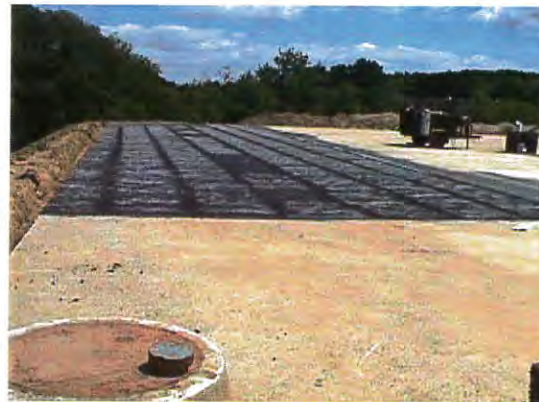
Rehabilitation and waterproofing application on top of Aqueduct Distribution Reservoir

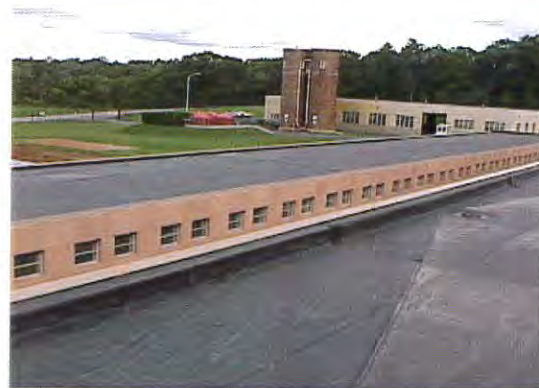
Construction consisted of the removal of the existing roof to the concrete deck and installation of new roof insulation and a new rubber membrane roof.

New treatment plant replacement roof

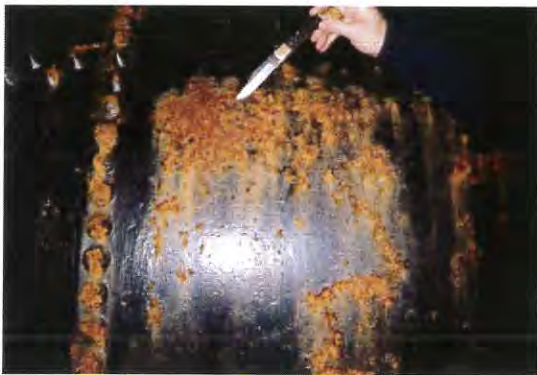
Corrosion on 60 inch main prior to rehabilitation

Construction was completed to rehabilitate and recoat the 900 feet long exposed portions of the twin 60 inch mains that run from underneath Gainer Dam to the treatment plant. Rusting was removed, the pipes sandblasted, and protective coatings applied.

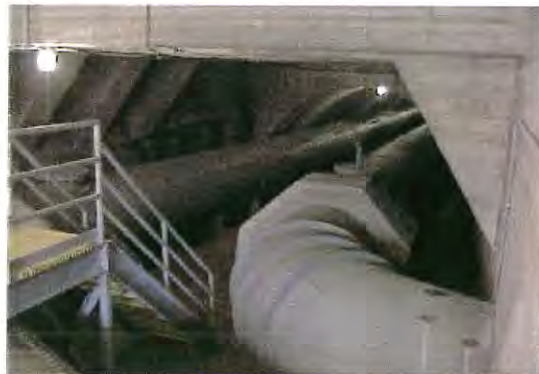
Twin 60 inch mains after rehabilitation

The exposed portion of twin 60 inch mains inside the junction chamber structure were sandblasted and protective coatings applied to protect against corrosion. In the process two lead joints that were found leaking were resealed.

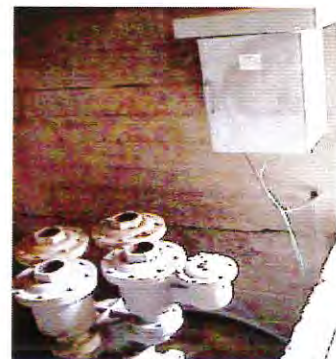
Electrical rectifier to provide cathodic protection to the twin 60 inch mains feeding raw water to the treatment plant

Construction has been completed to provide cathodic protection to 1000 feet of the underground portion of the two 60 inch riveted steel underground transmission mains that transport raw water from the Scituate Reservoir to the treatment plant. Four impressed current anode beds have been installed to complete the protection system.

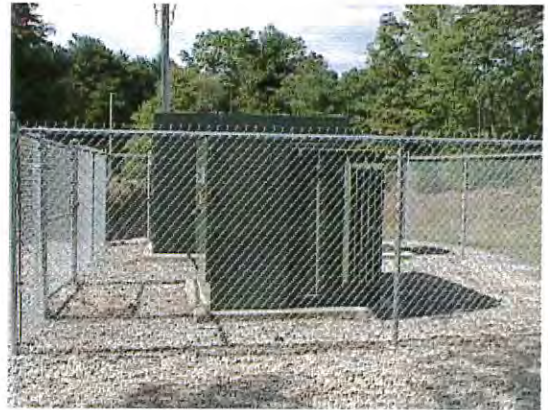
New 23,000 / 2,300 transformer and switchgear replacing obsolete electrical feed system to the treatment plant

Construction has been completed for replacement of the old 1920's vintage antiquated substation that fed the treatment plant, rehabilitation of the high voltage sub-transmission line from the Hope Substation to the new substation, replacement of the underground electrical feeders to the treatment plant with new above ground feeders, and provision of a 480 volt transformer and feed line into the plant. This essentially provides a completely new and reliable electrical feed service system to the plant.

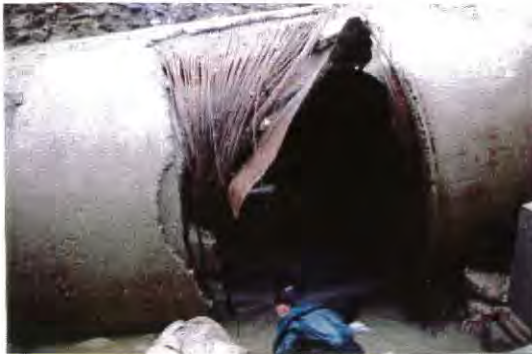
Rupture of the 102" Aqueduct – November 17, 1996

A portion of the 102" transmission aqueduct failed in November 1996. A failure analysis was conducted to determine the cause of the failure and corrective measures needed to prevent future failure. A risk assessment and internal inspection was performed between March 1998 and April 1998. The inspection and risk assessment resulted in recommendations to rehabilitate portions of the 102" main.

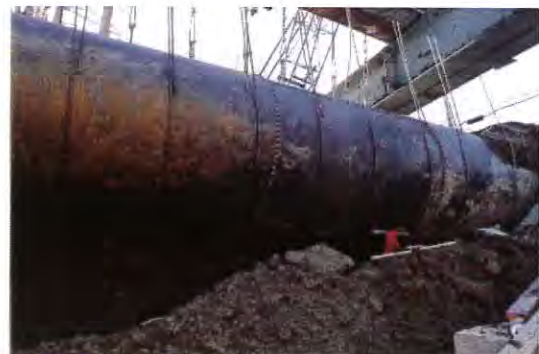
Temporary supports to adjacent 66" transmission main

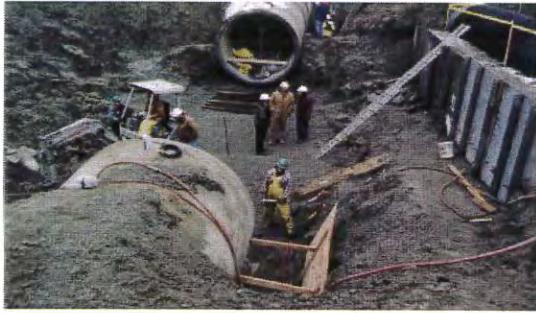
102" Aqueduct prepared for replacement sections

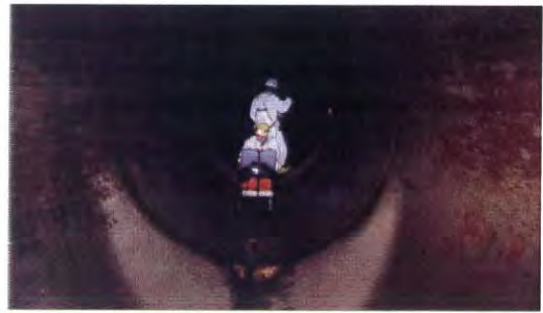
Impact Echo testing of 102" Aqueduct from interior

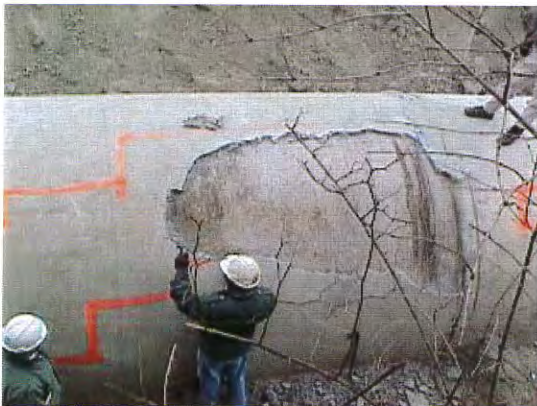
Exposing deteriorated section of 102" Aqueduct discovered through interior echo testing

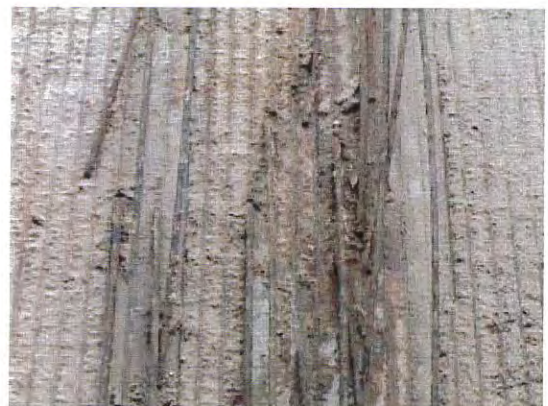
Close-up of failed pre-stressed wires of the 102" Aqueduct

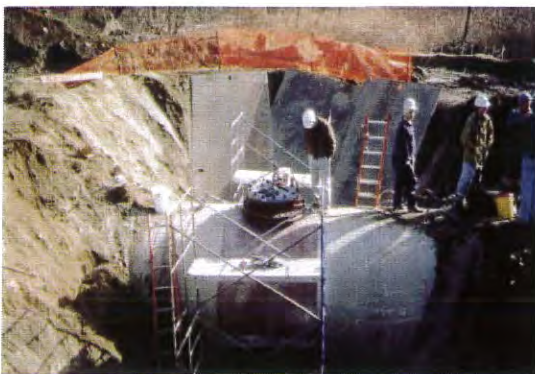
Installation of new access manhole into 102" Aqueduct

During January 2000, eleven sections of pipe were rehabilitated with carbon fiber linings, external restoration was conducted to seven sections of pipe with concrete mortar, and three manholes were installed for additional access and de-watering points. A 60" butterfly valve was installed at Budlong Road to replace a defective valve. Approximately 2.5 miles of the 5 mile long pipeline easement was cleared of trees and brush in order to have access to the pipeline for monitoring and maintenance. The entire 5 mile long pipeline route is now accessible by vehicle.

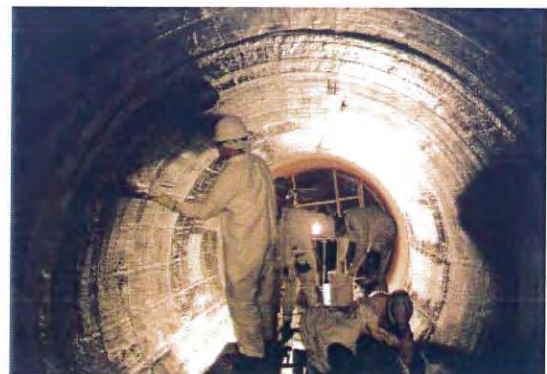
Crew applying Carbon Fiber Lining to interior of deteriorated section of 102" Aqueduct

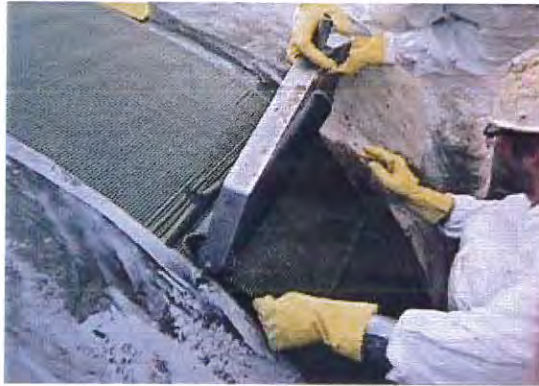
Application of carbon fiber to exterior of deteriorated section of 102" Aqueduct

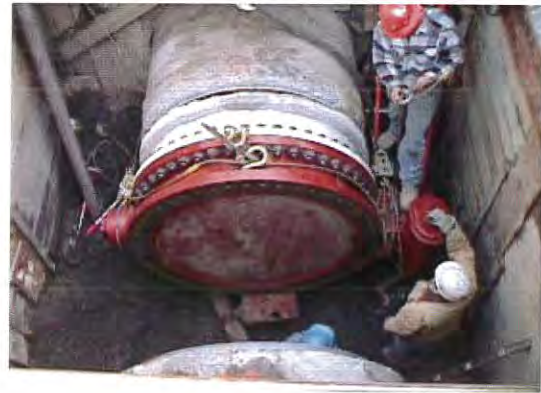
Installation of a new 60" butterfly valve to replace a defective valve at Budlong Road
