INFRASTRUCTURE REPLACEMENT PLAN

2001-2020

**Providence
Water**

INFRASTRUCTURE REPLACEMENT PLAN For Fiscal Years 2001 Through 2020

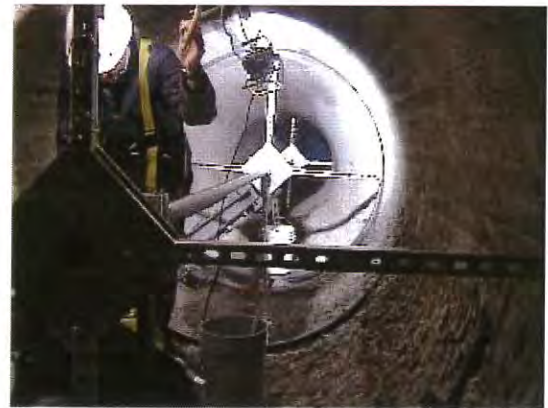
Concrete reconstruction and installation of new instrumentation in treatment plant's 72" x 42" effluent venturi meter

Construction is complete to rehabilitate the interior of the clearwell. Work consisted of rehabilitating eroded concrete surfaces and cracks, and leaking construction joints inside the interior of the structure. Also included in the scope was the structural rehabilitation of two cast-in place concrete 72" x 42" effluent venturi meters. The instrumentation has been fully restored with a new pressure sensing diaphragm type system replacing the annular rings. New process piping and signal wiring has been installed to carry the signal flow to the SCADA system.

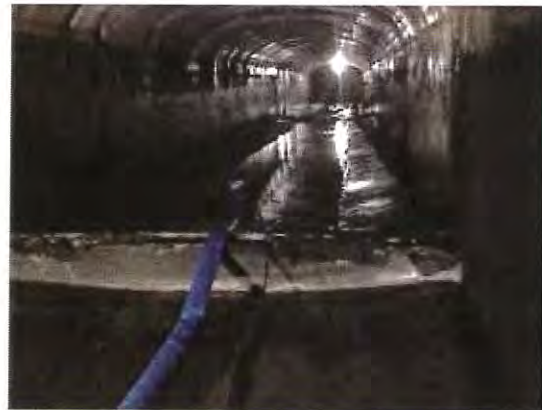
Interior of the Clearwell

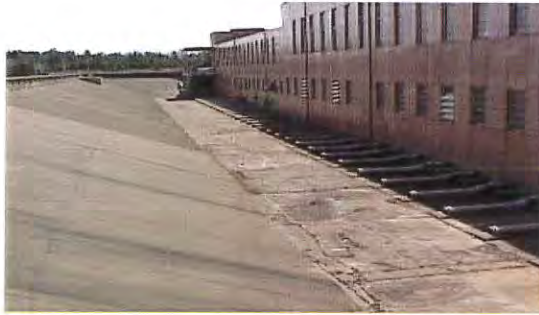
Effluent clearwell yard at treatment plant prior to rehabilitation

Construction is substantially complete for the rehabilitation of the area of the effluent yard located directly over the clearwell. The scope of work for the project consisted of installation of a new protective structure directly above the clearwell to eliminate the possibility of rainwater or contaminants from entering the clearwell. Also included was rehabilitation of the existing drainage system and replacement of deteriorated

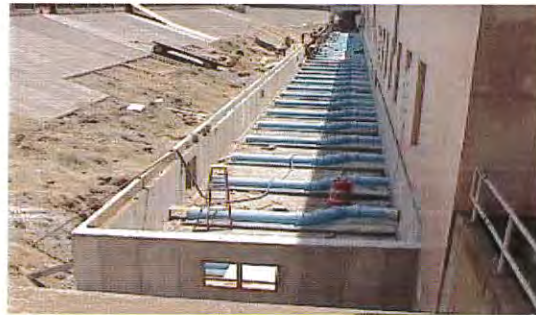
Construction of clearwell protective structure

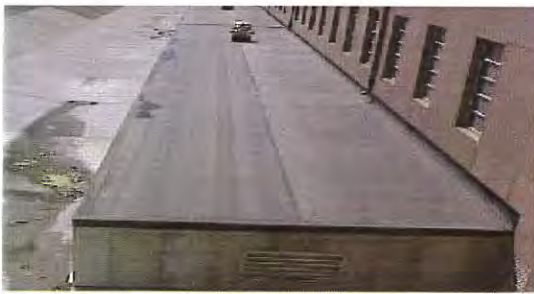
Completed clearwell protective structure

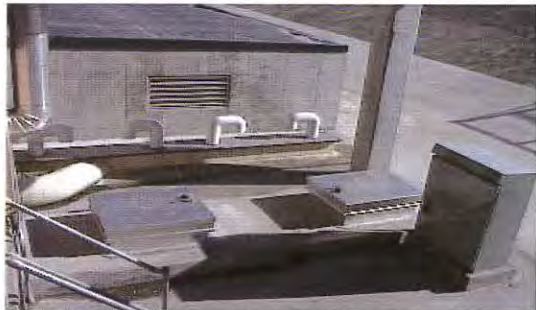
New Access Hatches and instrumentation panel installed over the opening of the venturi meters

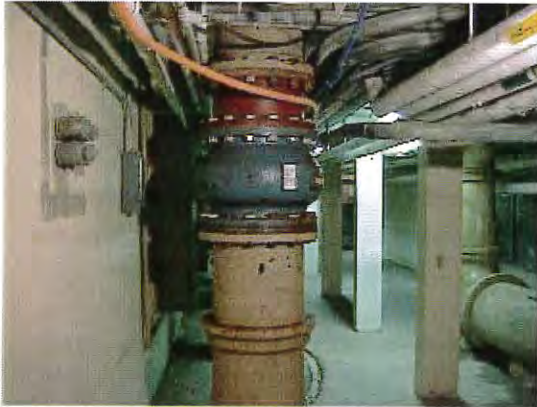
One of two new 18 inch check valves on suction lines to wash water pumps

Two 18" check valves on the washwater pump suction lines were replaced. The old check valves experienced leakage and were not capable of holding prime to the pumps.

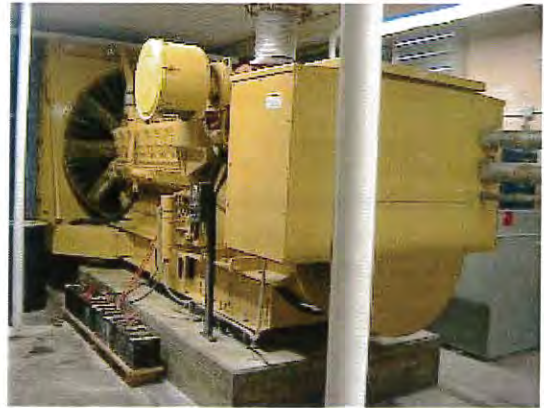
New Raw Water Booster Pump Station generator for backup power to treatment plant

In March 1996, the engine of the old diesel generator failed and became inoperable. The unit was obsolete and the cost made it unfeasible to further repair the generator. In December 1996 a new 2000 kW generator was installed to replace the old 1750 kW generator. This generator has the capacity to power the entire treatment plant and raw water pumps in the event of an emergency power outage.

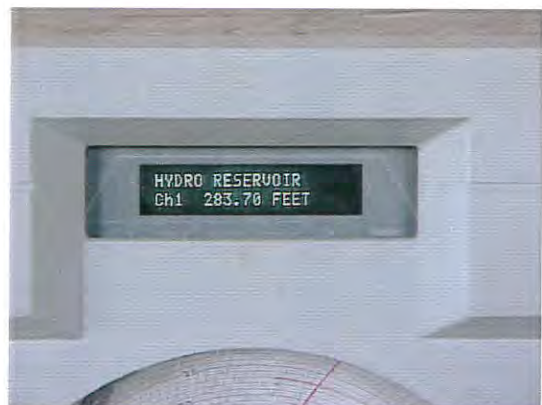
Gainer Dam reservoir elevation monitoring equipment

New sonar equipment was installed at Gainer Dam to replace older float style equipment in order to monitor reservoir elevations.

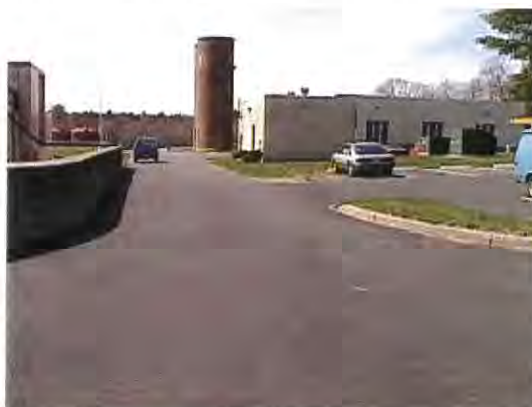
Rehabilitated north Access Road to treatment plant

Construction is complete for the restoration of the north access road leading into the treatment plant. The project consisted of removal of the deteriorated pavement and installation of a new bituminous concrete surface.

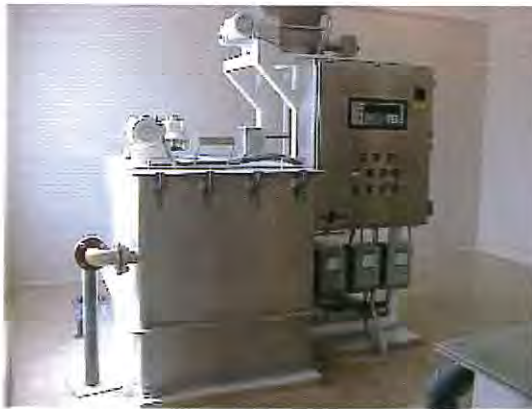
New fluoride feed equipment at treatment plant

Costs were associated with IFR projects that were in progress prior to the submission of the IFR plan commencing fiscal year 1996. These projects consisted of the elimination of the stormwater runoff from entering the filters; replacement of the fluoride feed equipment, and improvements to the pipe gallery wall.

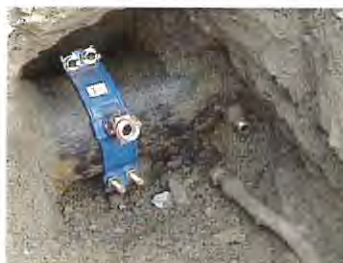
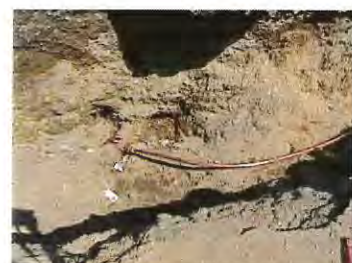
Typical lead service being replaced with a new copper service

Since the beginning of fiscal year 1996, 2907 lead services have been replaced. Replacement of lead services was significantly accelerated during the 1998 construction season to take advantage of the massive street repaving program conducted by the City of Providence.

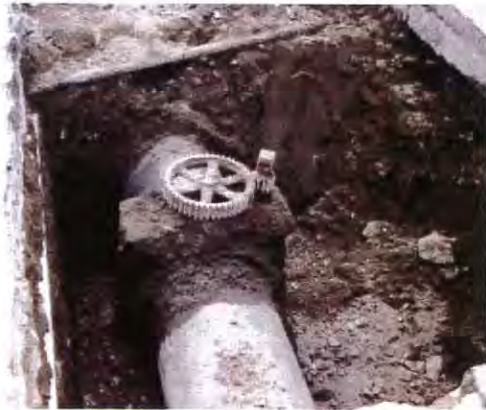
Antiquated 16 inch transmission gate valve prepared for replacement

Three separate contracts were completed for replacing 61 old and outmoded transmission valves in the system. The old gate style valves were replaced with new butterfly valves. The valves were comprised of the following sizes: two (2) 16", thirty-six (36) 24", nineteen (19) 30", and four (4) 42".

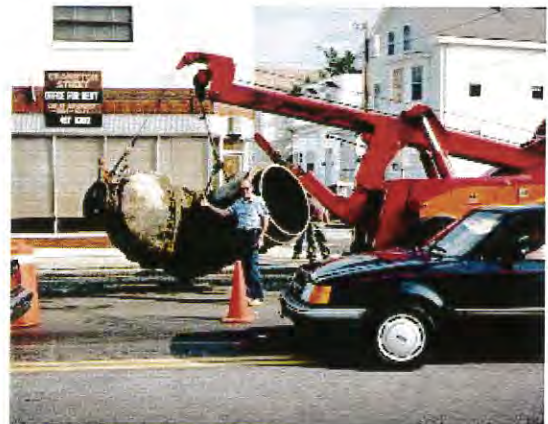
Removal of old 42 inch transmission gate valve

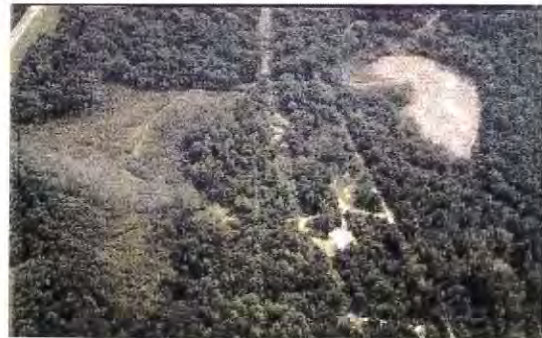
Aerial view of settling lagoons prior to sludge removal

Removal of sludge from lagoon #1 began in June 1998. Approximately 23,000 dry tons of ferric sludge were dredged and disposed of. Under the continuing contract, an additional 64,000 wet tons of sludge will be removed over the next five years. A new culvert and stop-log structure was installed between both sections of the lagoon to replace the existing clogged culvert and to provide better control of the deposit of residuals. The overall project consists of the removal, dewatering, and disposal of accumulated sludge from all of lagoon #1 to replace lost storage capacity.

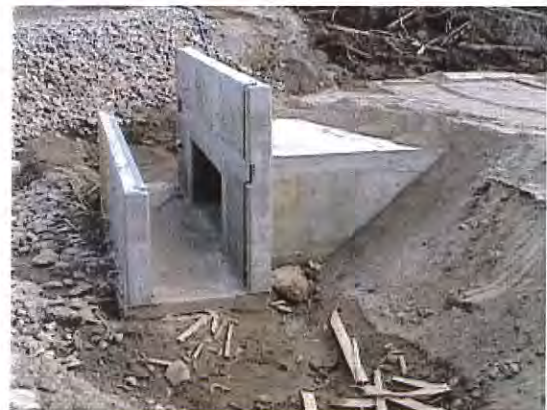
New culvert and stop-log structure prior to final backfill

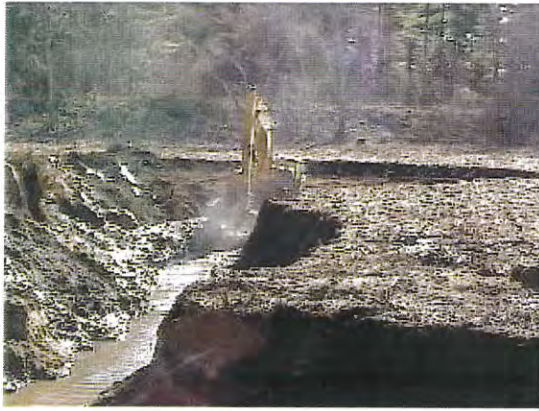
Sludge lagoon at the beginning of dredging operations

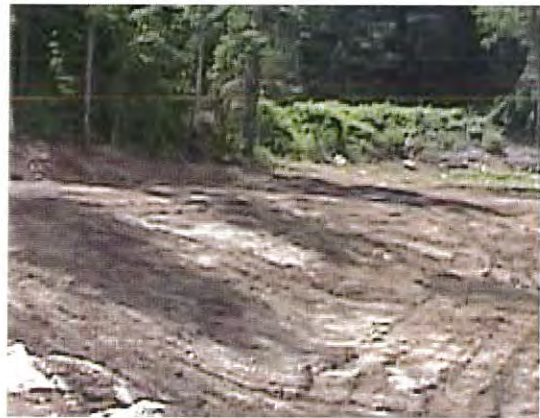
Sludge lagoon after dredging operations

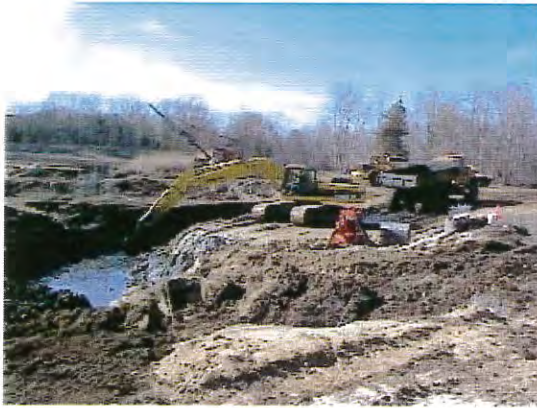
Sludge lagoon dredging operations in progress

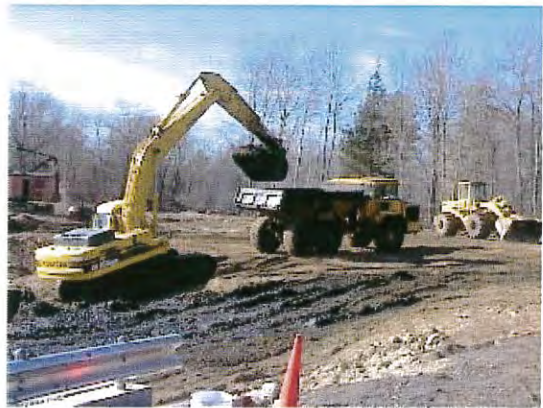
Sludge lagoon dredging operations in progress

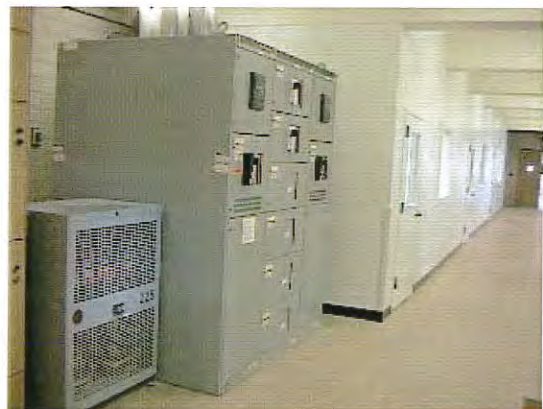
New 480 volt transformer and motor control center at treatment plant

A design / build project has been completed to supply power from the 175 kW generator located in the transformer house to the 480 volt motor control center located inside the treatment plant. The generator formerly provided power to only the older 550 volt equipment. The project enabled power supplied from the 175 kW generator located outside the plant to feed both the 550 volt and the new 480 volt motor control centers. As equipment is being upgraded, PW is converting the outmoded 550 volt system to the standard 480 volts.

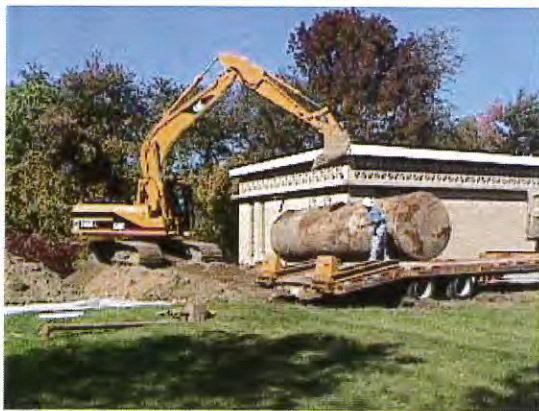
Removal of old underground fuel storage tank at the Western Cranston Pumping Station

Two (2) underground fuel storage tanks have been removed and replaced with two (2) above ground tanks at Raw Water Booster pump station and the Western Cranston pump station at Aqueduct Reservoir. On another regulated tank in Scituate leak monitoring equipment was installed, and modifications were made to the suction and return piping to comply with DEM regulations.

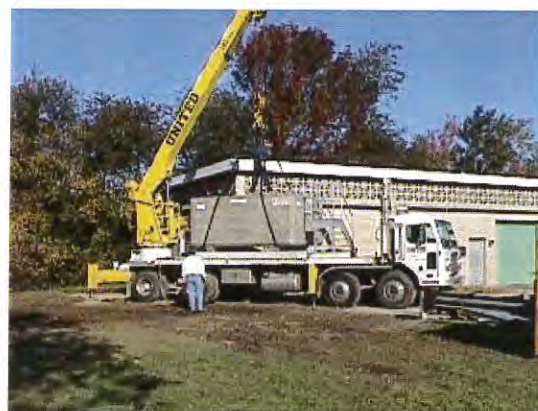
Delivery of new above ground fuel storage tank at the Western Cranston Pumping Station

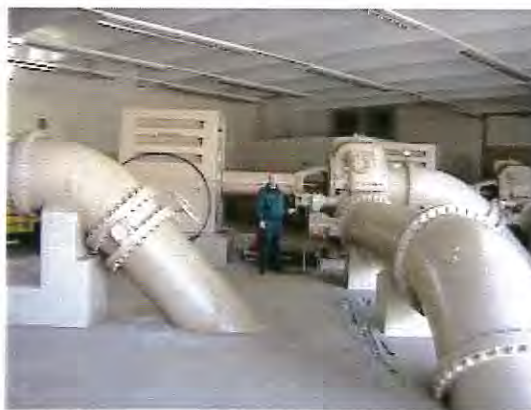
Existing Raw Water Booster pumps and valves

Additionally, the suction and discharge valves for each of the four Raw Water Booster Pumps inside the station were evaluated. All eight suction and discharge valves located inside the pump station do not provide a complete seal. Construction specifications have been advertised replace all eight valves and PW is in the process of evaluating the bids.

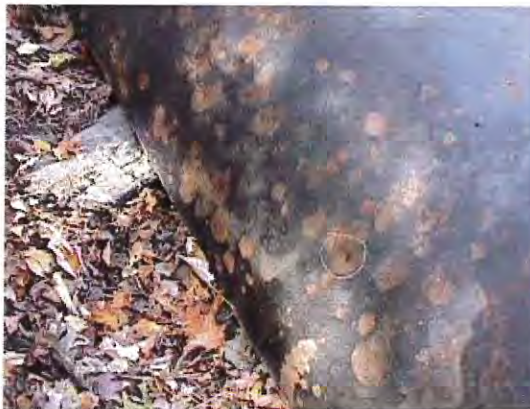
Exterior corrosion of 48" steel transmission main prior to rehabilitation

In 1990, a preliminary corrosion evaluation was conducted on a section of 48" steel transmission main that recommended corrosion protection of the structure to arrest any further deterioration.

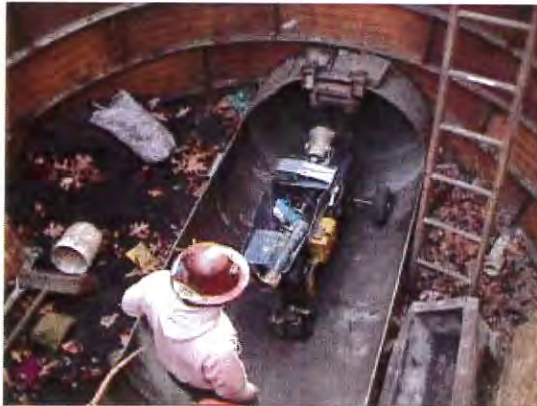
Interior cement mortar lining machine in 48" steel transmission main

In addition to cathodic protection, approximately 1400 feet of the 48" steel water main from Budlong Road to Reservoir Ave. was cleaned and relined with cement mortar to eliminate the leaks that were found on the main.

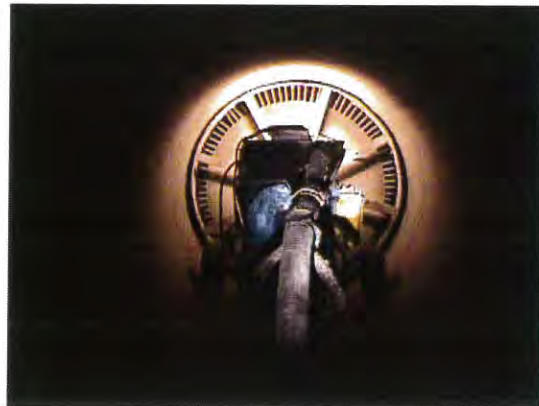
Lining machine applying and troweling cement mortar in 48" steel transmission main

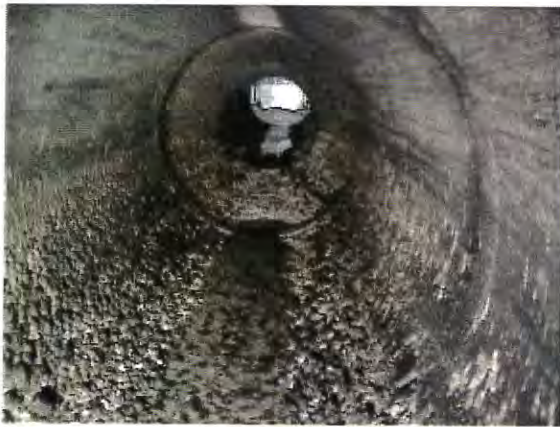
Concrete corrosion damage to the lower half of the effluent conduit

Extensive concrete corrosion damage was discovered in the treatment plant effluent conduit during the rehabilitation of the south venturi meter. Subsequently, a video inspection in mid November 1999 revealed further extensive concrete corrosion damage continuing along the 90" aqueduct as it leaves the plant. Following the inspection, cracks and joints that were found leaking were sealed to eliminate any outside source of water from entering the conduit.
