STATE OF RHODE ISLAND AND PROVIDENCE PLANTATIONS

Department of Administration

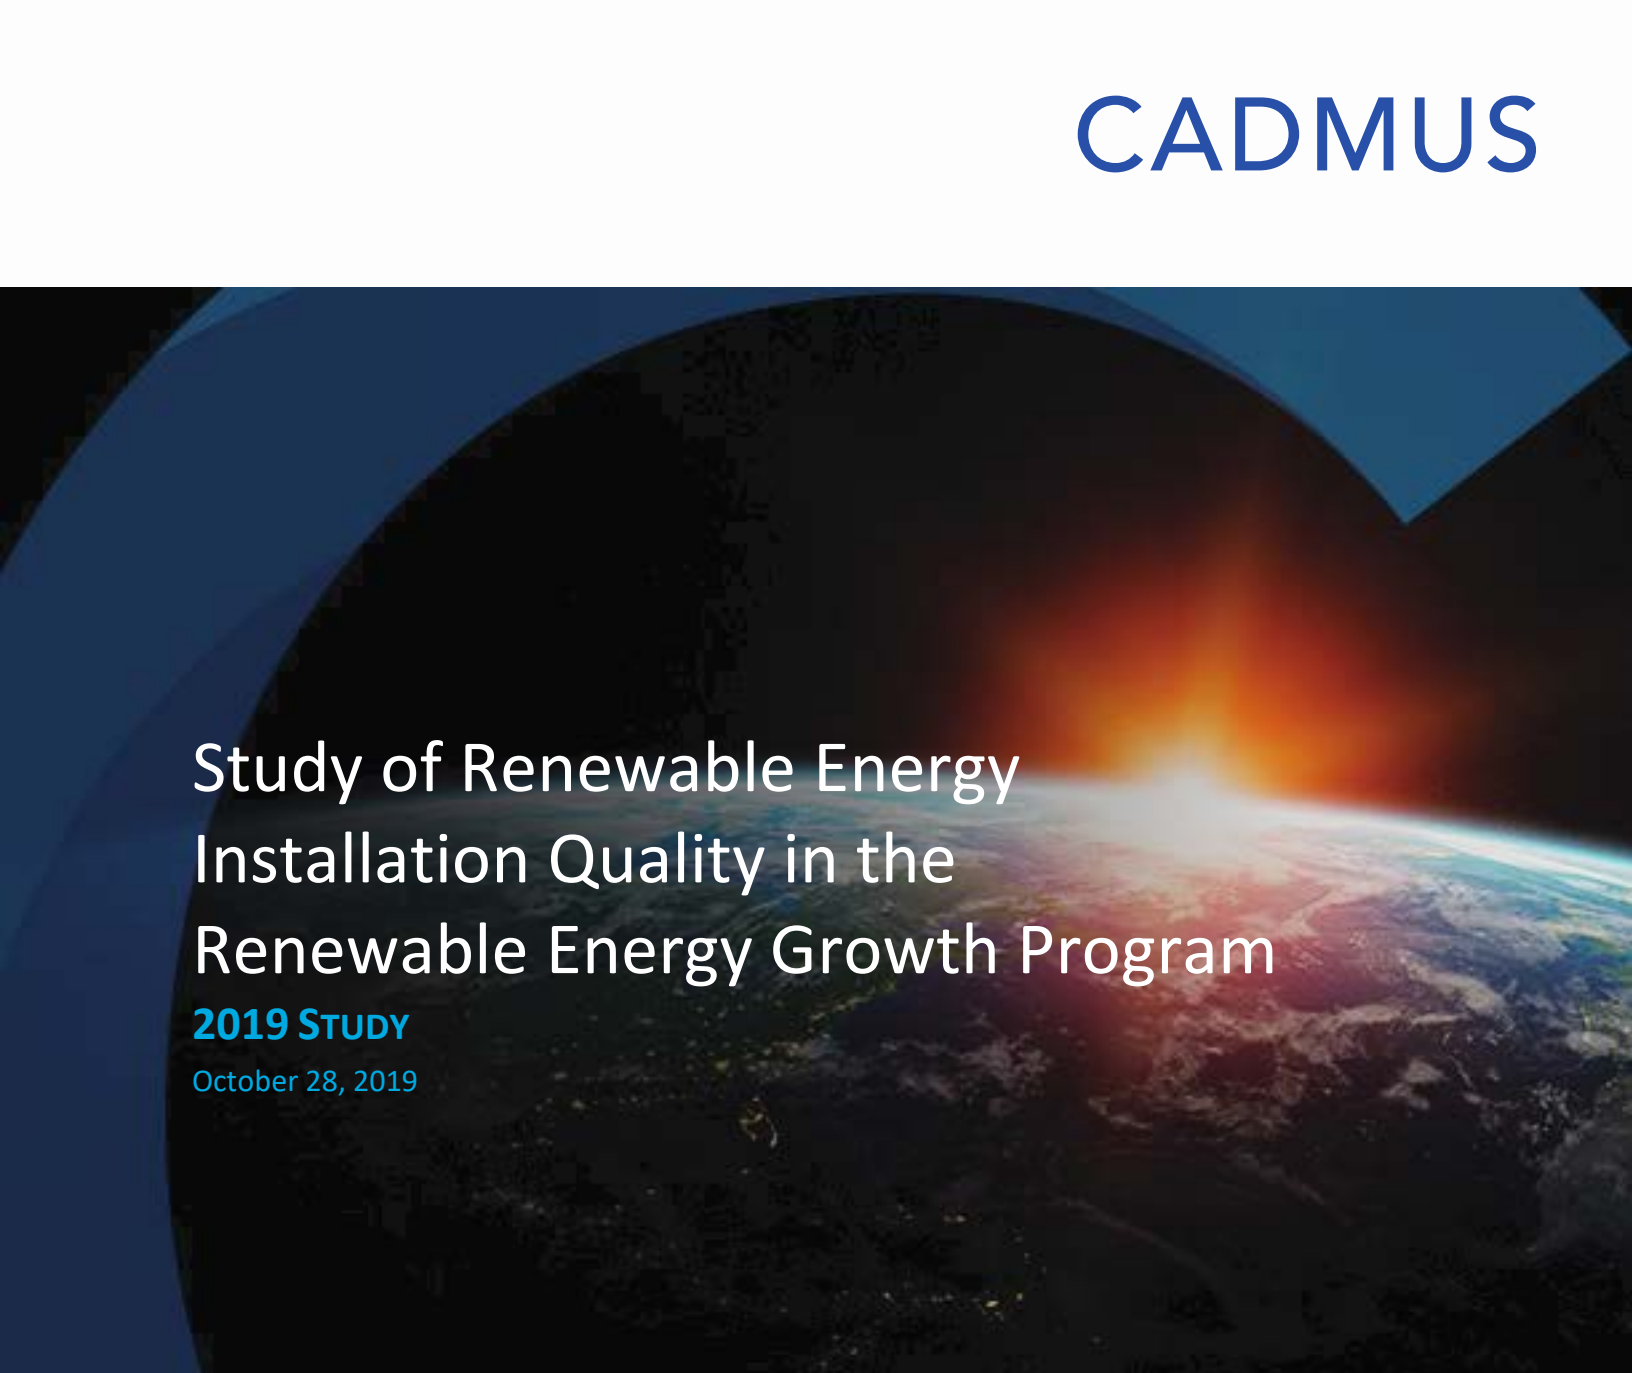
Study of Renewable Energy Installation Quality in the Renewable Energy Growth Program

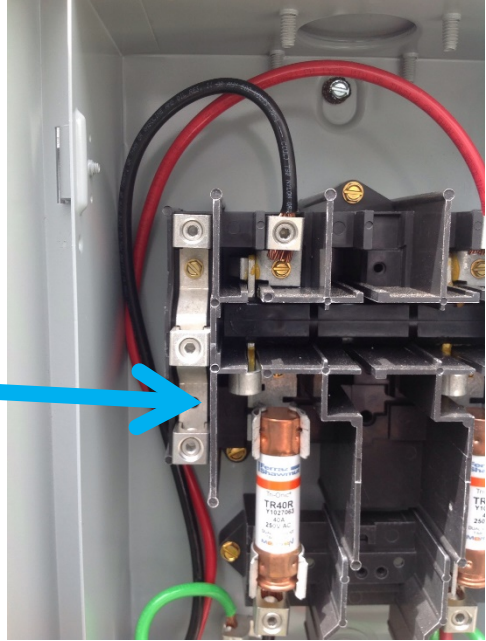
<p>Potential Impacts When a grounded conductor is not bonded in the PV service disconnect enclosure, it may not have an effective reference if a fault occurs. The main bonding jump helps limit the voltage imposed on the system by lightning or other fault sources.</p>	
<p>Best Practices The most common type of connection uses a screw, provided by the disconnect manufacturer. The screw should be installed to bond the grounded conductor to the equipment and grounding electrode system.</p>

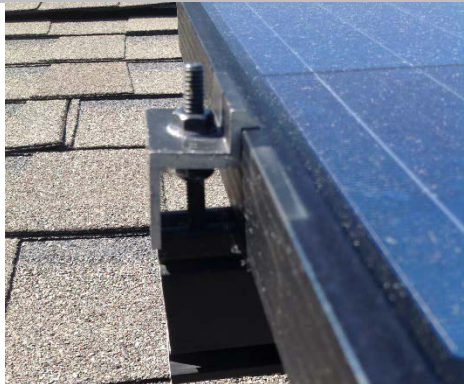
<p>Potential Impacts Modules not properly secured to racking pose a risk of falling from the array. These include improper or missing hardware, or modules secured at improper locations.</p>	
<p>Best Practices Equipment should be installed in accordance with manufacturers' installation instructions.</p>

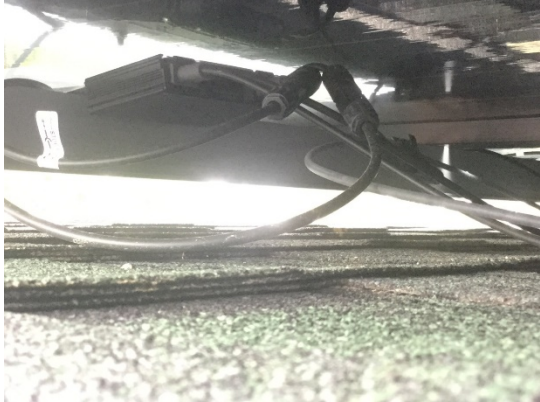
<p>Potential Impacts Conductors exposed to damage from rooftop debris, sharp edges, and abrasive surfaces may have damaged insulation, increasing the likelihood of a ground fault and shock hazard.</p>	
<p>Best Practices To protect them from damage, conductors should be secured using durable methods (such as stainless-steel clips).</p>

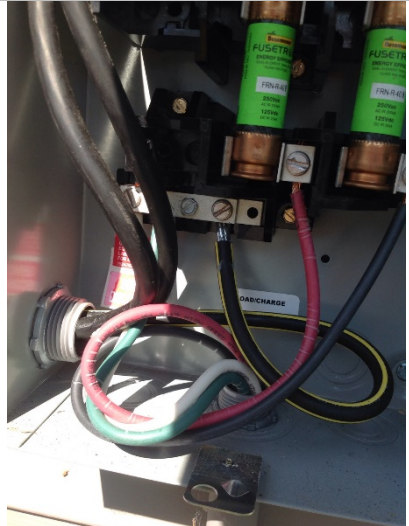
<p>Potential Impacts Failure to ground service disconnect enclosures can pose personnel risks if a fault occurs.</p>	
<p>Best Practices Service disconnect enclosure should be grounded to protect personnel.</p>

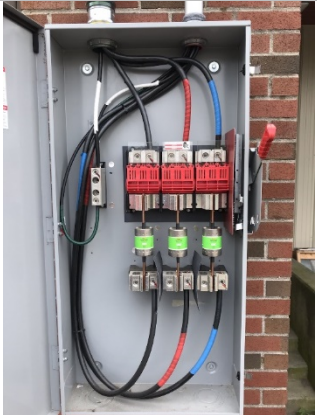
Potential Impacts For an undersized unit experiencing a fault, a GEC may not carry current or may overheat, creating a potential fire hazard. Grounding must be indicated.	
Best Practices Consideration should be given to electrode conductor size. GEC should be green and clearly grounded.

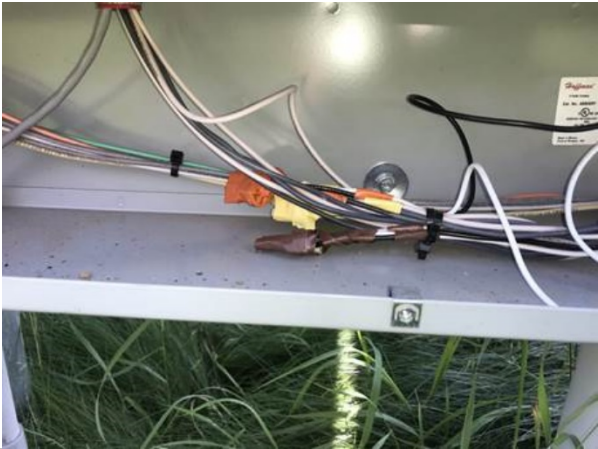
Potential Impacts Due to the fact that junction box splice components are not listed for or rated for wet location use, corrosion from the environment will create additional resistance and may eventually lead to a fire hazard.	
Best Practices Wiring within junction boxes should always be rated for its environment.

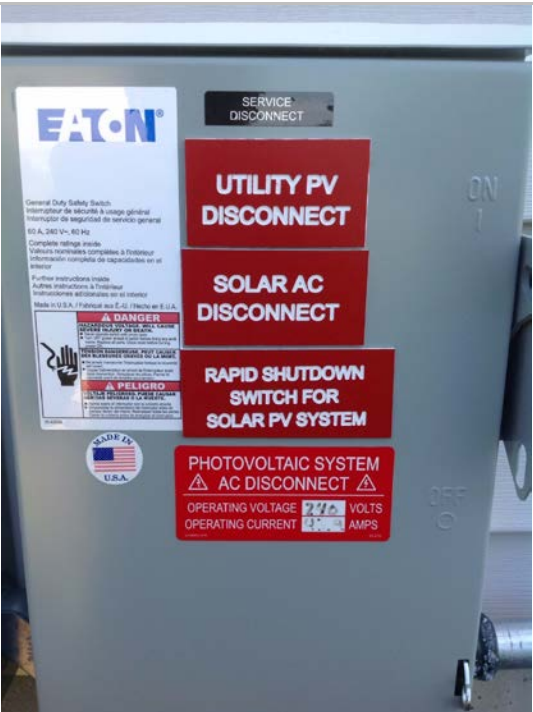
Potential Impacts Improper labeling of AC combiner, in this case in a matter that is not suitable for environment (permanent marker), which if faded or removed could cause potential personnel hazard onsite.	
Best Practices Utilization of proper NEC rated labeling indicator(s).

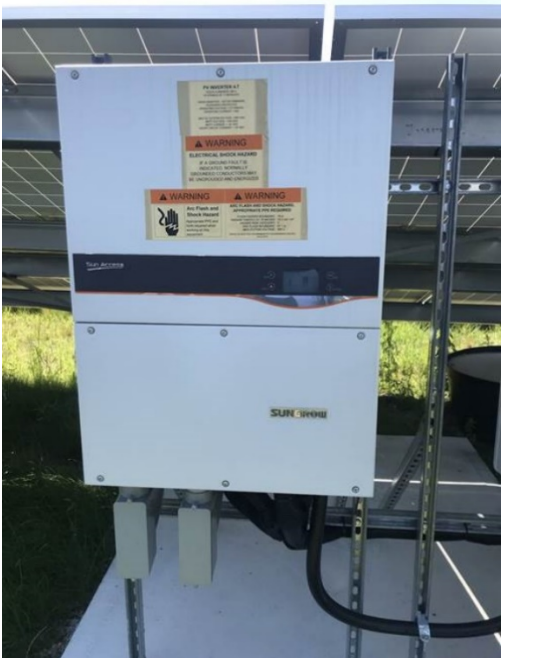
Potential Impacts Properly labeling system components proves important for the safety of those working on the system. Personnel must know the details and dangers of working on the equipment for safe servicing and maintenance.	
Best Practices Enclosures containing circuit breakers should be identified to allow the safe isolation of equipment during maintenance. All equipment should include the required hazard markings, as outlined in the code.

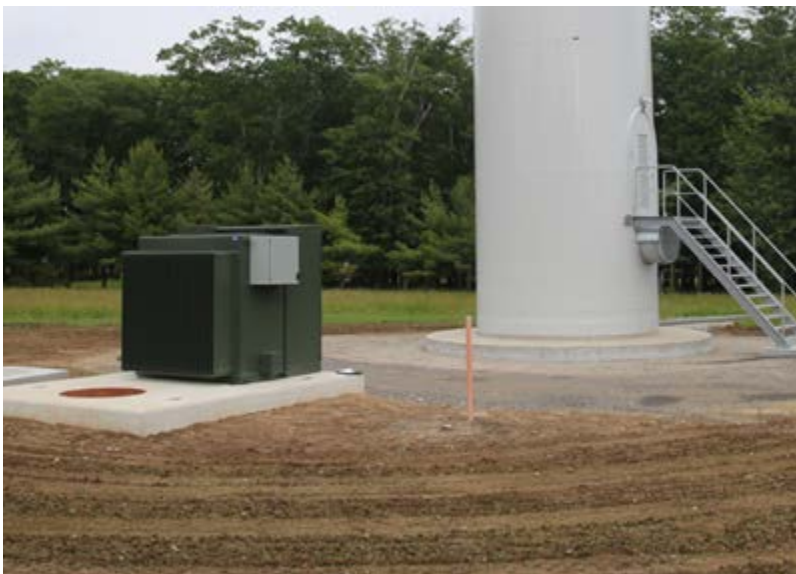
Installer Responsiveness to Quality Installation Issues
