Property Condition Assessment

125 Dupont Drive
Providence, RI

June 2015

RE: Property Condition Assessment Report
Proposed Central Operations Facility
125 Dupont Drive, Providence RI

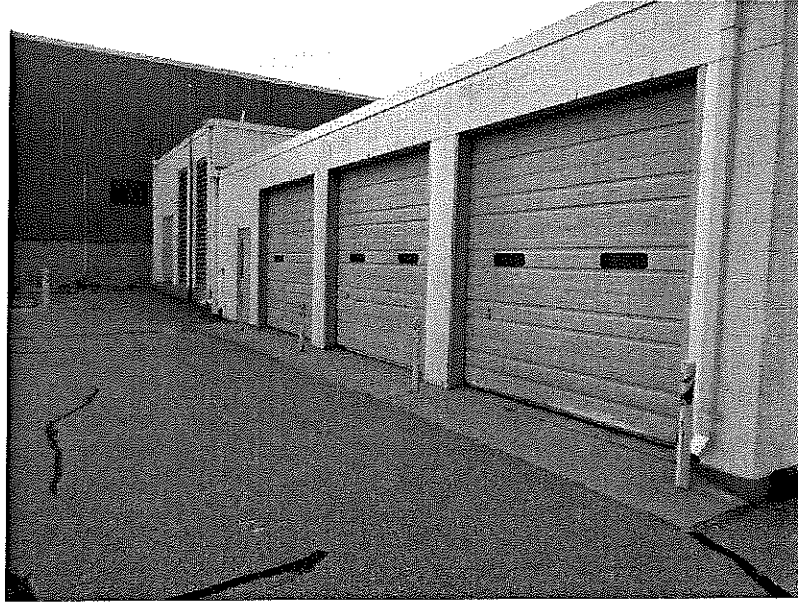
Photo A-7: Concrete masonry façade at garage in north eastern corner

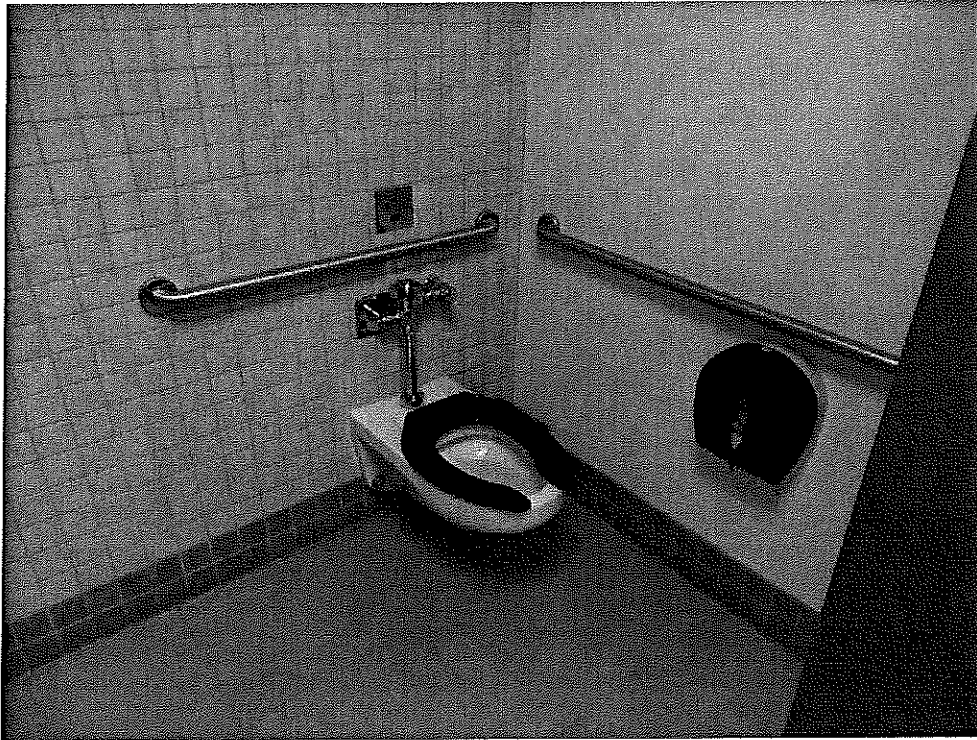
Photo B-7: Accessible Toilet (Typical)

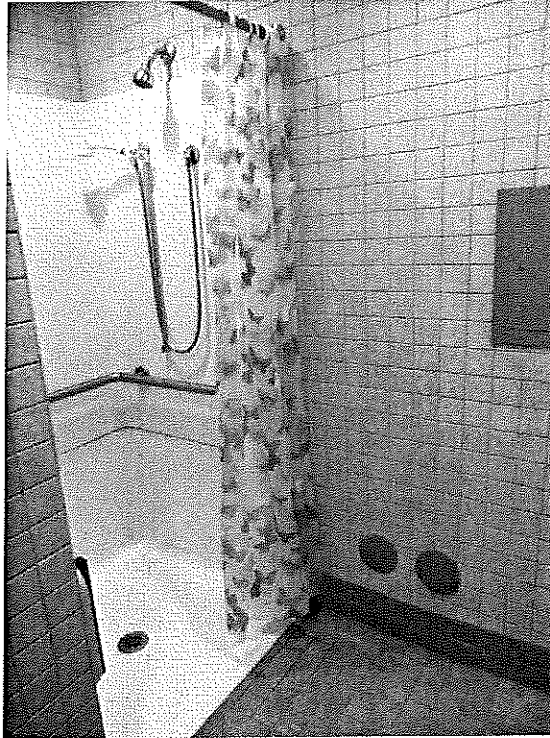
Photo B-9: Shower Stall (Typical)

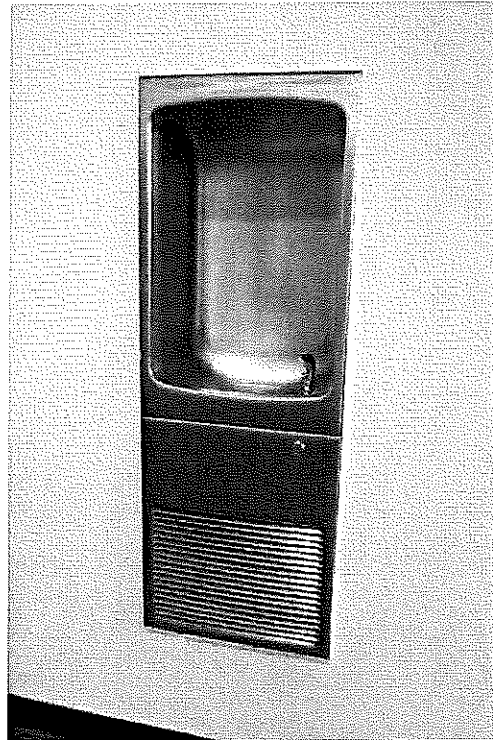
Photo B-18: Water Coolers (Typical)
